Environment Assisted Cracking of Target Structural Materials Under Different Loading Conditions

ENVIRONMENT ASSISTED CRACKING OF TARGET STRUCTURAL
MATERIALS UNDER DIFFERENT LOADING CONDITIONS

Master of Science Degree in Mechanical Engineering
Department of Mechanical Engineering
Howard R. Hughes College of Engineering

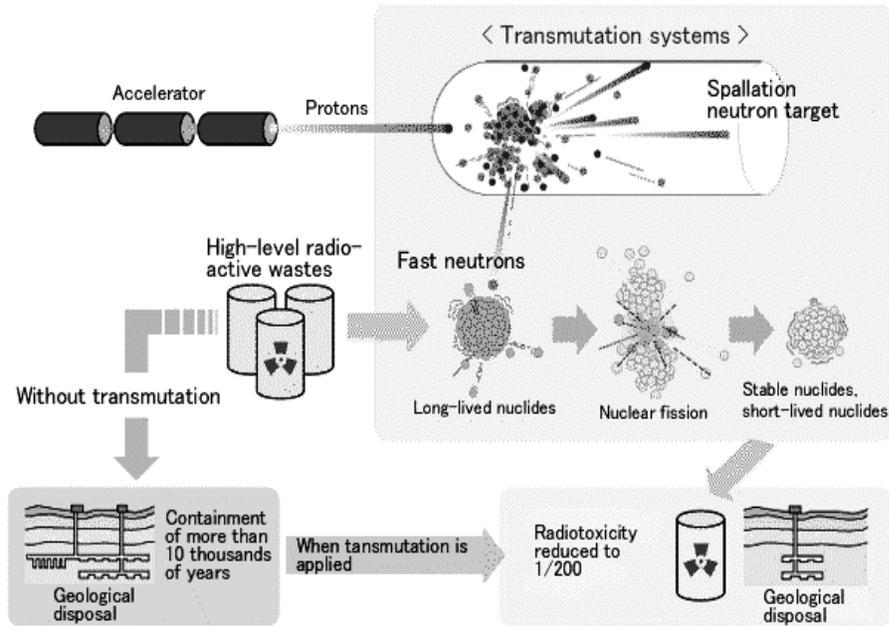
Figure 1.1 Overall Transmutation Process

In order to circumvent the problems associated with the disposal of highly radioactive nuclear waste, the United States Department of Energy (USDOE) has recently initiated an extensive effort to develop an alternate method to reduce the radioactivity of HLW/SNF, and subsequently dispose of them. This method, known as transmutation, is based on the reduction or elimination of radioactive species and isotopes from HLW/SNF by bombarding them with proton-generated neutrons, followed by their disposal in the proposed geologic repository.^[1] These neutrons are generated by impinging protons from an accelerator or a reactor onto a target material such as molten lead-bismuth-eutectic (LBE). The transmutation process is illustrated in Figures 1.1 and 1.2. The molten LBE

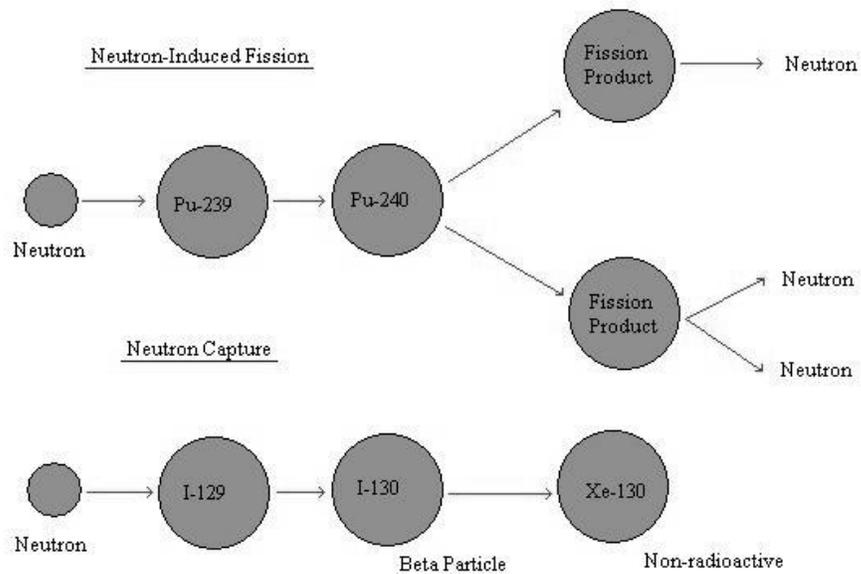
Figure 1.2 Use of Neutrons during the Transmutation Process

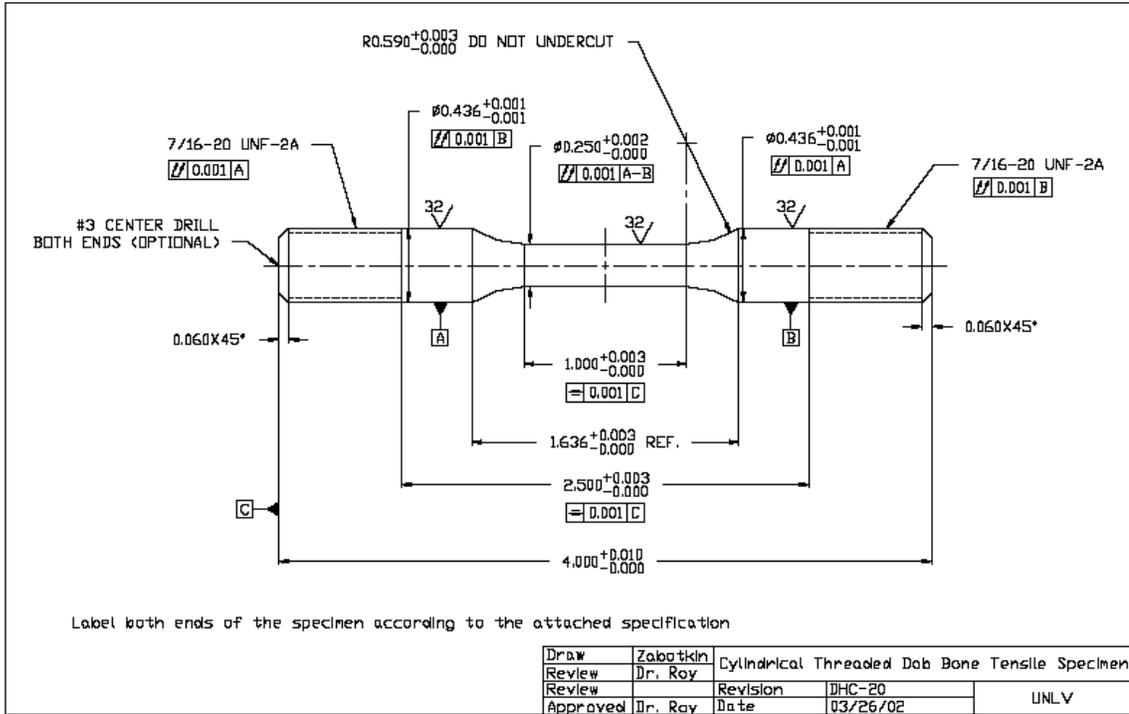
Figure 2.2 Dimensions of Smooth Cylindrical Specimen

The ratios of D/d and r/d were used to estimate the magnitude of the stress concentration factor (k_t)^[15] based on the plot shown in Figure 2.5. An approximate k_t value of 1.45 was determined based on the following analysis.

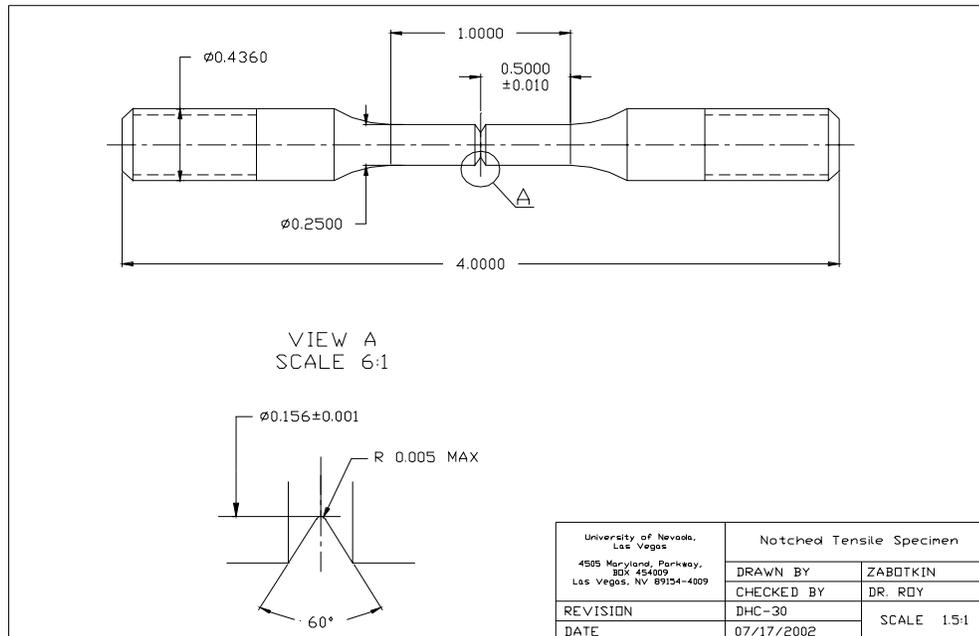
Figure 2.4 Dimensions of Notched Cylindrical Specimen

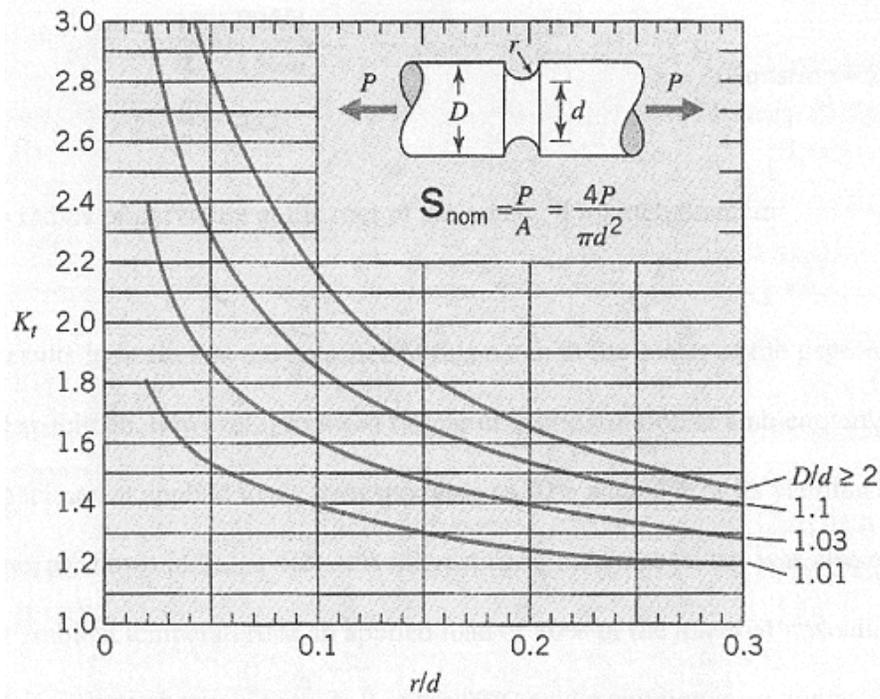
Figure 2.5 Geometric Stress Concentration Factor for Notched Specimen^[15]

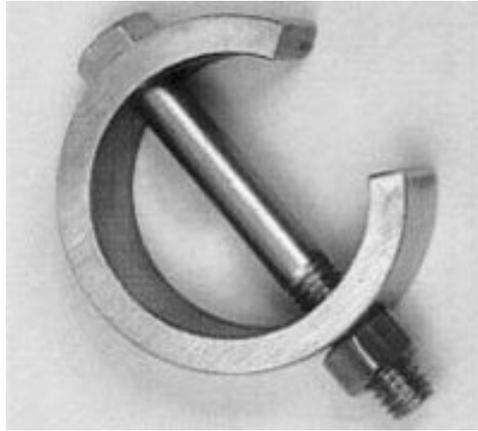
Figure 2.6 Pictorial View of C-ring Specimen

Self-loaded specimens such as C-ring and U-bend (Figures 2.6 - 2.9) were also used in this investigation for the evaluation of SCC. The C-ring is a versatile and economic type of specimen for quantitatively determining the susceptibility of a material to SCC of all types of alloys in a wide variety of product forms. It is particularly suitable for making short-transverse tests of various products. The U-bend specimen is generally a rectangular strip which is bent 180° around a predetermined radius and maintained in this

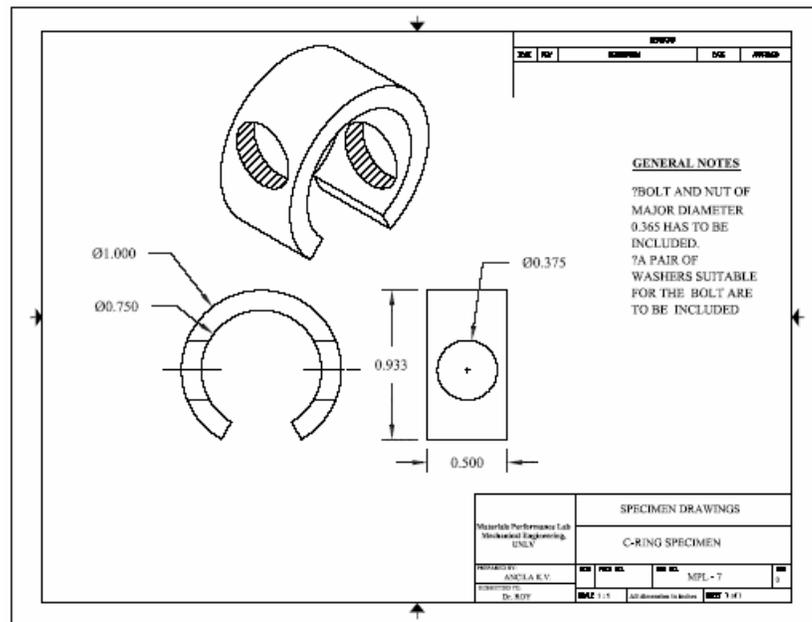
Figure 2.7 Dimensions of C-ring Specimen

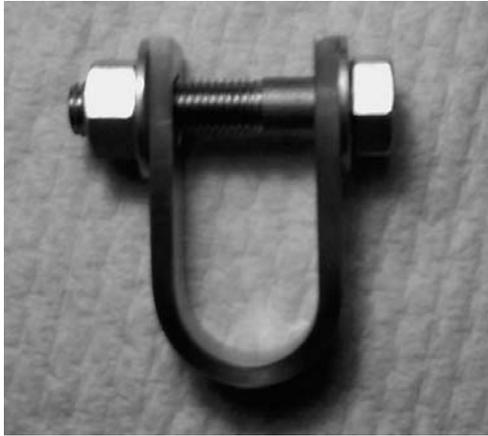
Figure 2.8 Pictorial View of U-bend Specimen

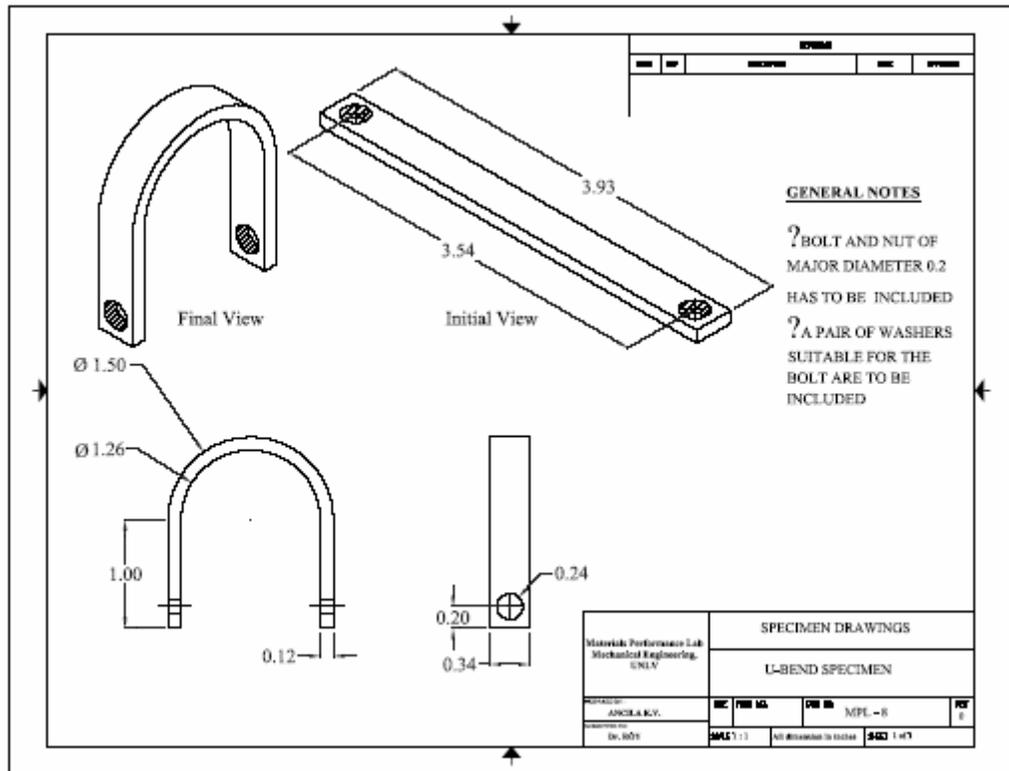
Figure 2.9 Dimensions of U-bend Specimen

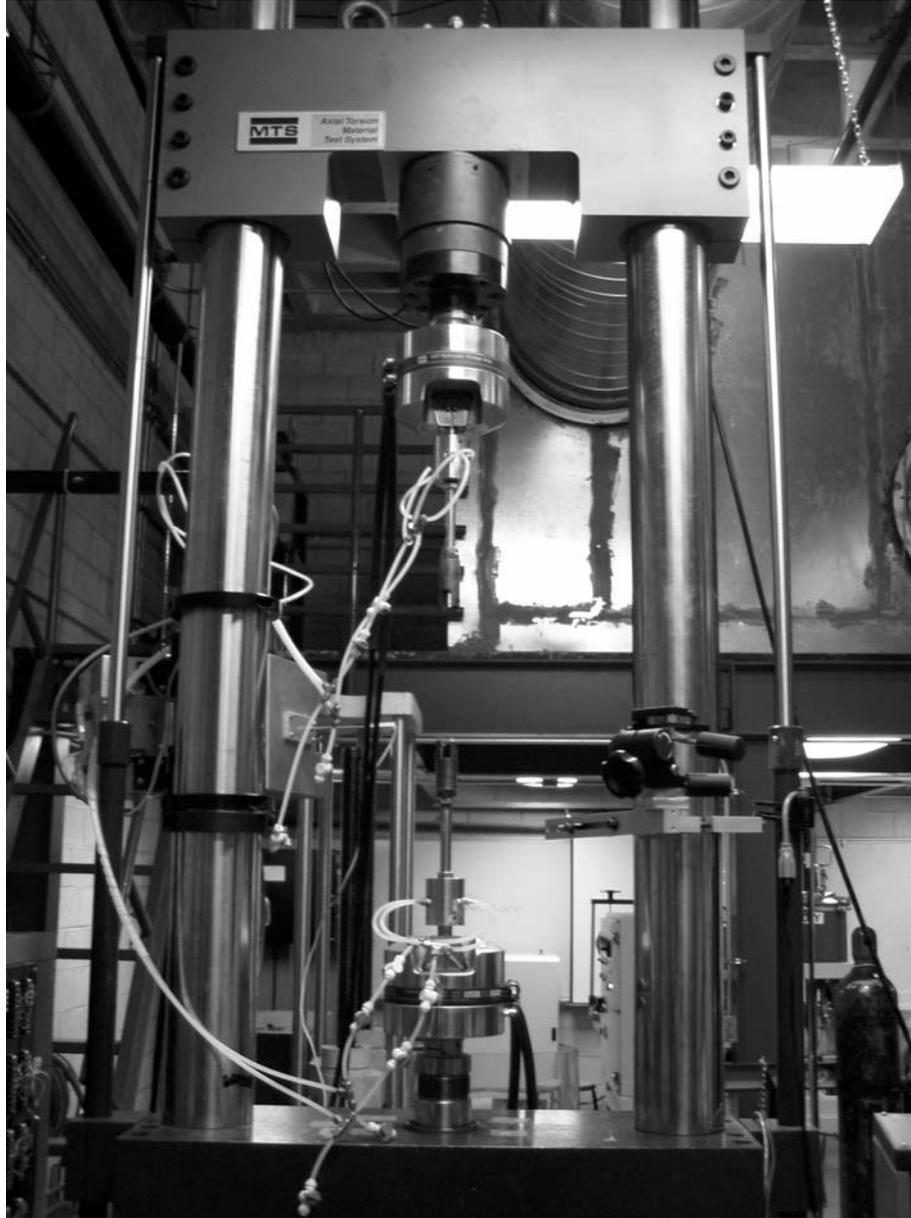
Figure 3.1 MTS Setup

An axial/torsional servohydraulic and computer-controlled MTS unit was used to determine the tensile properties including yield strength (YS), ultimate tensile strength (UTS), and ductility parameters such as percentage elongation (%El) and percentage reduction in area (%RA) at ambient temperature and at atmospheric conditions according to the ASTM designation E 8. ^[14] The MTS test setup is shown in Figure 3.1. The ambient temperature tensile properties of Alloy HT-9 obtained by using the MTS machine at a strain rate of 10^{-3} second are given in Table 3.1.

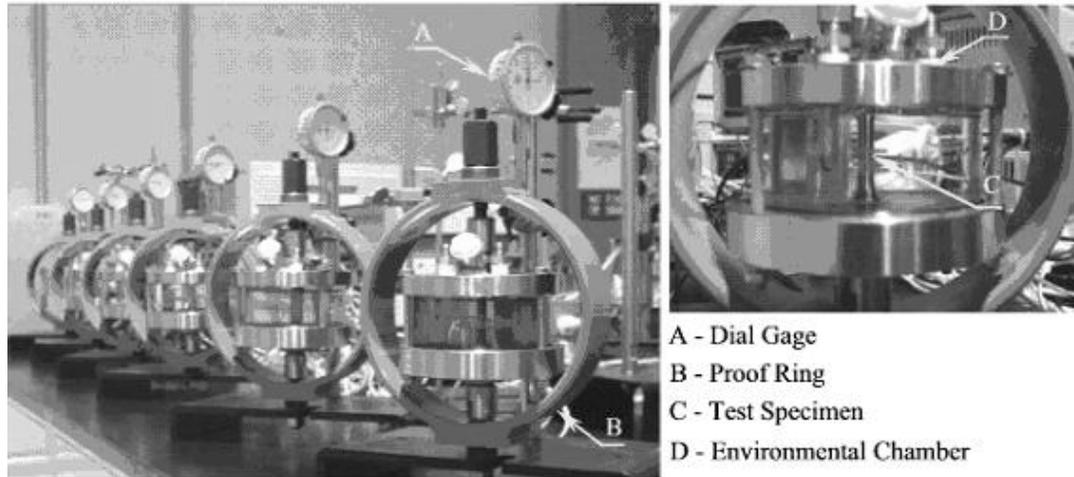
Figure 3.2 Constant-Load Test Setup

A calibrated proof ring was used for testing at constant load (CL). These proof-rings were specifically designed to meet a National Association of Corrosion Engineers (NACE) standard. ^[16] Each individually calibrated proof ring was made by Cortest Inc using precision-mechanics alloy steel and was accompanied by a calibration curve showing the load versus deflection. The test specimens were loaded under uniaxial tension. The ring deflection was measured with a 8-9" diameter micrometer, with the supplied dial indicator. The tensile load on the proof ring was quickly and easily adjusted using a standard wrench on the tension-adjusting screw and lock nut. A thrust bearing distributed the load and prevented seizure. The specimen grips in these proof rings were made of stainless steel, fully-resistant to corrosion in the testing environments. The environmental test chamber was secured by O-ring seals that prevented any leakage during testing. The environmental chambers made of highly corrosion-resistant Hasteloy C-276 were used for testing at elevated temperatures. The experimental setup is shown in Figure 3.2

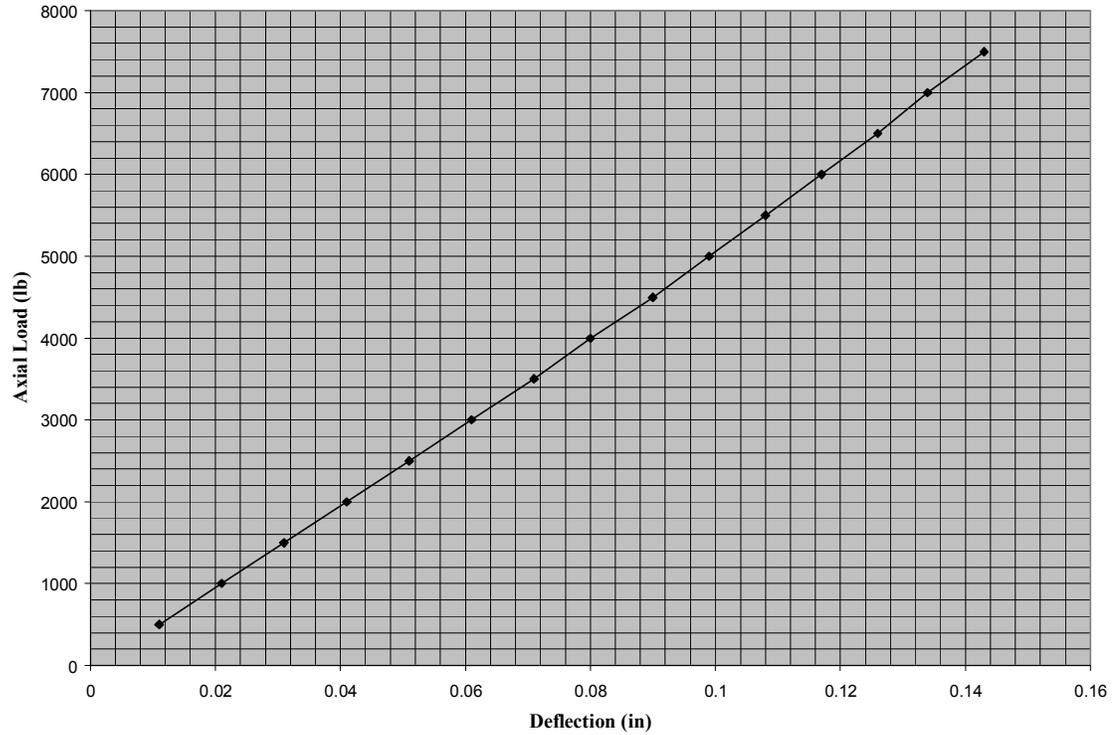
Figure 3.3 A Typical Calibration Curve for a Proof Ring

The amount of deflection needed to apply the desired load in the CL testing was determined by use of the calibration curve of each proof ring, as shown in Figure 3.3. The magnitude of the applied stress was based on the ambient-temperature tensile YS of the test materials. The specimens were loaded at stress values equivalent to different percentages of the material's YS value, and the corresponding time-to-failure (TTF) was recorded. The determination of the SCC tendency using this technique was based on the TTF for the maximum test duration of 30 days. An automatic timer attached to the test specimen recorded the TTF. The cracking susceptibility was expressed in terms of a threshold stress (σ_{th}) for SCC below which cracking did not occur during the maximum test duration of 30 days.

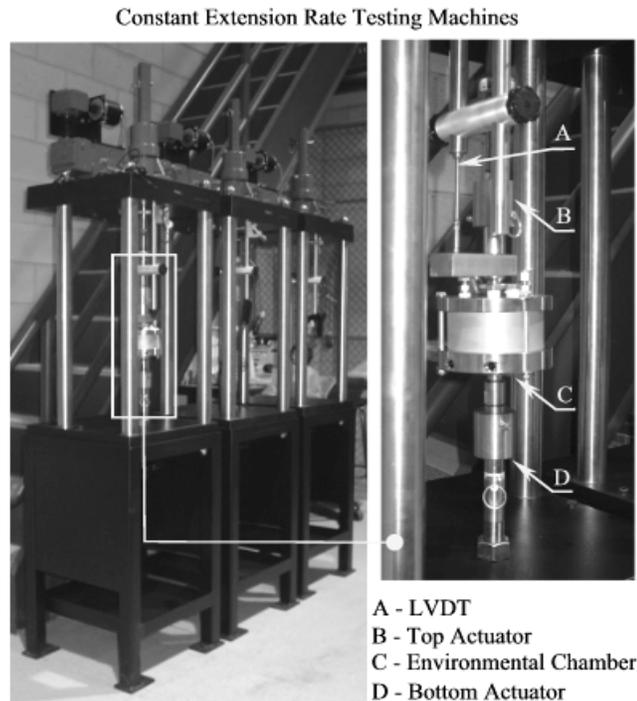
Figure 3.4 CERT Machines for SSR Testing

To ensure the maximum accuracy in test results, this apparatus was comprised of a heavy-duty load-frame that minimized the system compliance while maintaining precise axial alignment of the load train. An all-gear drive system provided consistent extension rate. This machine provided the maximum flexibility and working space for test sample configuration, environmental chamber design, and accessibility. An added feature included in this model (model# 3451) for ease of operation was a quick-hand wheel to apply a pre-load prior to the operation.

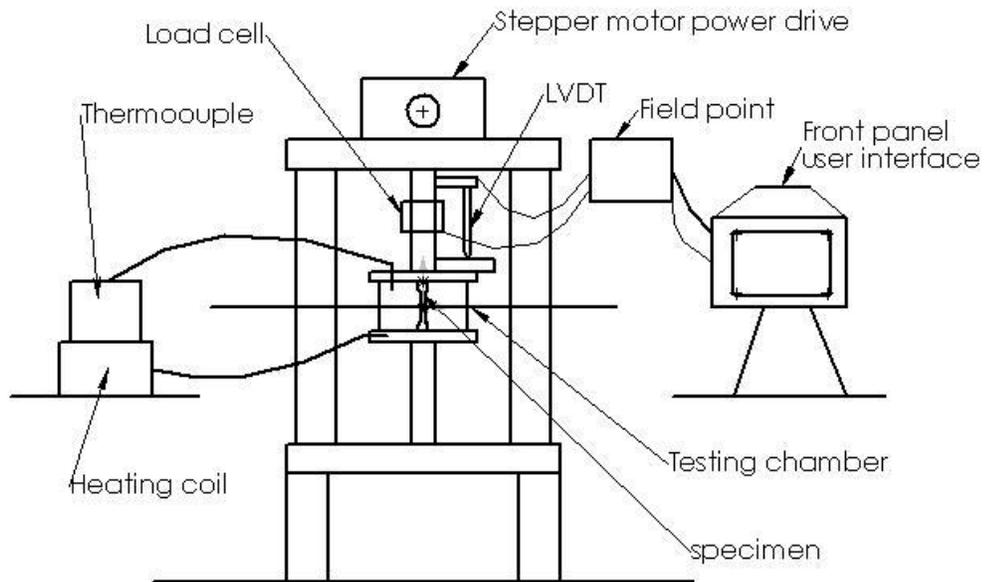
Figure 3.5 SSR Test Setup

The SSR test setup used in this study consisted of a top-loaded actuator, testing chamber, linear variable differential transducer (LVDT) and load cell, as shown in Figure 3.5. The top-loaded actuator was intended to pull the specimen at a specified strain rate

so that the spilled solution, if any, would not damage the actuator. A heating cartridge was connected to the bottom cover of the environmental chamber for elevated-temperature testing. A thermocouple was connected on the top cover of this chamber to monitor the inside temperature. The load cell was intended to measure the applied load through an interface with the front panel user interface. The LVDT was used to record the displacement of the gage section during the SSR testing.

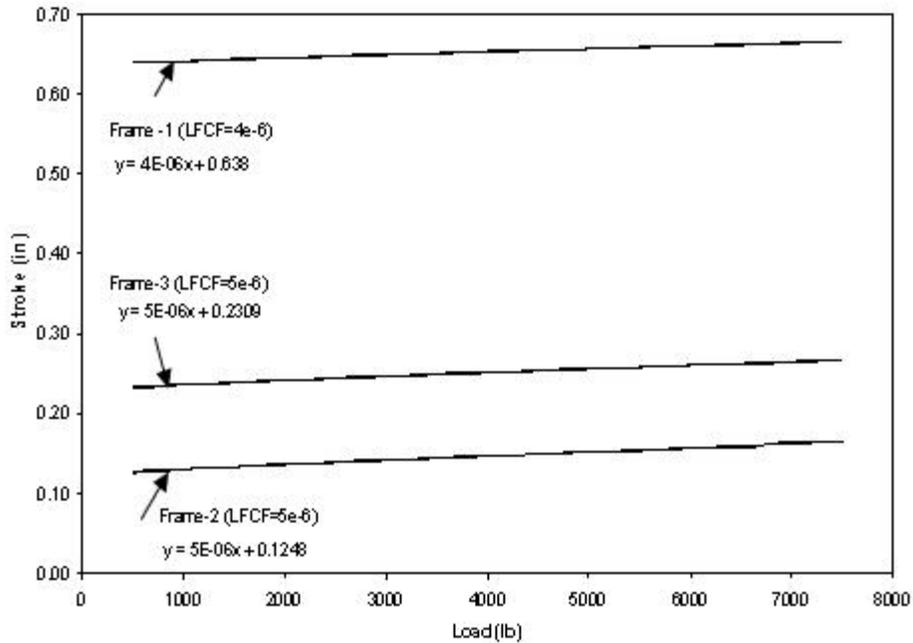
Figure 3.6 Load Frame Compliance Test

Prior to the performance of SCC testing by the SSR technique, the load-frame-compliance factor (LFCF- the deflection in the frame per unit load), was determined by using a Type 430 ferritic stainless steel specimen. The generated LFCF data are shown in Figure 3.6. These LFCF values were inputted to a load frame acquisition system prior to the SCC testing. The resultant LFCF values are also shown in Figure 3.6.

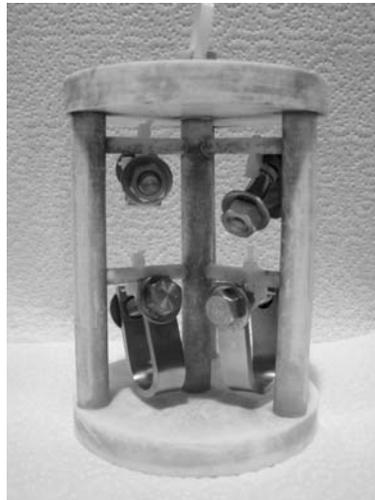
Figure 3.8 Specimen Holder

The loaded specimens were then immersed inside an Acidic solution either in a desiccator or in an autoclave for testing at the room and elevated temperatures, respectively. The test specimens were periodically removed from the test cells for visual and microscopic evaluation. Some of the specimens were returned to test cells for further exposure if no cracks were observed. The picture of the specimen holder and the Autoclave is shown in Figures 3.8 and 3.9, respectively.

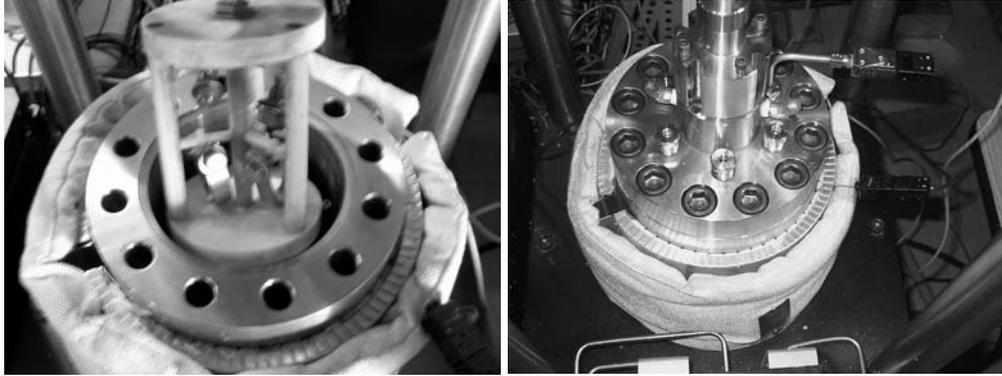
Figure 3.9 Self-Loaded Testing Setup

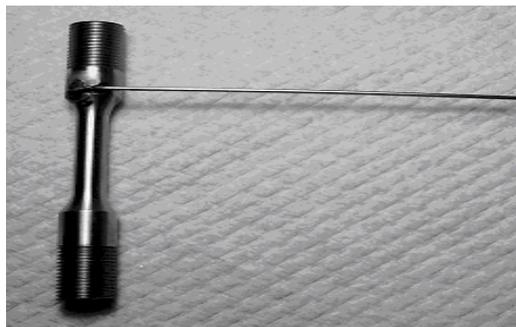
Figure 3.10 Spot-Welded Cylindrical Specimen

A limited number of SCC tests were performed in the acidic solution using the SSR technique at controlled cathodic potential (E_{cont}) to study the effect of hydrogen on the cracking susceptibility of Alloy HT-9. The magnitude of E_{cont} was based on the corrosion potential (E_{corr}) of this material performed in a similar environment by a previous investigator. ^[20] The Spot-Welded Cylindrical Specimen is shown in Figure 3.10 and the SCC test setup under E_{cont} is illustrated in Figure 3.11, showing the application of the applied potential by use of a conductive wire, spot-welded to the tensile specimen at the shoulder.

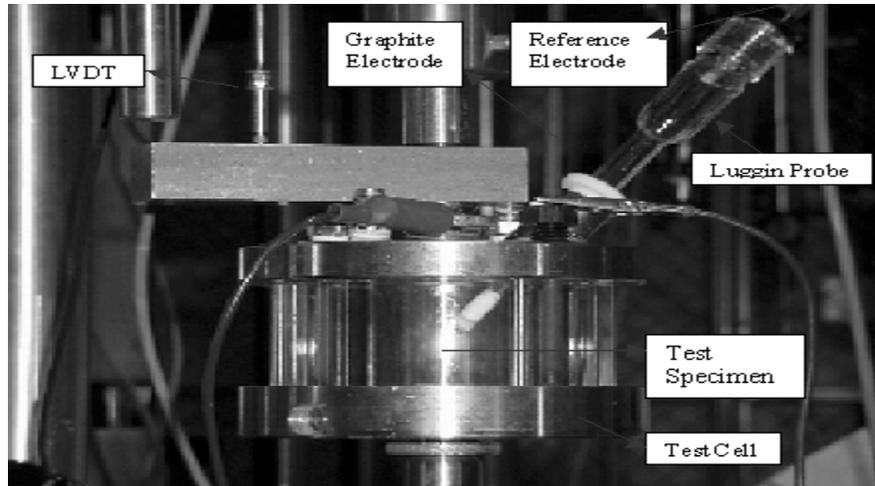
Figure 3.11 SCC test Setup under E_{cont}

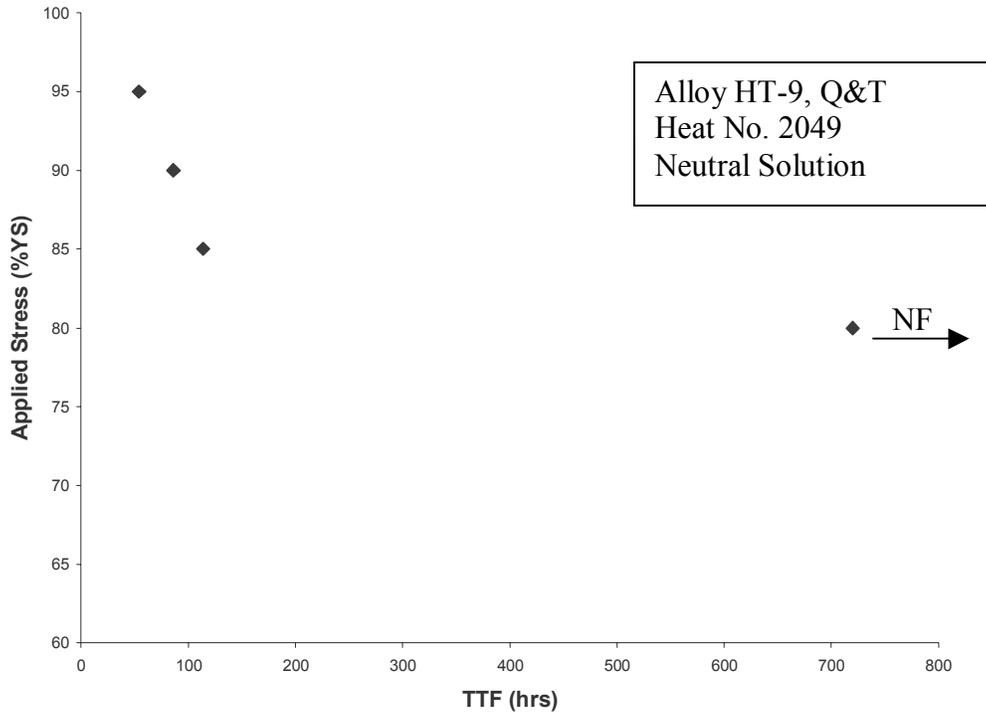
Figure 4.1 Applied Stress vs TTF for Smooth Specimen

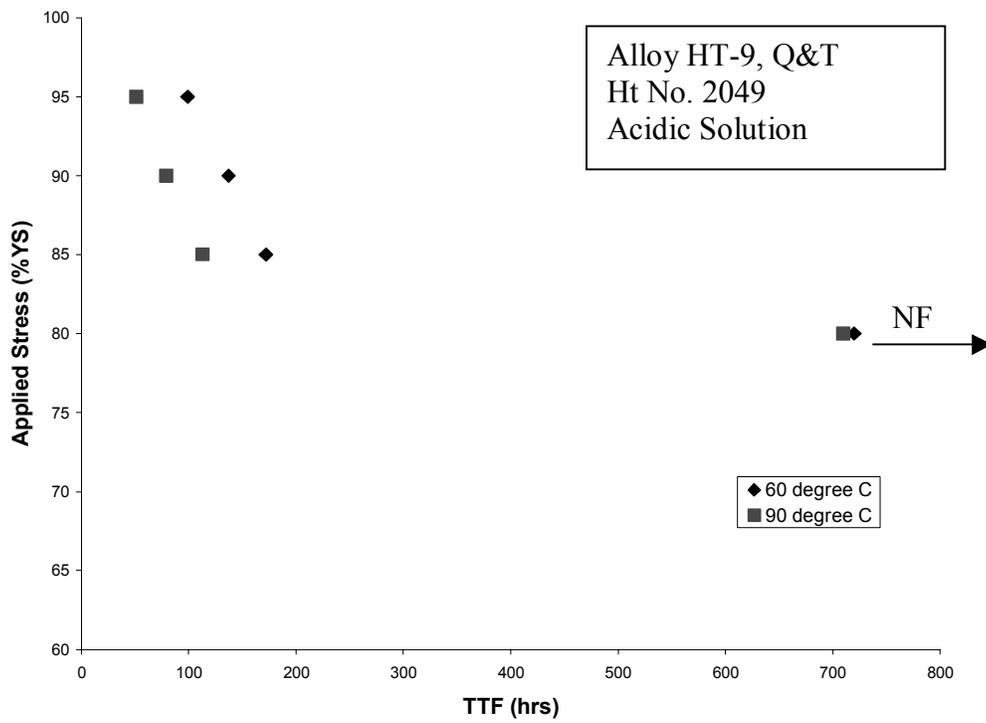
Figure 4.2 Applied Stress vs TTF for Smooth Specimens

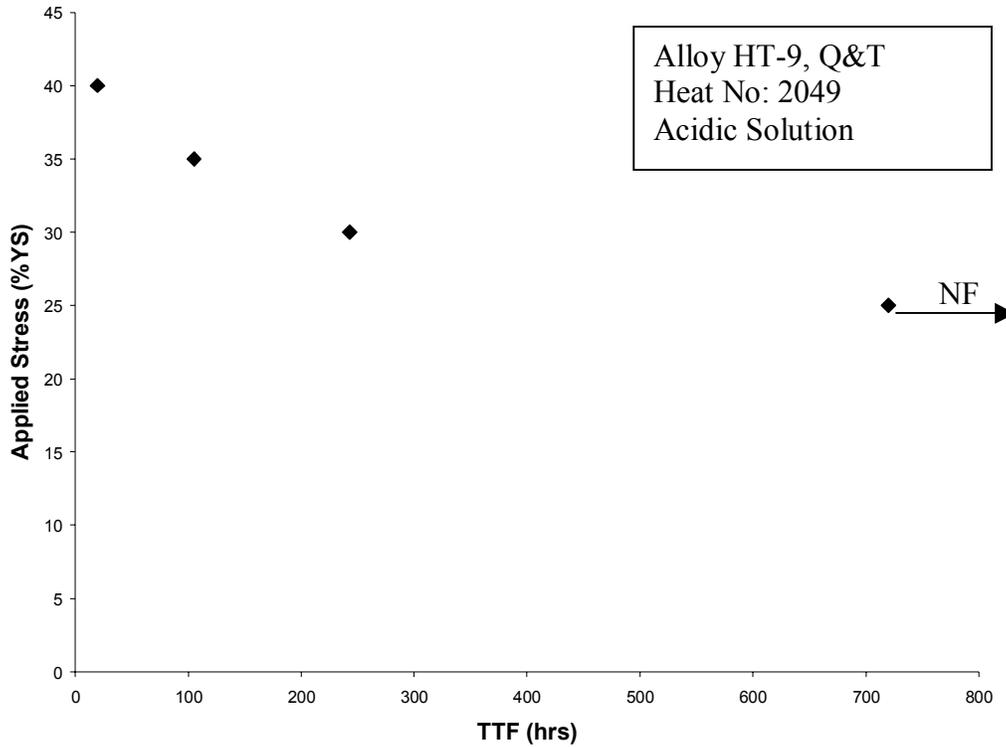
Figure 4.3 Applied Stress vs TTF for Notched specimen

The results of SCC testing using notched specimens under constant loading condition in the acidic solution at ambient temperature and 90°C are shown in Table 4.2. As expected, the presence of a notch in the cylindrical specimen reduced the magnitude of σ_{th} to a much lower value. For example, at ambient temperature, the threshold stress was close to 40% of the material's YS value. It should be noted that the notched specimen could not be loaded at stresses above 0.40YS value since the specimen broke during the loading stage. On the other hand, the magnitude of σ_{th} was close to 0.25YS value of the test material at 90°C. The applied stress versus TTF for the notched specimens tested in the 90°C acidic solution is shown in Figure 4.3, providing the magnitude of σ_{th} .

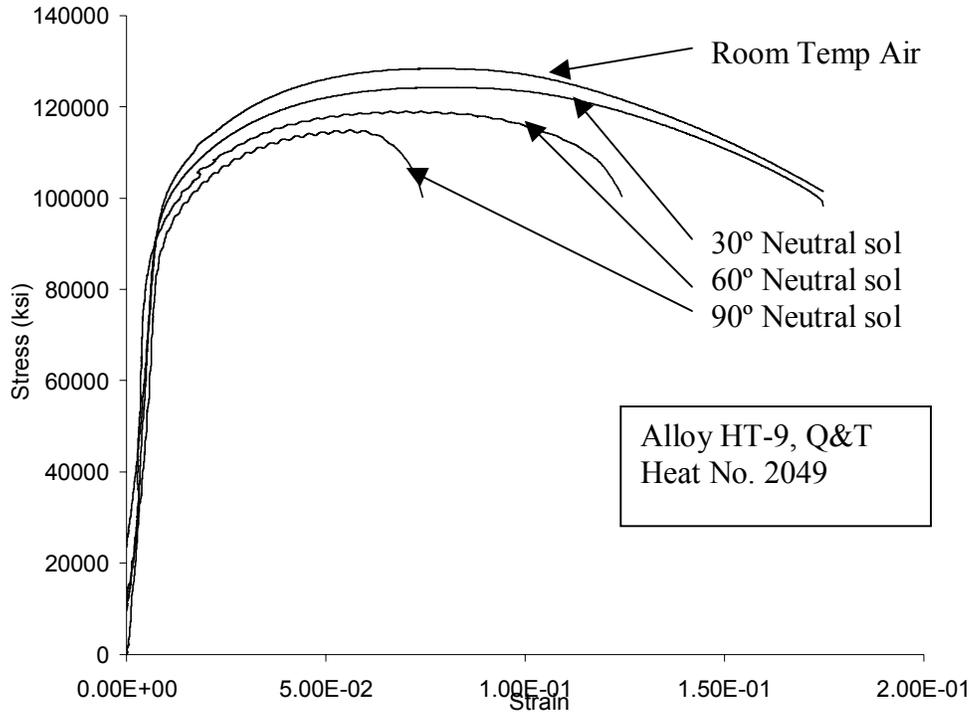
Figure 4.4 Comparison of σ - ϵ Diagrams using Smooth Specimens in Neutral Solution

A comparison of the stress-strain diagrams using smooth cylindrical specimens obtained in SSR testing in the neutral and acidic solutions at different temperatures are shown in Figures 4.4 and 4.5, respectively. These figures reveal that the magnitude of strain was gradually reduced with increasing temperature irrespective of the testing environment. The data shown in these two figures are reproduced in Table 4.3, showing the effect of temperature and pH on the true failure stress (σ_f), TTF, %El and %RA, which are conventionally used to characterize the cracking susceptibility of a material of interest when tested by the SSR technique.

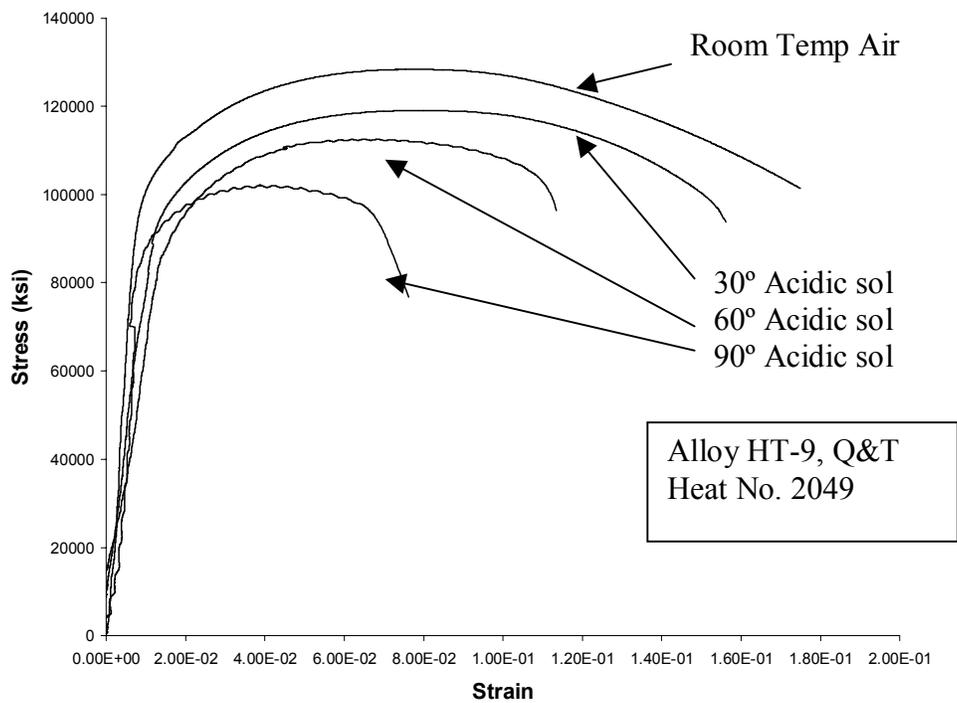
Figure 4.5 Comparison of σ - ϵ Diagrams using Smooth Specimens in Acidic Solution

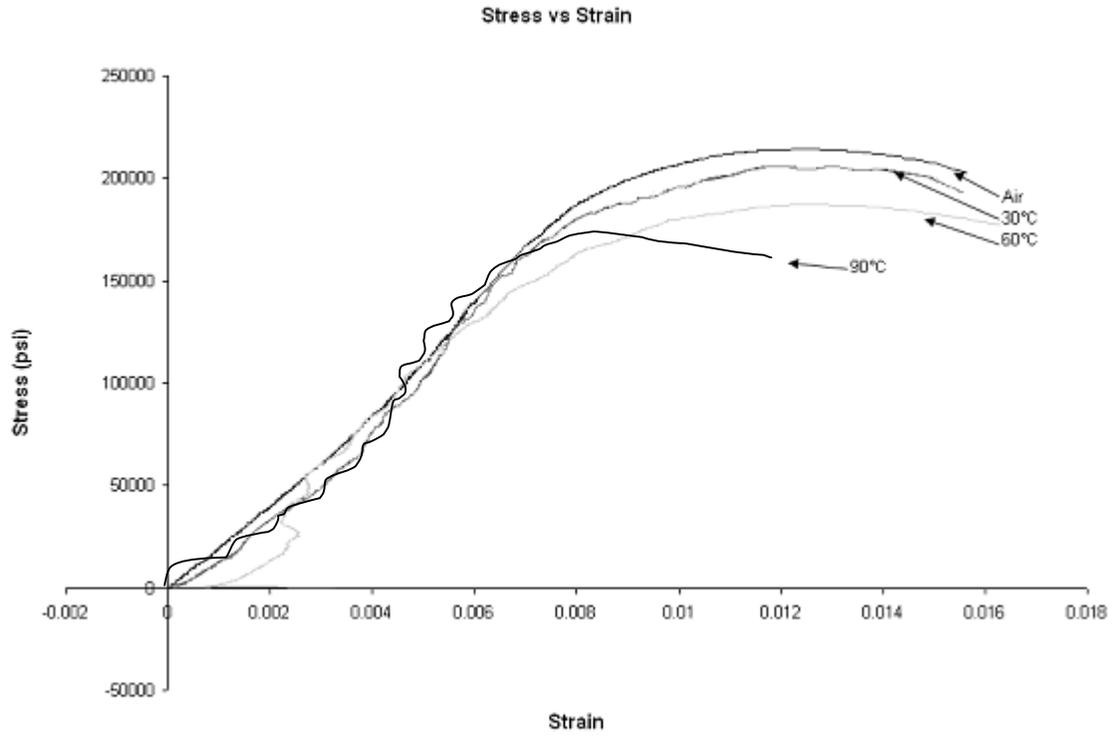
Figure 4.6 Comparison of σ - ϵ Diagrams using Notched Specimens in Neutral Solution

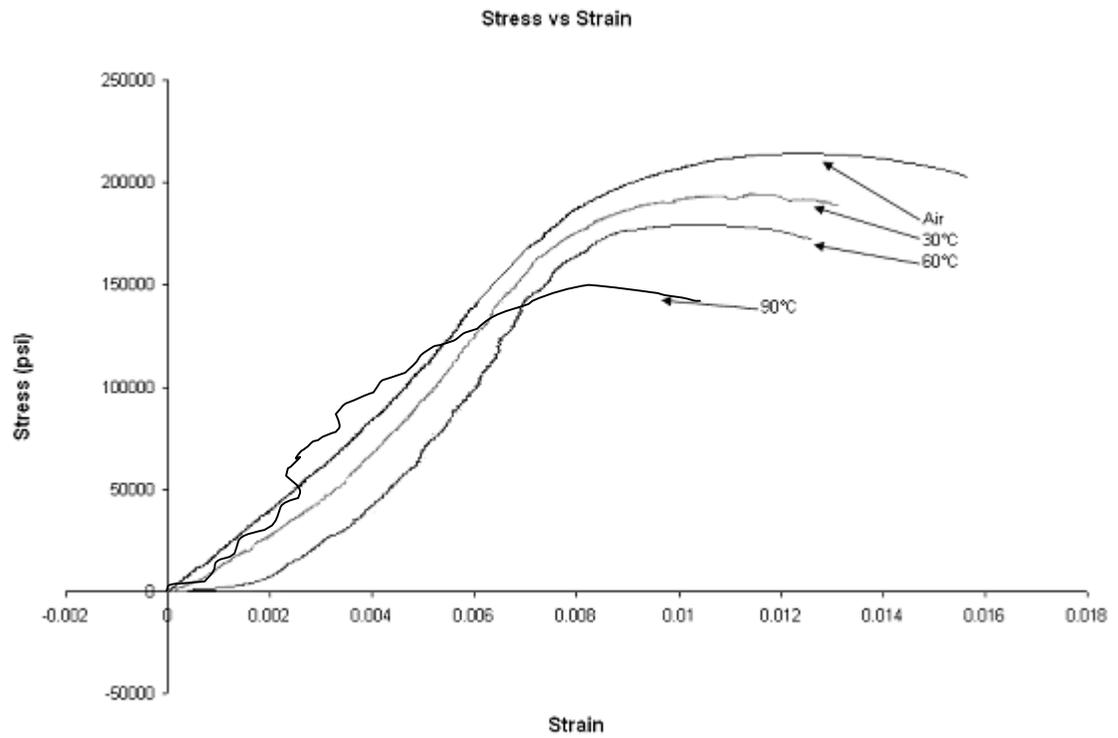
Figure 4.7 Comparison of σ - ϵ Diagrams using Notched Specimens in Acidic Solution

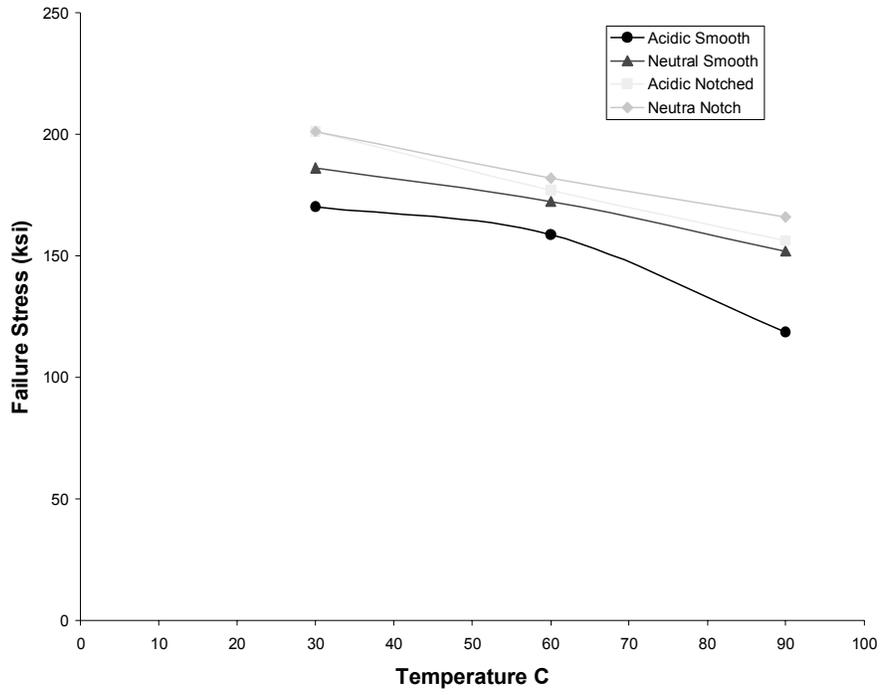
Figure 4.8 Temperature vs Failure Stress

The results of SSR testing using smooth and notched cylindrical specimens, shown in Tables 4.3 and 4.4, respectively are graphically reproduced in Figures 4.8 through 4.11, showing the effects of temperature, pH and specimen geometry on σ_f , TTF, %EI, %RA. An examination of these figures clearly indicate that all these parameters were reduced in either testing environment at elevated temperatures showing more pronounced effect in the acidic solution. The presence of a notch significantly reduced the TTF, %EI and %RA. However, the magnitude of σ_f increased in the presence of a notched due to the relatively smaller cross-sectional area at the root of the notch that also produced a large mechanical constraint in the vicinity of the notch.

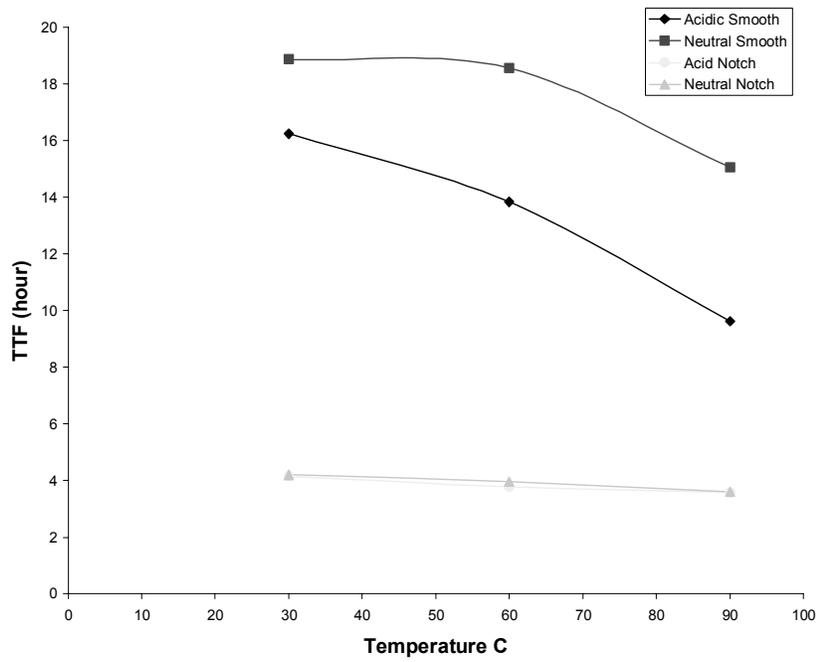
Figure 4.9 Temperature vs TTF

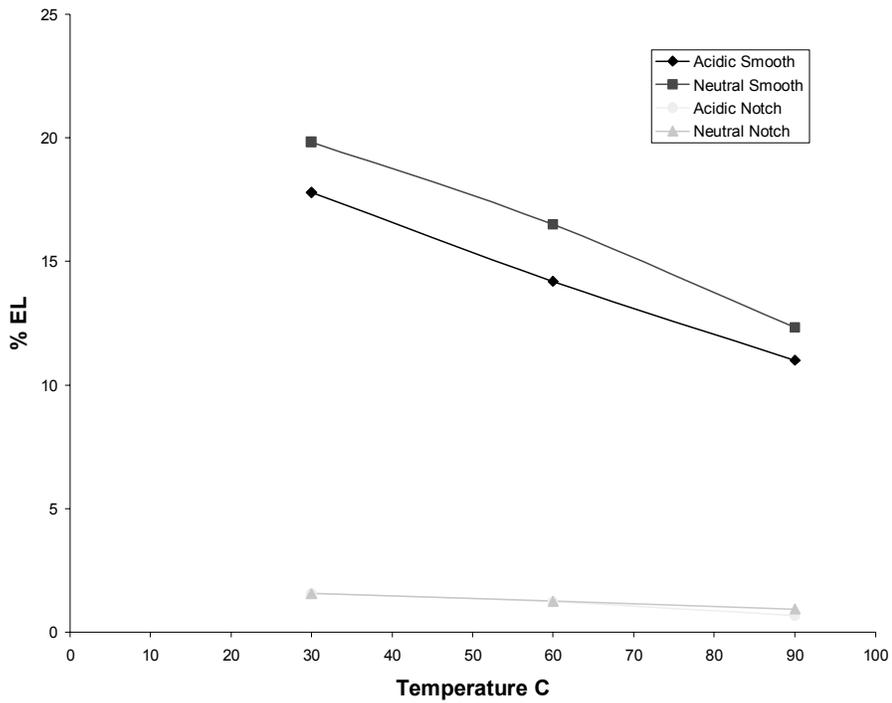
Figure 4.10 Temperature vs %EI

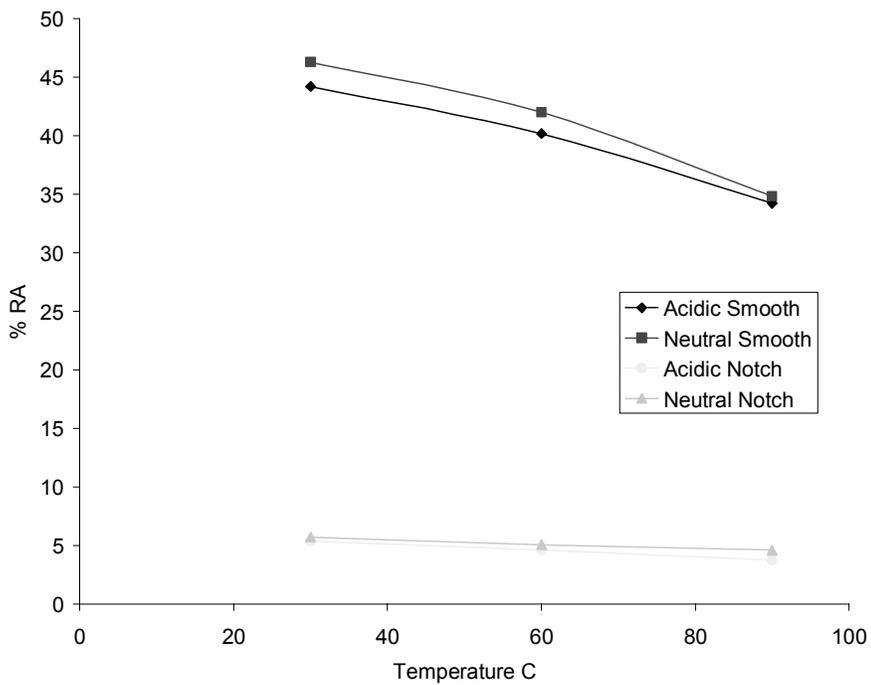
Figure 4.11 Temperature vs %RA

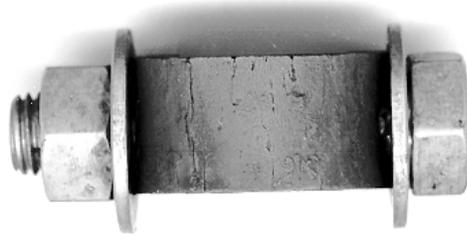
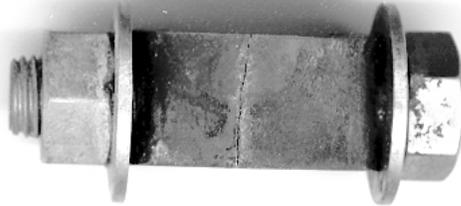
(a) 100°C, $\sigma_a = 0.95Y_S$, 2 Days

(b) 50°C, $\sigma_a = 0.98Y_S$, 7 weeks

(c) 100°C, $\sigma_a = 0.98Y_S$, 2 Days

Figure 4.12 Appearance of C-ring Specimens Tested in Acidic Solution

The results of SCC testing using C-ring specimens of Alloy HT-9 indicate that cracks were observed in the acidic solution both at 50 and 100°C at applied stresses

corresponding to 95 and 98% of this material's yield strength value. However, the time to initiate cracking in the 50°C acidic solution was significantly higher (7 weeks) compared to that (2 days) in the 100°C acidic solution. The appearances of the C-ring specimens tested at both temperatures are illustrated in Figure 4.12. None of the U-bend specimens of Alloy HT-9 showed any cracking in the tested environment at either testing temperature. However, they showed some parallel degradation marks (crack-like indications), as shown in Figure 4.13, indicating that cracks could have been initiated in these specimens provided they were exposed for longer durations.

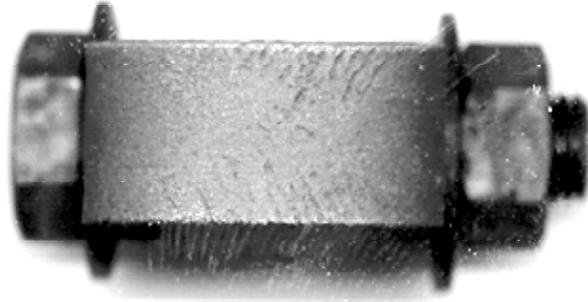
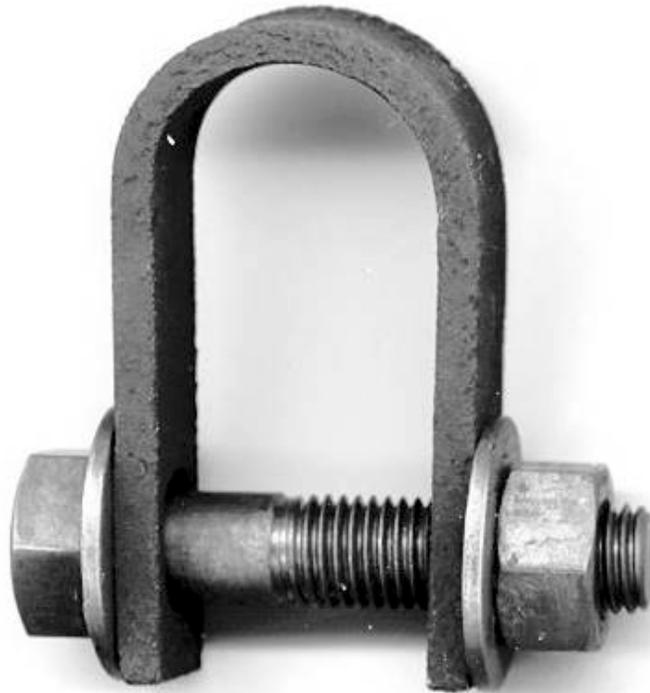
(a) Top View

(b) Front View

Figure 4.13 Appearance of U-bend Specimen in Acidic Solution

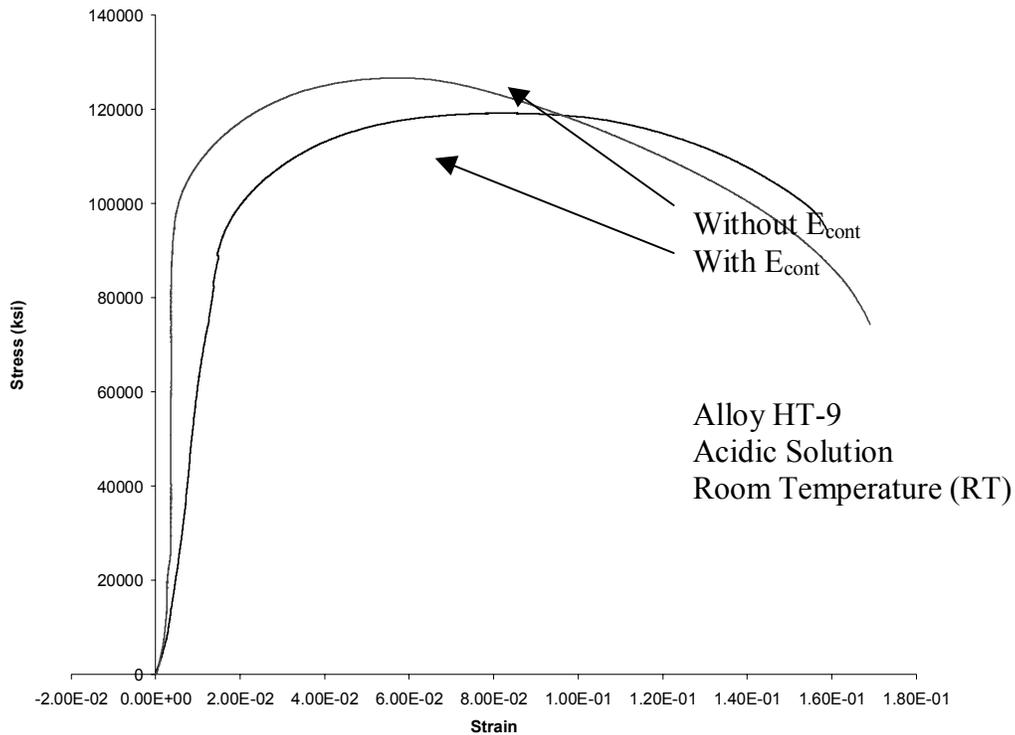
Figure 4.14 Stress-Strain Diagrams with and without E_{cont} at RT

The susceptibility of Alloy HT-9 to hydrogen-induced cracking was determined by applying cathodic electrochemical potential (E_{cont}) to the spot-welded cylindrical specimen while loaded in tension by the SSR technique. The magnitude of E_{cont} was based on the corrosion potential (E_{corr}) determined by a previous investigator [22] at UNLV. The results, shown in Figures 4.14 and 4.15 indicate that the magnitude of strain was reduced at ambient temperature and 90°C due to the application of E_{cont} , indicating reduced ductility.
