Environment Assisted Cracking of Target Structural Materials Under Different Loading Conditions

ENVIRONMENT ASSISTED CRACKING OF TARGET STRUCTURAL
MATERIALS UNDER DIFFERENT LOADING CONDITIONS

Master of Science Degree in Mechanical Engineering
Department of Mechanical Engineering
Howard R. Hughes College of Engineering

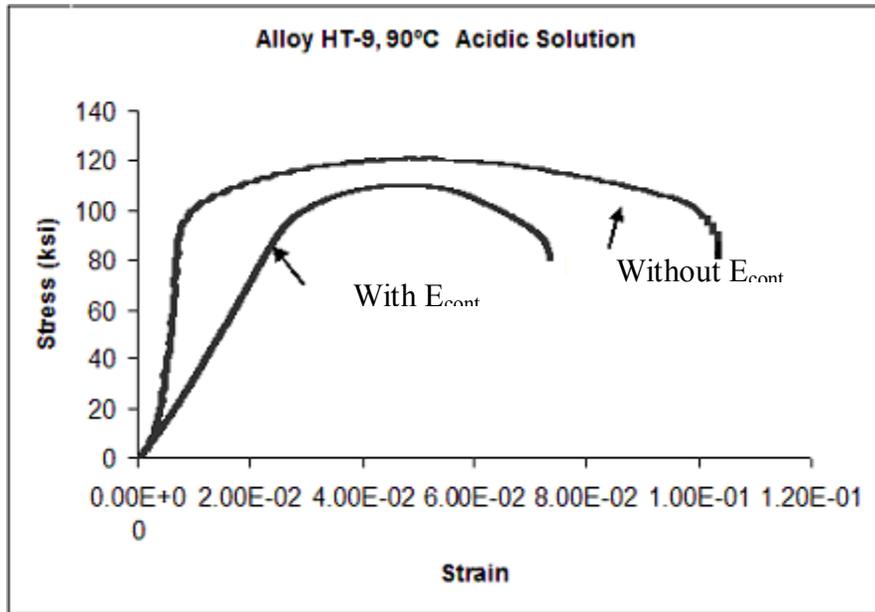
Figure 4.15 Stress-Strain Diagrams with and without E_{cont} ^[22] at 90°C

The susceptibility of Alloy HT-9 to hydrogen-induced cracking was determined by applying cathodic electrochemical potential (E_{cont}) to the spot-welded cylindrical specimen while loaded in tension by the SSR technique. The magnitude of E_{cont} was based on the corrosion potential (E_{corr}) determined by a previous investigator [22] at UNLV. The results, shown in Figures 4.14 and 4.15 indicate that the magnitude of strain was reduced at ambient temperature and 90°C due to the application of E_{cont} , indicating reduced ductility.

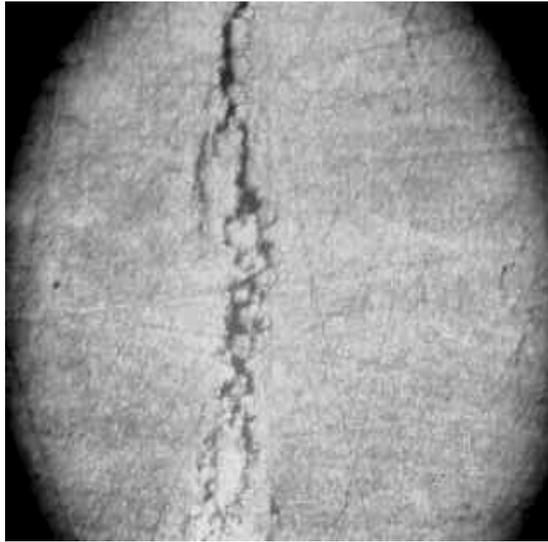
Figure 4.17 Secondary Cracks Determined by Optical Microscopy
Etched in Fry's Reagent, 10X

Figure 4.16 illustrates the metallurgical microstructure of Alloy HT-9 following quenching and tempering. Examination of this figure confirms that fully-tempered and fine-grained martensitic microstructure was developed in this alloy. As shown earlier, ductility was significantly reduced in specimens loaded in tension while exposed to a 90°C acidic solution. An examination of the tested specimens in this environment revealed secondary cracks along the gauge section of the broken specimen, as shown in Figure 4.17, as determined by optical microscopy. An optical micrograph of a failed C-ring specimen of Alloy HT-9 is shown in Figure 4.18, illustrating the extent of cracking on its outer surface.

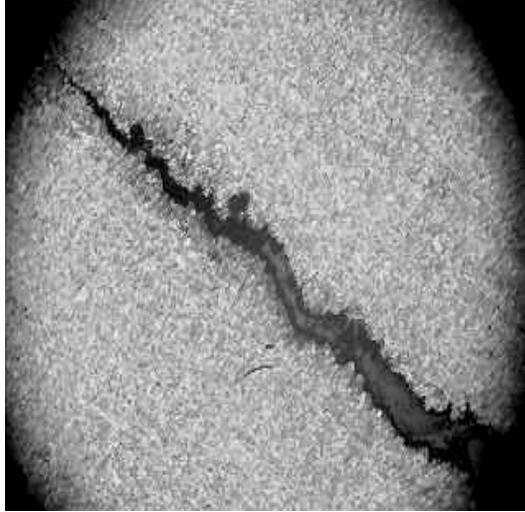
Figure 4.18 Optical Micrograph of Failed C-ring Specimen
Etched in Fry's Reagent, 10X

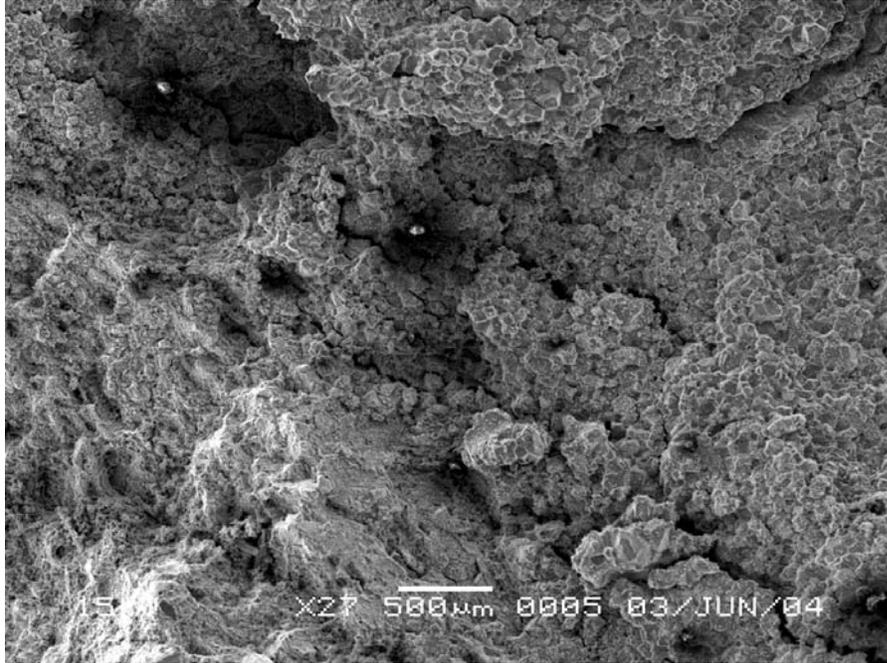
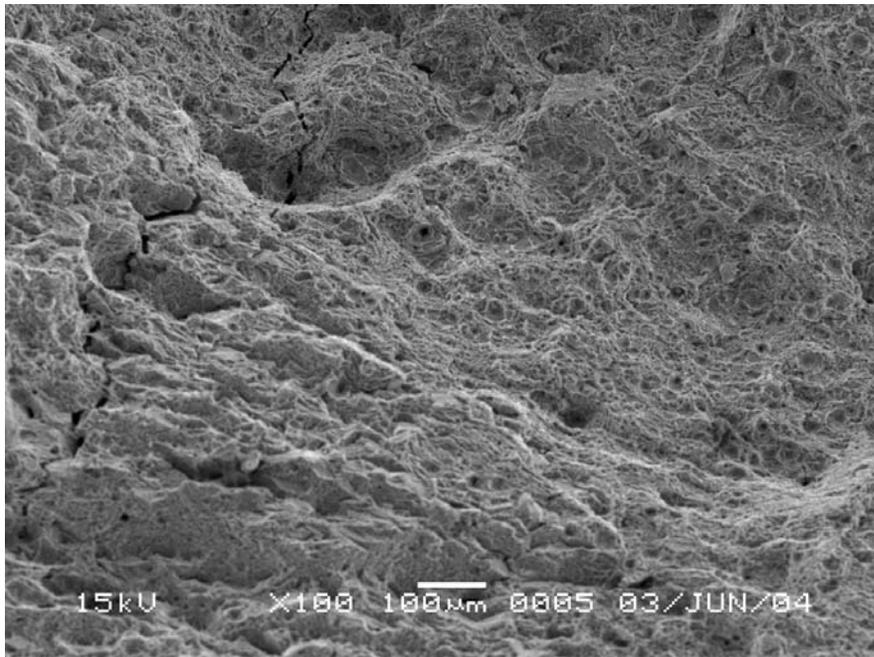
(a) 90°C Neutral Environment

(b) 90°C Acidic Environment

Figure 4.19 SEM Micrographs of the Primary Fracture Face of Alloy HT-9

The results of fractographic evaluation of the primary fracture faces of the cylindrical specimens of Alloy HT-9, tested in both neutral and acidic solutions, are shown in Figure 4.19. An examination of these micrographs reveals that both intergranular and transgranular cracks were developed in the tested specimens irrespective of test solution. However, dimpled microstructure, indicative of ductile failures, were also observed in these specimens. An evaluation of the fractured C-ring specimens by SEM revealed intergranular failure, as illustrated in Figure 4.20.

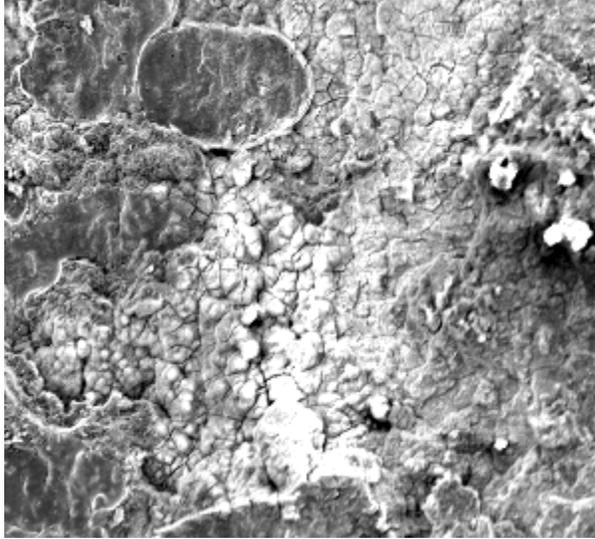
Figure 4.20 Intergranular Brittle Failure in C-ring Specimen in 100°C Acidic Solution
