# Trail conditions and preferences from a mountain bike users perspective in Cottonwood Valley

Trail Conditions and Preferences from a Mountain Bike Users Perspective in Cottonwood Valley.

Bachelor of Arts  
In  
Environmental Studies Program  
University of Nevada, Las Vegas  
By

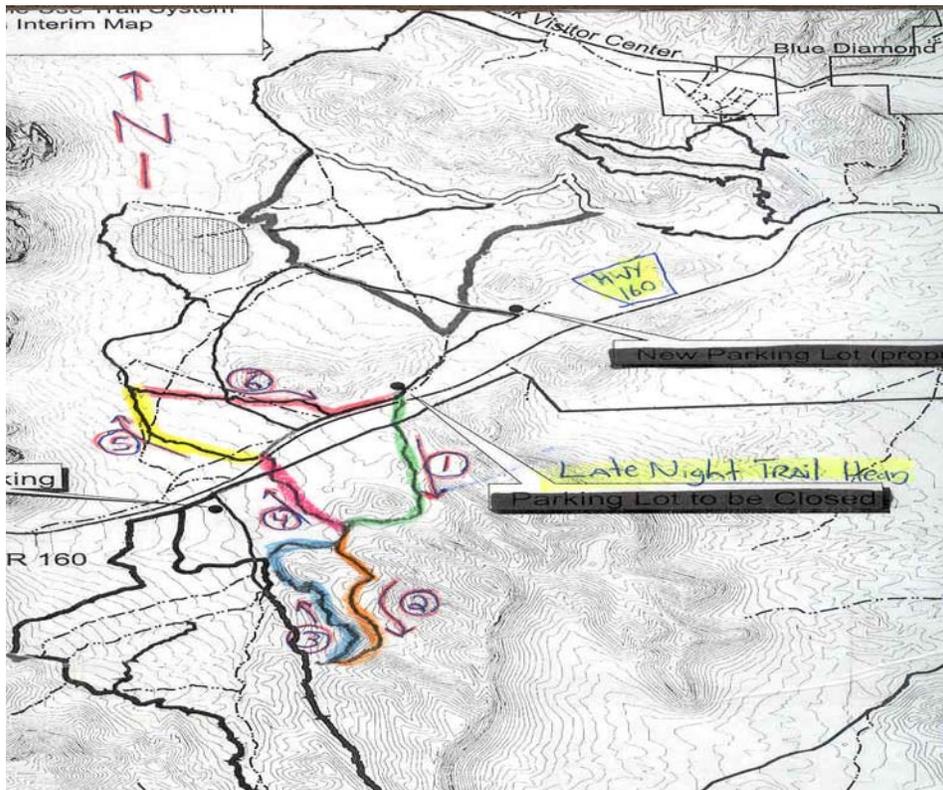
**Figure 1b.** This is a map of the actual trail that participants were told to follow.

The first step in conducting this survey was to define where the participants would gather their information. A well-defined route was established to incorporate as many diverse trails conditions that presently exist in the system within an eight-mile loop. The criterion for this trail was established by the content advisor and I, which both have extensive experience with the trail system in question and are avid mountain bikers. This is the starting point for the VEP. This delimiting of trail to be studied is essential in finding key areas within the system to address. Once a trail was established a survey was designed to collect specific information about the users of this area. The survey went through a human subject's board on the UNLV Campus and was approved (Appendix A). The survey (Appendix B) included demographic information, rider preference, and knowledge the user had about the area. The survey also asked participants if there was something they could change about the area, what it would be. Appealing aspects of mountain bike trail systems that the user had been exposed to was also asked in the survey. Specific site information addressing the weather conditions and outside sources affecting the participant were also gathered. It was also important to log when the survey took place and how long it took for completion, because this may reveal a difference in why participants focused on what they did. Participants were told to follow this specific trail (Figure 1b) and take pictures of positive and negative conditions and aspects of the

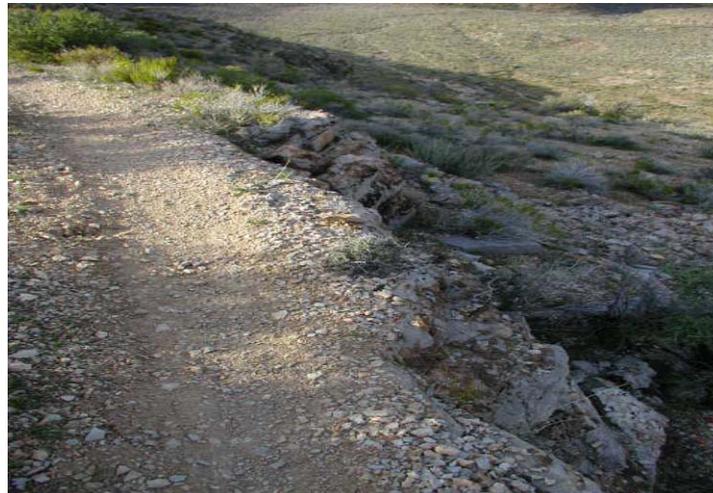
**Figure 5.**

Positive results from the survey had distinct characteristics that allowed them to be grouped into three sub-categories. The first sub-category is Trail Diversity. This sub-category received the most attention by this user group. Forty-one percent of the total responses to this survey had attributes dealing with Trail Diversity, sixty-nine percent in the category: positive aspects. Trail Diversity includes twists, turns, and switchbacks, steep as well as gradual grades, rocky (technical) and smooth terrain and many other attributes. Jumps and obstacles on the trail were also looked at as positive aspects. Participants explained these diverse trail conditions as challenges and looked at them as positive aspects of the trail. These challenges to the trail were a popular response among this user group. The picture below (Figure 5) is an example of Trail Diversity as well as Scenic aspects of the trail. This picture was described as being very scenic and the small cliff to the right of the trail was a desired aspect.

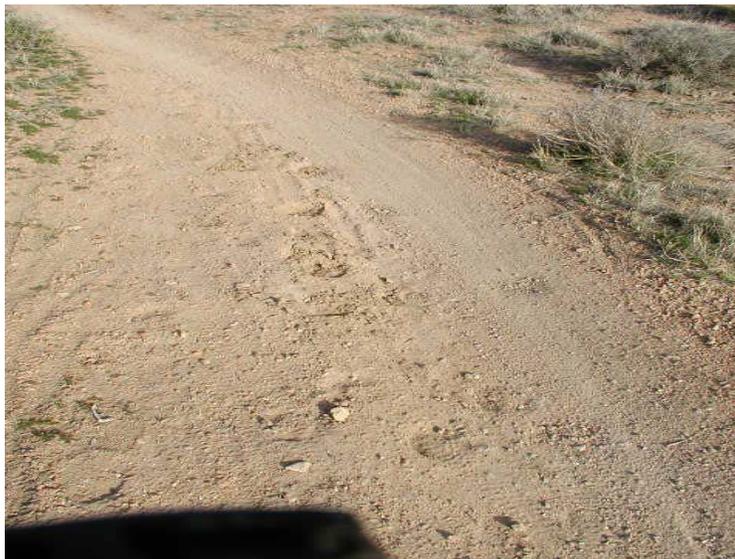
**Figure 6.**

Negative impacts to the trail were also grouped into three distinct sub-categories (Figure 8). The first and most occurring attributes to be grouped fell into the sub-category Trail Conditions. These are negative impacts to the actual trail condition usually incurred by the users themselves. Users include bikers, hikers, and horseback riders. Participants defined negative Trail Conditions as horse hooves depressions in the trail, scarred natural settings due to unnecessary webbing or braiding to the trail, parallel trails, riding around obstacles, illegal trails and garbage. This is accounted for in results from the V.E.P. survey and can be seen in Figure 6. The picture was described as being a negative aspect of the trail and was not appreciated by others who would not do this to the area. This picture is riddled with bike tracks off of the main path as well as hoof

depressions from when a horse rode the trail when the trail was wet. Trampled vegetation and scarred desert floor were considered to have the most negative impacts by this group to the trail. Trail widening and braiding were also mentioned by participants in this study as having negative physical and visual impacts to the singletrack. This aspect of Trail Conditions makes up twenty percent of the total responses, which is fifty eight percent of the negative aspects category.

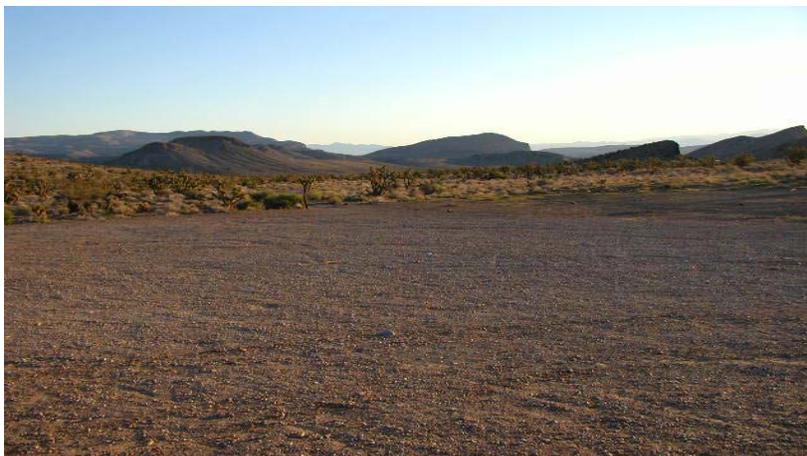
**Figure 7.**

The third most recognized aspect to be grouped was based upon lack of trail signage. The No Signage sub-category was identified by users as not having any indicators as to where they are or where they are going due to lack of signs (Figure 7).

A participant took the above picture and it is of one of the main parking lots that is used for staging before accessing the trails. It was described as not having any information for the public describing where the trails were, what the appropriate etiquette was or who could use these trails. This aspect has been accounted for under positive and negative categories in this study. This is a re-occurring theme throughout this study and will be addressed in the discussion. Eighteen percent of negative impacts were devoted to this category. Results with aspects of negative impacts to the area can be seen distributed in the pie chart below.

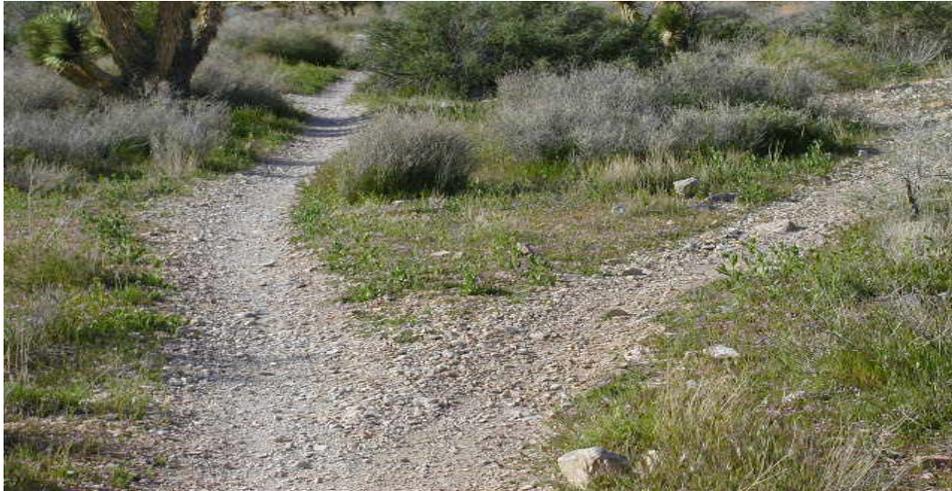
**Figure 9.** This is a picture of a parallel trail (i.e. webbing) that is not necessary.

This example of user's views is a great reason for education on trail etiquette and interpretation of resource values, which was also one of the most important attribute that were derived from the survey.

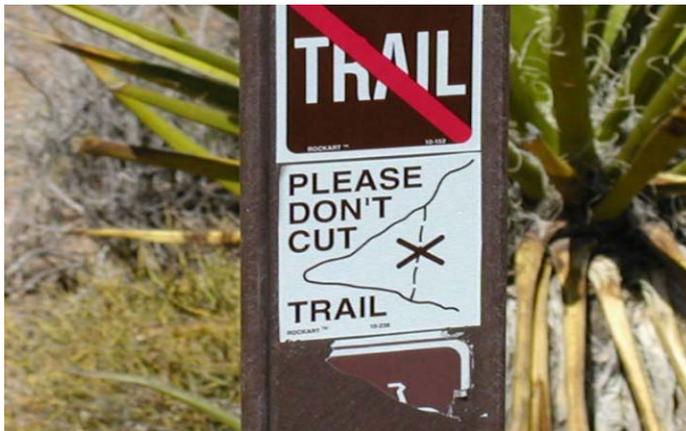
Trail closures (Figure 10) were among the data collected that can be considered a negative aspect to the trails.

**Figure 10.** This is a photo taken by a participant that was affected in a negative way due to the closing of this trail.

Because this is a conservation area, trails sometimes need to be closed for rehabilitation. Having the permission to actually ride trails in an area such as this is a special experience and cannot be replicated. This opportunity should not be taken for granted. This is a direct correlation to the request by users for more trails. Because of the designation of the area, more trails may not be a suitable remedy for the area. Introducing other options around the Valley may be an option for managers to consider. Responses to trail closures
