Cracking of Martensitic Alloy EP-823 Under Controlled Potential

A.K. Roy and M.K. Hossain

The susceptibility of martensitic Alloy EP-823 to stress corrosion cracking was evaluated with and without an applied cathodic potential using the slow-strain-rate (SSR) testing technique. The magnitude of the applied potential was based on the corrosion potential determined by cyclic polarization. The cracking susceptibility in an acidic environment at different temperatures was expressed in terms of the true failure stress (σ_f), time to failure (TTF), and ductility parameters, including percent elongation (%El) and percent reduction in area (%RA). The data indicate that the magnitudes of σ_f , TTF, %El, and %RA were reduced due to cathodic charging. The scanning electron microscopic evaluations of the primary fracture surface of the specimens used in SSR testing revealed a combination of ductile and brittle failures. Further, the secondary cracks at the gauge section of these specimens were characterized by branching.

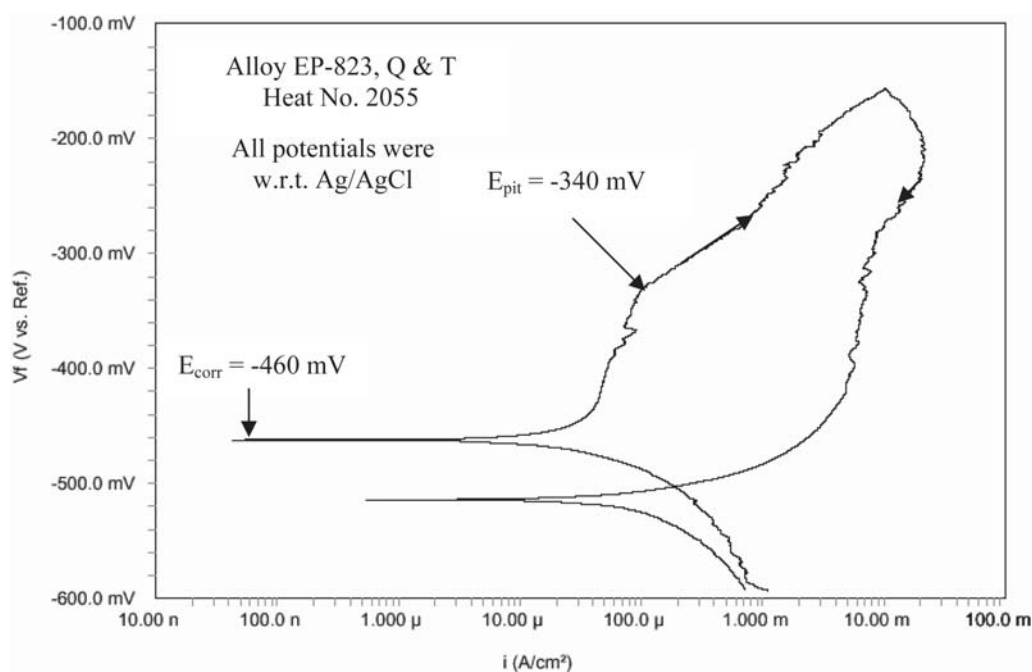
Fig. 6 CPP diagram in 90 °C acidic solution (pH ~ 2.35)

The results of CPP testing conducted in the acidic solution at 30 and 90 °C are shown in Fig. 5 and 6, identifying the corrosion potential (E_{corr}), critical pitting potential (E_{pit}), and protection potential (E_{prot}), if any. An examination of these diagrams indicates that the magnitude of E_{corr} at 90 °C was

A comparison of Fig. 5 and 6 also indicates that no protection or repassivation potential (E_{prot}) was observed at 90 °C, possibly caused by the breakdown of the surface film under the combined effect of acidic pH and elevated temperature. The appearances of the polarized specimens in the acidic solution at 30 and 90 °C are illustrated in Fig. 8, showing deeper pits at the elevated temperature. However, the tested specimens showed crevice corrosion at both temperatures.

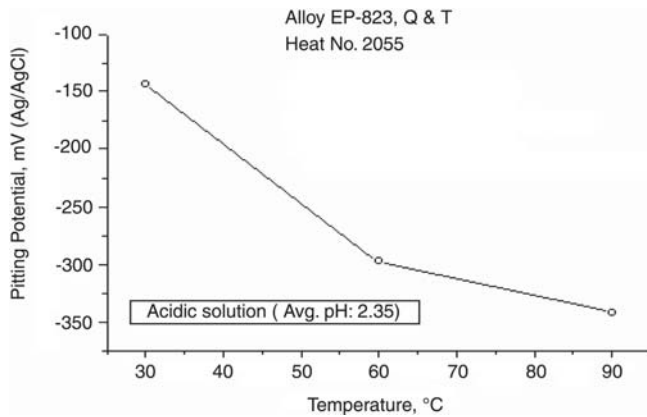
Fig. 7 Effect of temperature on critical pitting potential

slightly more noble (-460 mV, Ag/AgCl), than that at 30 °C (-500 mV, Ag/AgCl). The variation of the average E_{pit} value, determined from the CPP testing, is illustrated in Fig. 7. An evaluation of these data indicates that the magnitude of E_{pit} gradually became more active (negative) with increasing temperature. A similar effect of temperature on E_{pit} has been reported elsewhere (Ref 16).

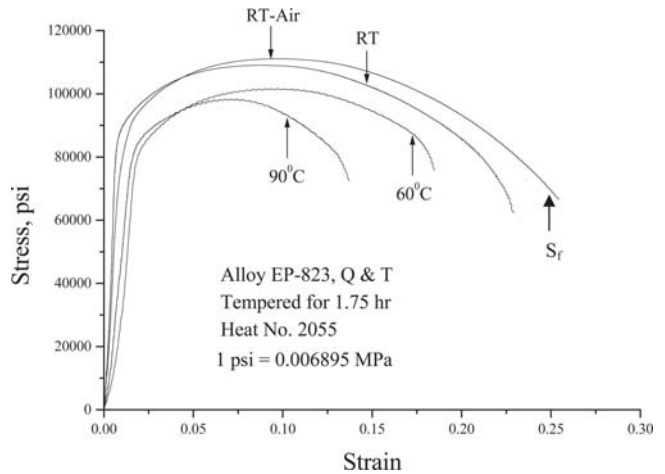
Fig. 9 Stress-strain diagrams in acidic solution (pH ~ 2.35)

The results of SSR testing of Alloy EP-823 in the acidic solution without E_{cont} are illustrated in Fig. 9, showing s-e diagrams as a function of the testing temperature. This figure also shows an s-e diagram obtained in air for comparison purposes. An examination of these s-e diagrams reveals that the magnitude of the failure strain was reduced with increasing temperature. Obviously, the maximum failure strain was noted in the s-e diagram obtained in air at room temperature (RT). The results of SCC testing performed in a similar environment at 30 , 60 , and 90 °C under an E_{cont} value of -1000 mV (Ag/AgCl) are shown in Fig. 10. A similar effect of temperature on the cracking susceptibility was observed under E_{cont} once again, showing reduced failure strain at higher testing temperatures.

The data presented in Fig. 9 and 10 are reproduced in Table 5, showing σ_f , %EI, %RA, and TTF, with and without E_{cont} . As indicated earlier, the determination of %EI, %RA, and σ_f was based on the s-e diagram and the dimensions of the cylindrical specimens before and after testing. An evaluation of these data indicates that the magnitude of all these parameters was reduced under an E_{cont} value of -1000 mV (Ag/AgCl), compared with those obtained without the E_{cont} . However, the extent of reduction of all these parameters was more pronounced at 90 °C, indicating a detrimental effect of higher testing temperature on the cracking susceptibility of Alloy EP-823, with or without the E_{cont} . Comparisons of all four parameters, with and without the E_{cont} , are illustrated in Fig. 11-14, as a function of

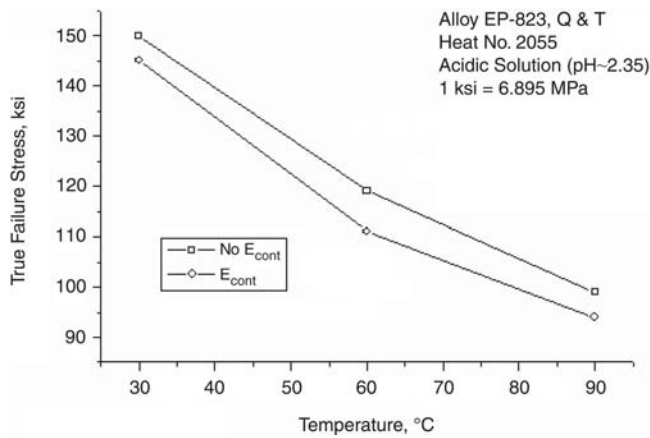
Fig. 11 Effect of temperature on true failure stress (σ_f)

different testing temperature. The detrimental effects of higher temperature and cathodic potential on the cracking susceptibility are illustrated in these figures. A similar effect of cathodic applied potential on the cracking susceptibility of engineering materials has been reported by other investigators (Ref 9-12, 17-20). However, no attempt has been made to analyze the concentration of hydrogen resulting from the cathodic applied potential.

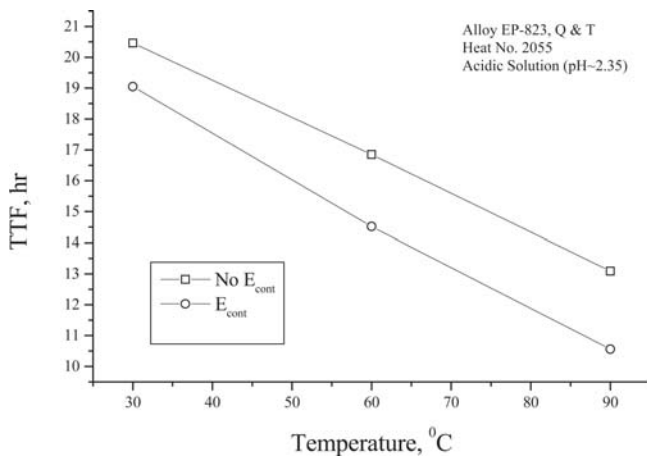
Fig. 12 Effect of temperature on TTF

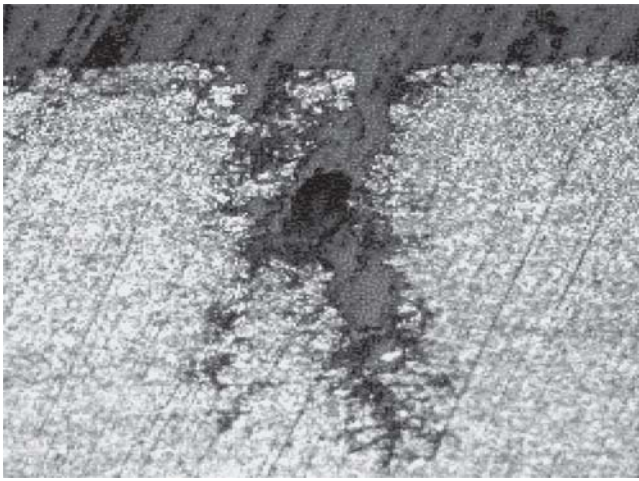
Fig. 17 Optical micrograph of secondary cracks (no E_{cont}), etched in Fry's reagent, 200 \times

The extent of brittleness was, however, more pronounced in specimens tested under E_{cont} at higher temperatures, as noted by the wider transgranular cracks. Branched secondary cracks were also observed in all cylindrical specimens, with and with-

out the application of E_{cont} , as shown by optical micrographs in Fig. 17 and 18.
