# Investigation of Chloride Induced Corrosion of Bridge Pier and Life-Cycle Repair Cost Analysis Using Fiber Reinforced Polymer Composites

Master of Science in Engineering – Civil and Environmental Engineering

December 2014

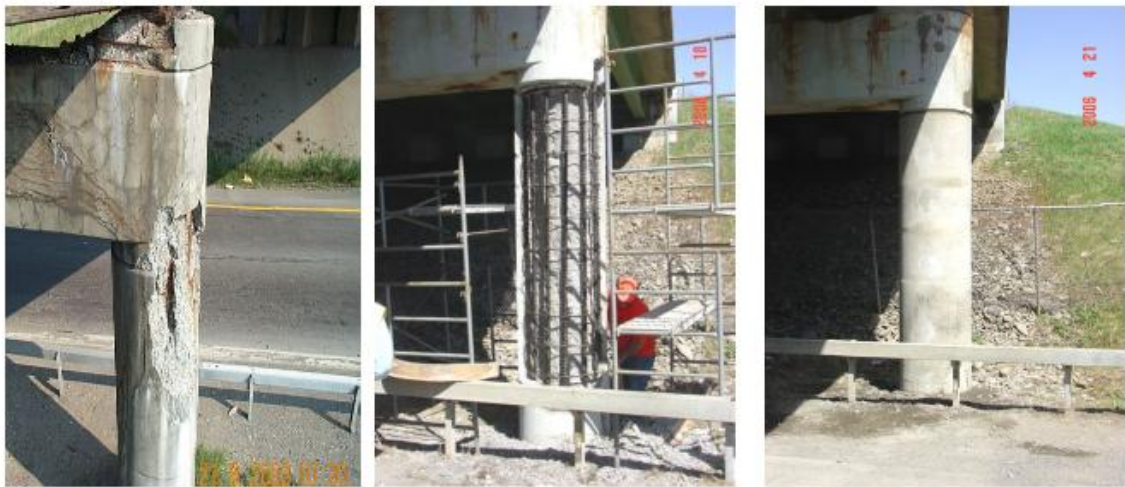
**Figure 10.** (Left) Corrosion Damage, (Center) Removal of Concrete and Repair Reinforcement, and (Right) Replace Concrete (NYDOT, 2008)

The corrosion repair method includes the removal and replacement of concrete up to  $\frac{3}{4}$ " (19 mm) below the reinforcement layer in damaged area. The reinforcement should be replaced if any corrosion is found. Figure 10 shows the typical corrosion damage and concrete repair process.
