Measuring Impacts and Vibrations on a Volumetric Modular House During Transportation

MEASURING IMPACTS AND VIBRATIONS ON A VOLUMETRIC MODULAR HOUSE
DURING TRANSPORTATION

Master of Science in Engineering – Civil & Environmental Engineering

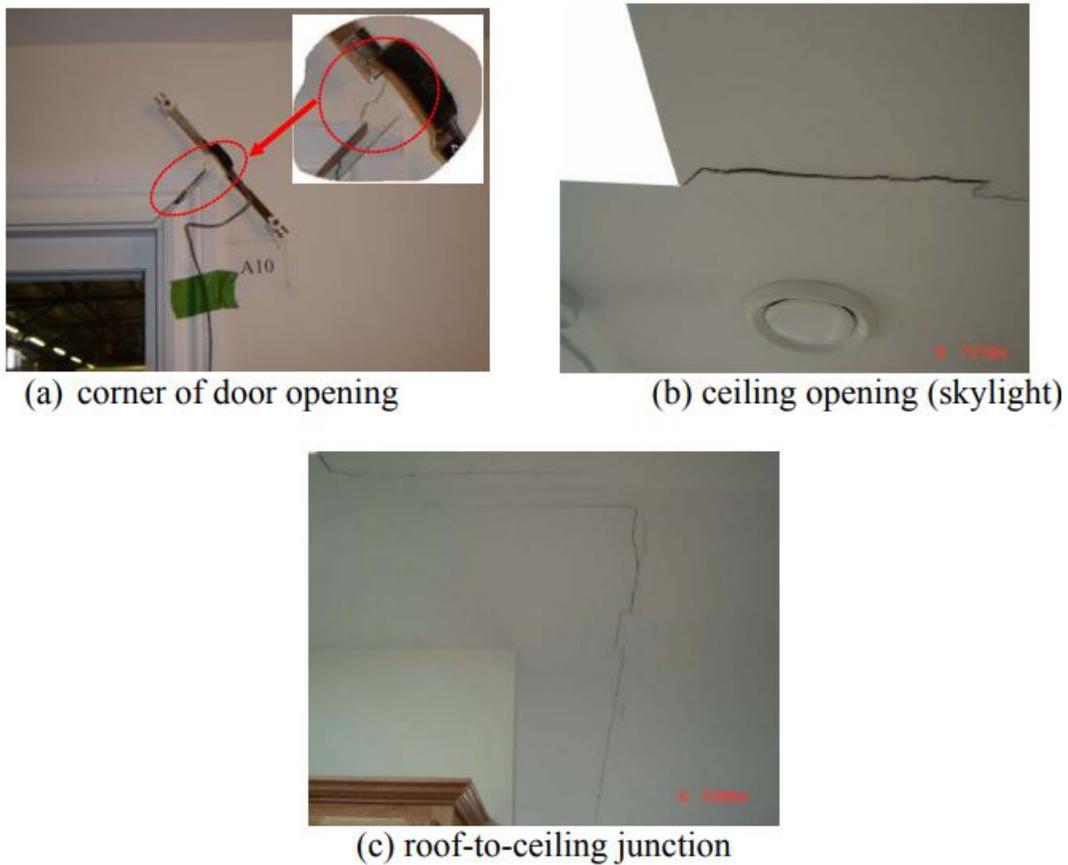
Figure 1. Damages occurred to the mini home (Smith et al., 2007).

The damage occurred in the patterns of long horizontal cracks on the plasterboard linings of the side walls, vertical cracks on the kitchen ceiling, and 45-degree cracks on the corners of the frames of the windows and doors. According to the author, lifting/offloading-induced impact initiated the damage in the form of various types of cracks within the module, and vibration, impact, and wind pressure affected the module during transportation and further developed those existing cracks.

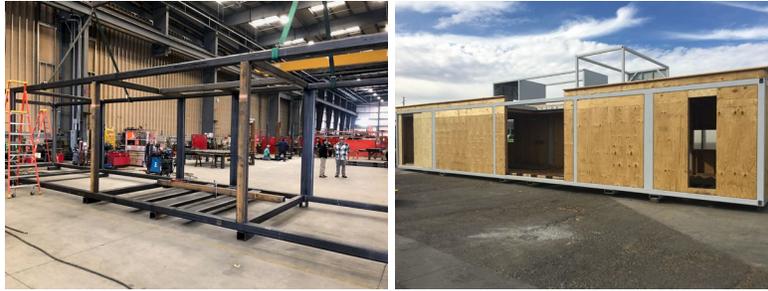
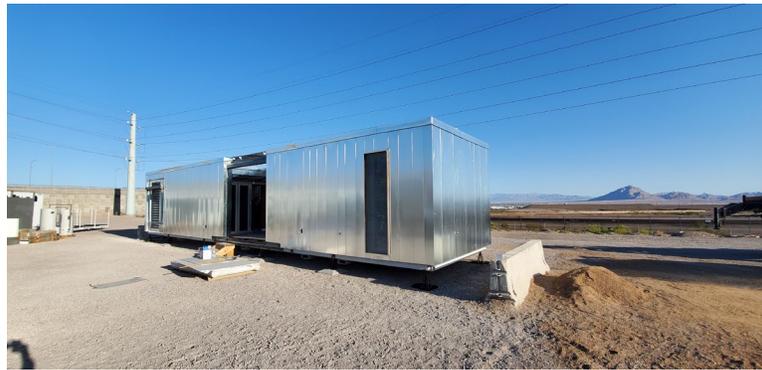
Since the originally anticipated transport distance was far beyond the typical mobile home transport distances, the team adopted 6 in. X 6 X. ¼ in. square Hollow Structural Sections (HSS) for the framing of the modular house to help maintain its structural integrity throughout the extended trip. Figure 3 shows distinct stages of modular house construction, denoted as structural components finished, exterior walls finished, and the modular house completed.

Figure 3. Structural Components (a), Exterior Walls (b), Finished Modular House (c)

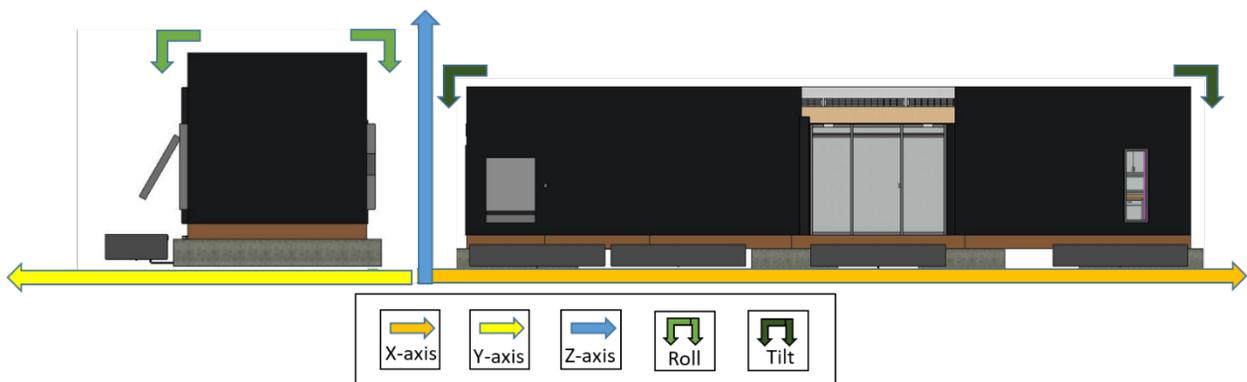
either of the tilt and roll data displayed 180 degrees, and 0 degrees would mean the modular house is upright/centered. Given the sensor's orientation for this case study, a negative value in tilt and roll would mean a tilt or roll towards the front or right, and a positive value towards the back or left. Also, the sensor records the maximum and the minimum values of tilt and roll in one slot, meaning there would be two columns of tilt and roll data when extracted into an excel file. The numerical data orientation based on ShockLog 298 installation location is represented with the 2D view of the modular house in Figure 5.

Figure 5. Numerical data orientation

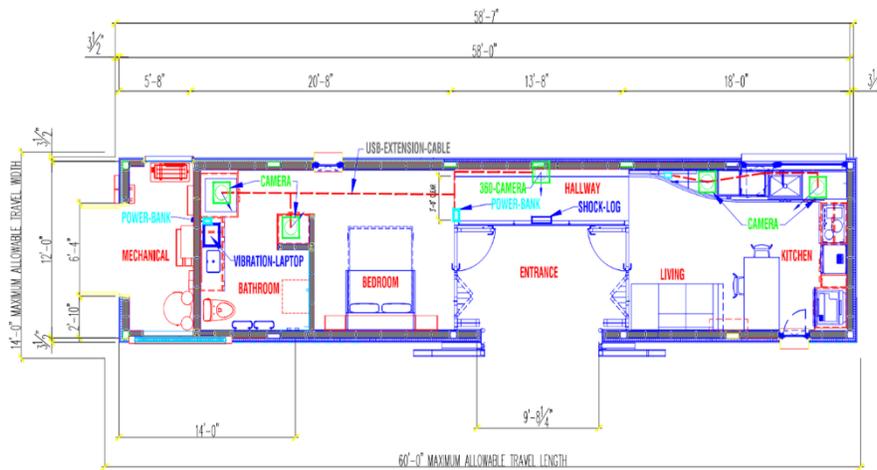
modular house's longest horizontal wall and the glass wall panel. Samsung Gear 360 was attached to the horizontal wall at the 'Hallway.' The dashcams were installed in locations that allowed them to capture the widest angles. One set of dashcams (front/rear dashcam) was installed in the 'Kitchen/Living' area, and their angle of view was adjusted to capture both the inside view of the modular house and the outside view through the glass wall panels and doors at the 'Entrance' area. The other set was installed in the 'Bathroom' and 'Bedroom' areas and captured the views of their respective installed areas. Figure 6 shows the prospective installation locations of the sensor and cameras.

Figure 6. Sensor & Cameras layout

Connections to power banks are not shown in Figure 7. However, all cameras had a power bank allocated to them. Contrary to the original layout plan pictured in Figure 6, a front dashcam was installed to the structural component that serves as a frame for the glass panel instead of installing both front and rear dashcams in the 'Bathroom' area. The author was not only unable to determine an ideal location for its installation in the 'Bathroom' area but also believed installing it to the structural component would allow it to capture both the 'Bedroom' area and a portion of the 'Bathroom' area more effectively. In the 'Bathroom' area, the rear dashcam was installed on top of the cabinet to capture the widest view. However, its vision was significantly obstructed by the cabinet top due to not having a proper elevation required to locate the lens high enough to prevent the cabinet top from taking up much of the frame. By this time, all three parties had arrived, and it was inevitable for the author to evacuate the modular house to let them proceed with the transportation. Unfortunately, the author had to disregard using rear dashcam (Bathroom) data for the case study. It was around 8:30 AM when the author left the modular house.

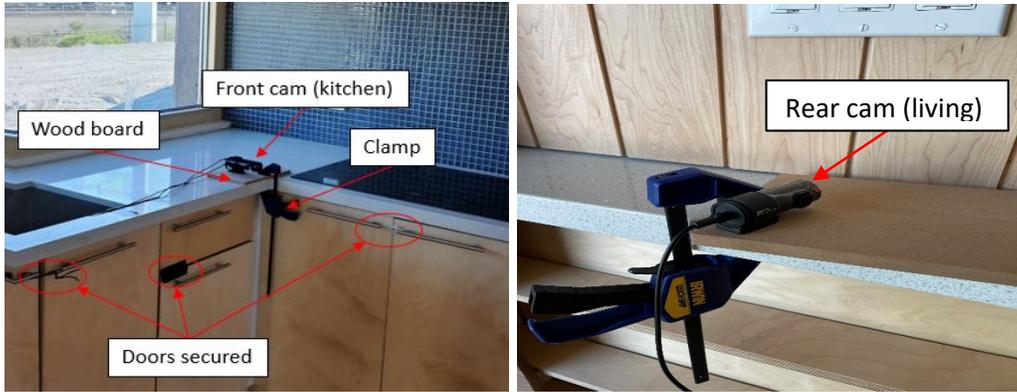
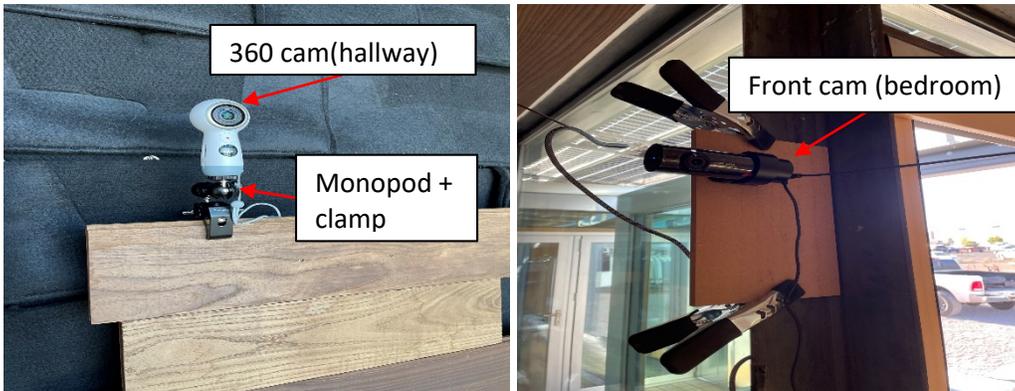
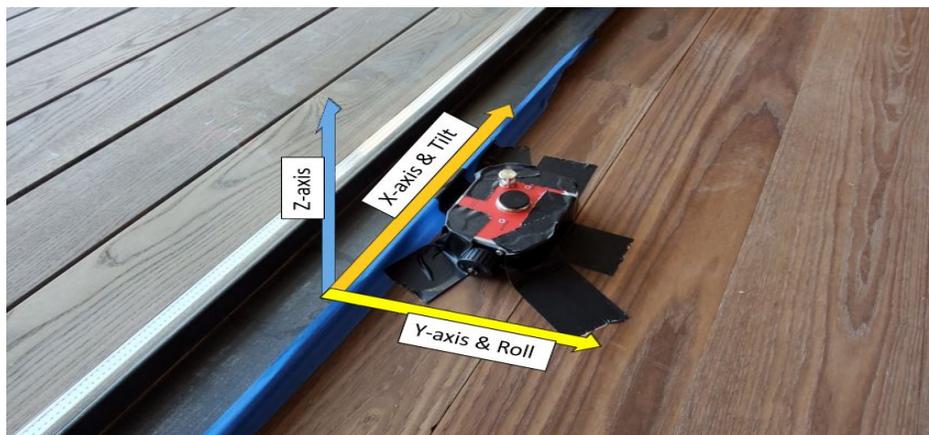
sufficient for 10 hours. However, the cameras do not have batteries. They require a connection to a separate power source at all times of their operation. Accordingly, three power banks were installed to power the cameras. The author used duck tapes to install and secure the ShockLog 298 sensor. The Samsung Gear 360 was attached to the wall via the monopod and clamp, and the dashcams were first attached to the wooden boards, then secured to their respective installation locations using clamps to avoid damaging the furniture. The author used duck tapes and/or iron wires to secure the cabinet doors to prevent them from bursting open during transportation due to impact. The actual installation locations for the sensor and cameras are shown in Figure 7.

Figure 7. Front & Rear dashcams (Kitchen/Living) (a & b), 360 cam (Hallway) (c),
 (Front dashcam (Bedroom) (d), ShockLog sensor (Hallway) (e)

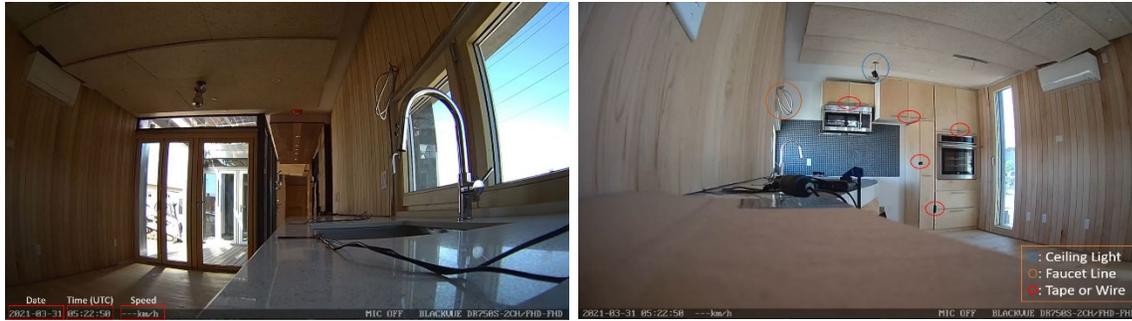
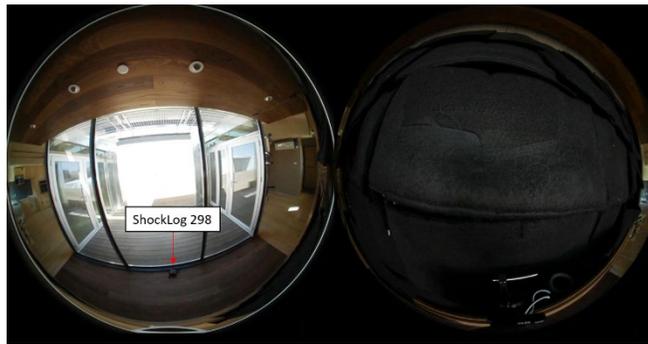
Views captured by the two dashcams and a 360 camera in the 'Kitchen/Living' and 'Hallway' areas are presented in Figure 8.

Figure 8. Front dashcam (living) (a), Rear dashcam (living) (b), 360 cam (hallway) (c)

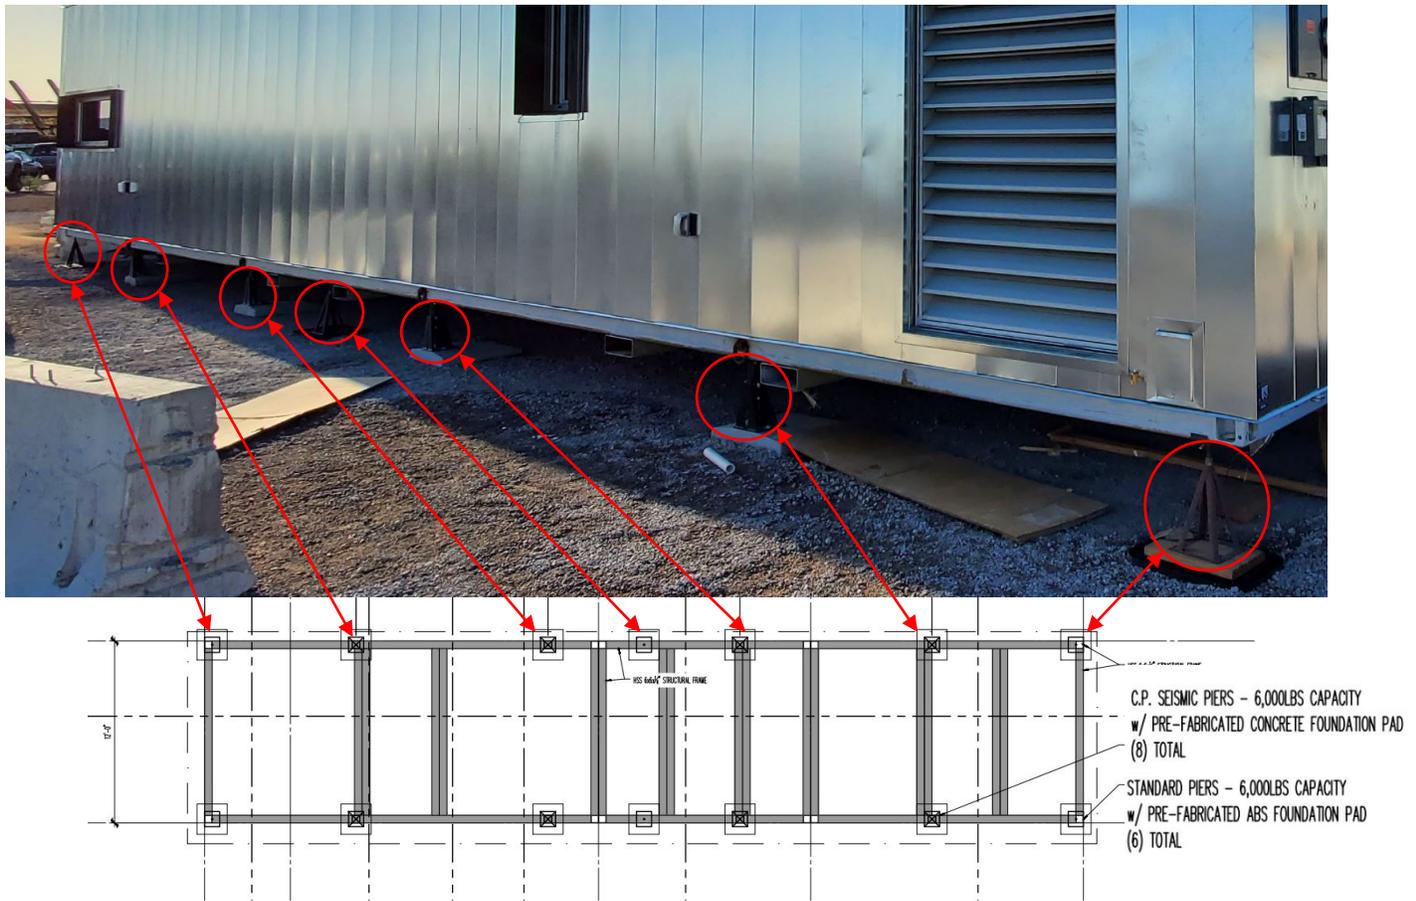
At default, the modular house was positioned 19" + above the ground on top of the C.P. Seismic/Standard Piers. Each pier has 6,000 lbs. capacity, and seven piers were on either side, as shown in Figure 9. In total, fourteen piers supported the modular house.

Figure 9. C.P. Seismic/Standard Piers supporting the modular house

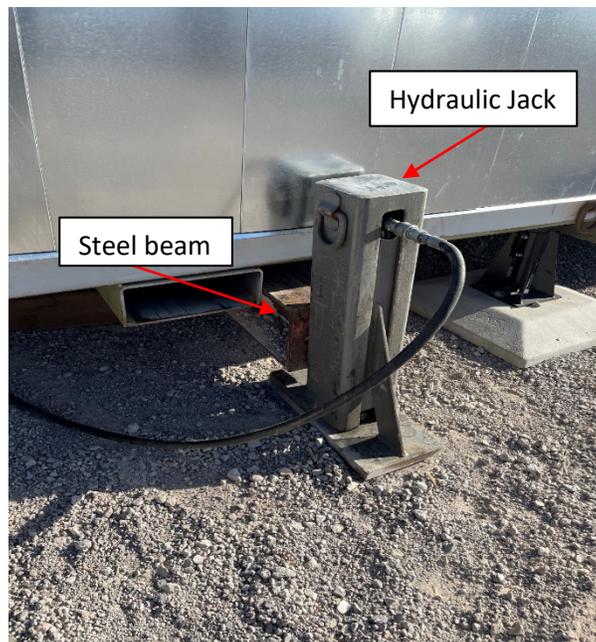
side of the two steel beams, as shown in Figure 10 (the beams have long enough spans to establish hydraulic jacks' attachment to their sides underneath the modular house).

Figure 10. View of one of four hydraulic jacks (rear)

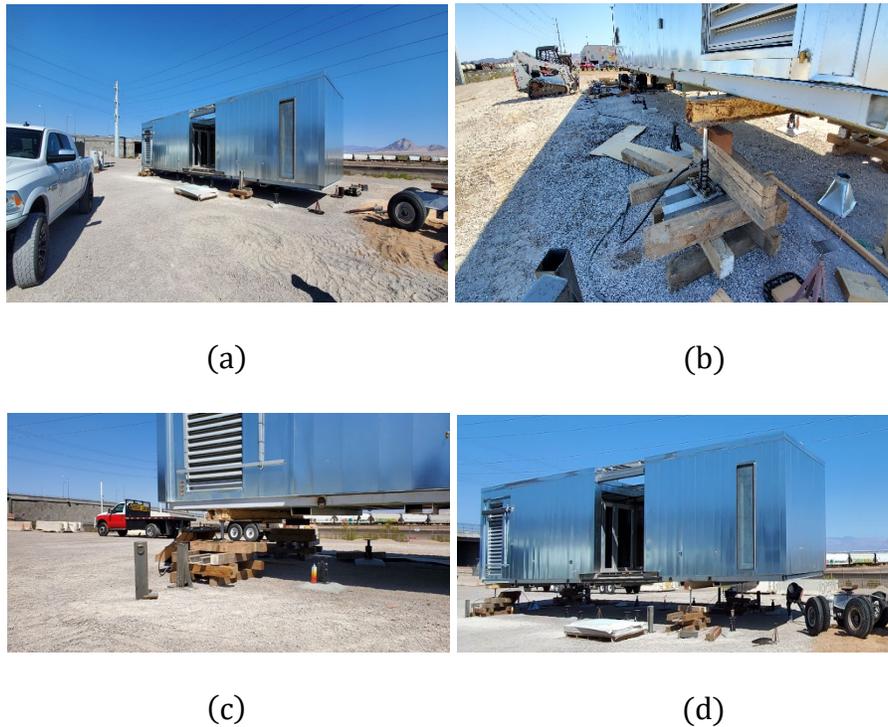
3 to 6 were repeated to lift the modular house in small increments. Figure 11 depicts a summary of the modular house lifting steps.

Figure 11. First lumber stacks made (a), more lumber being stacked (b), several lumber stacks made (c), lifted high enough for tandem axle dollies (d)

When the modular house was at the level shown in Figure 11. (d), the subcontractors attached the two tandem axle dollies to the steel beam attached to the rear side of the modular house. The steel beams, like an I-beam, have a top and bottom flange, and the axle dollies have flange clamps. The attachment of the axle dollies to the steel beam was a simple work of sliding and clamping. The axle dollies were inserted from one side of the steel beam, attached to a Bobcat

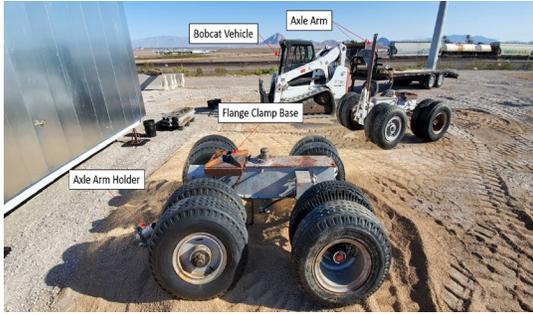
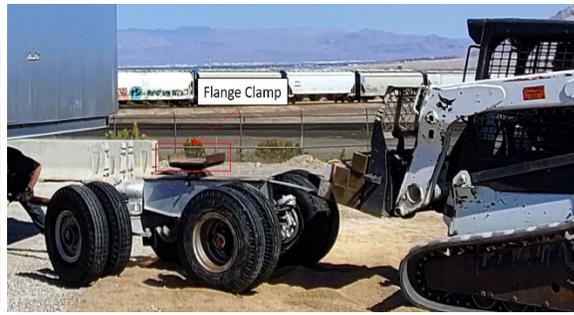
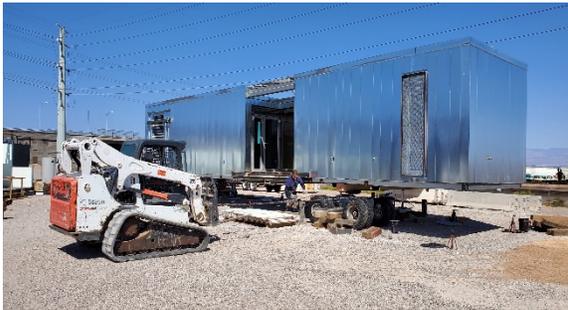
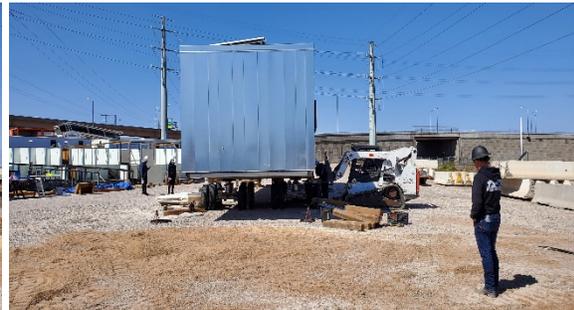
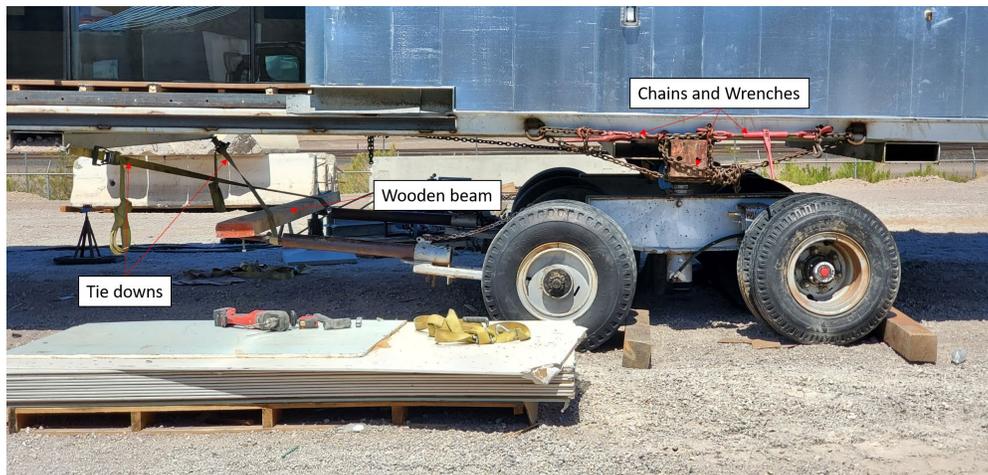
utility vehicle on the opposite side via a chain, and the vehicle pulled the chains backward to adjust the axle dollies to the desired position. After the two tandem axle dollies were installed, the two hydraulic jacks were removed, and their axle arms were attached to either side of a wooden beam and secured with mechanical tie downs. As a result, the axle dollies' attachments were further strengthened, and uniform movements between the axle dollies were established. Moreover, chains and wrenches have been used on either side of both frontal/rear steel beams to tighten their attachments to the modular house. The above attachment of axle dollies is depicted in Figure 12.

Figure 12. Tandem Axle Dollies (no clamp) (a), Tandem Axle Dolly (clamp) (b), Bobcat pulling axle dolly (c), two axle dollies attached (d), left side view of a completed rear wheel system (e)

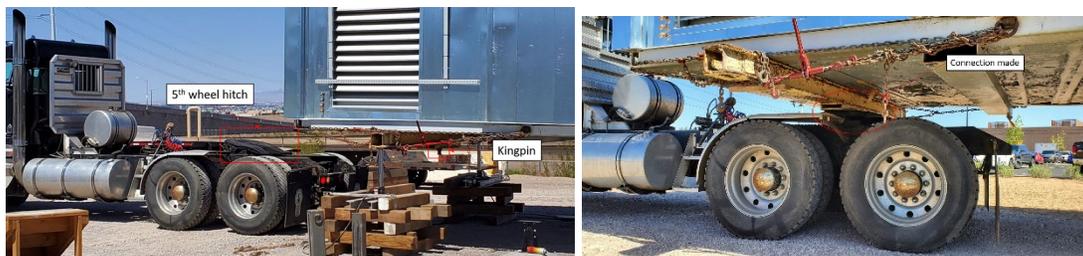
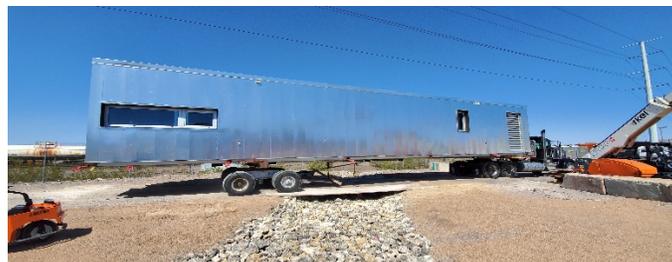
The lifting of the rear side of the modular house was completed with the attachment of the two tandem axle dollies. The steel beam on the front side has a trailer kingpin, and it was going to be attached to the truck's 5th wheel hitch to establish a connection between the modular house and the truck. However, the truck was at a slightly higher level than the modular house, so the modular house was lifted once again by a small increment to be leveled with the truck. After leveling the modular house to the truck, the driver carefully pulled back to connect the 5th wheel hitch to the kingpin. The process of connecting the modular house to the truck is shown in Figure 13.

Figure 13. Modular house lifting for leveling (a), Modular house connected to the truck (b),
Modular housing leaving jobsite (c)

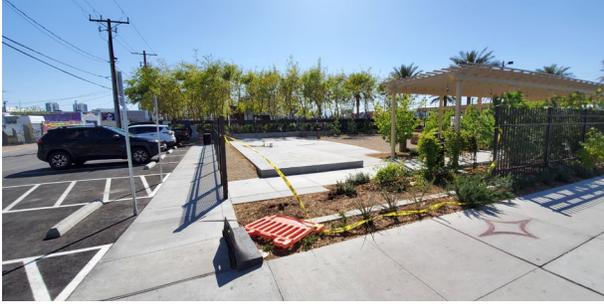
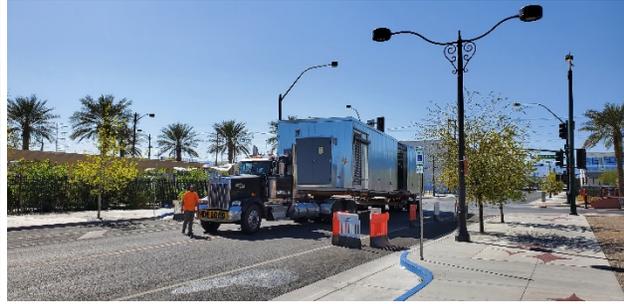
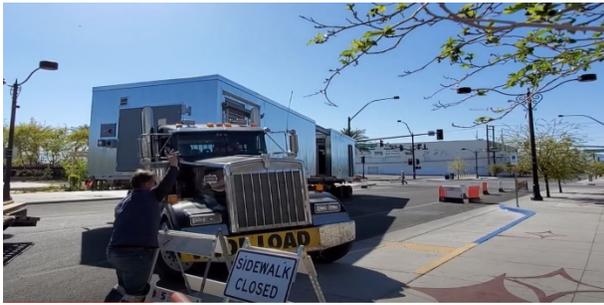
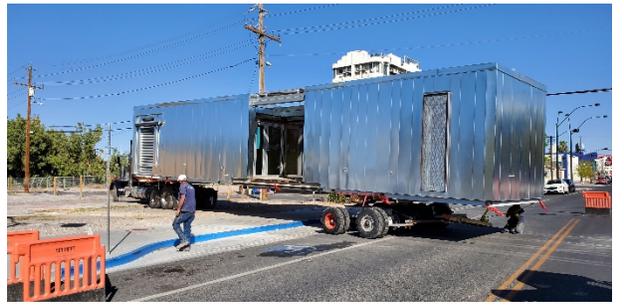
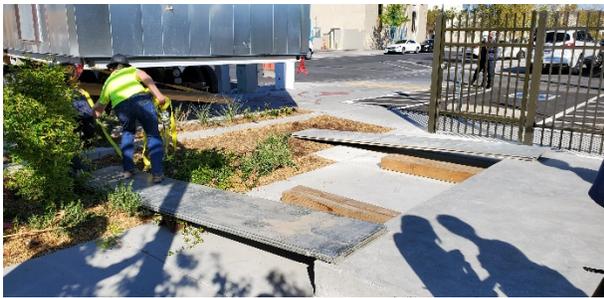
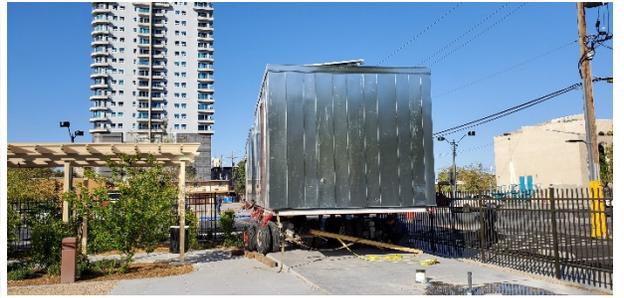
The driver drove the modular house on the pre-planned transportation route as shown in Figure 4, and delivered the modular house from its fabrication yard, Xtreme Manufacturing, to its Jobsite/installation location in Las Vegas Community Healing Garden. Inside the healing garden is a 6.2-inch-thick concrete slab, where the modular house was planned to be offloaded. The garden was surrounded by fences and plants. A narrow entrance was created by temporarily removing a part of the fences to incorporate modular house installation. Still, the space inside the garden was extremely limited. Any modular house maneuver would be impossible once it makes the initial movement to enter the garden. In other words, the truck must be driven in rear gear to enter the garden and offload the modular house on top of the concrete slab. The modular house made a right turn to arrive at the road next to the garden, meaning the garden was on the right side of the modular house. Making an immediate right turn into the garden would not have worked as there is not any extra space in the garden to allow the modular house to adjust its positions. Thus, the driver made a left turn into the empty lot across the garden. From there, the driver pulled back in rear gear into the garden. Figure 14 shows the summary of the described truck maneuvers.

Figure 14. concrete slab (fences removed) (a), Modular housing driving in (b), Modular housing into empty lot (c), Modular housing pulling out (d), Two steel plates as driveway (e), Modular house into the garden (f)

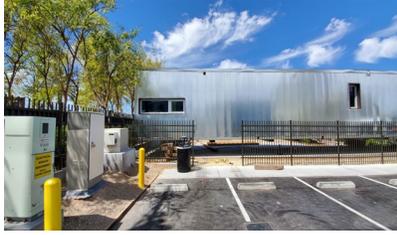
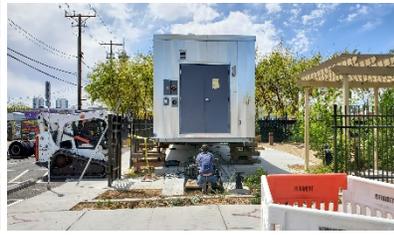
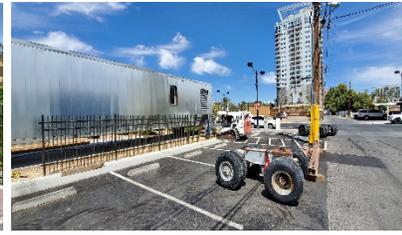
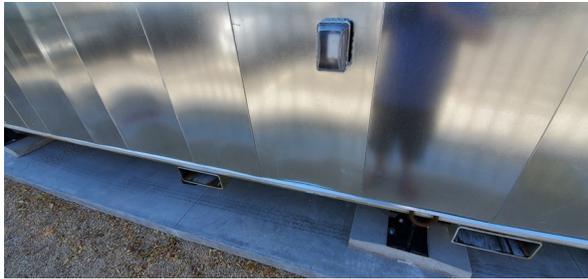
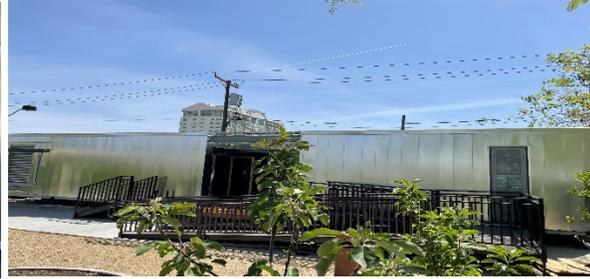
The contractors and the subcontractors began offloading the modular house using a similar technique they used to lift the modular house. First, they removed fences adjacent to the truck's wheels and axle dollies to create sufficient working spaces. Second, they established four lumber stacks on either side of the front and rear attached steel beams. Third, a connection between the truck's 5th wheel and a front steel beam's kingpin had been loosened, and the driver pulled out the truck. Fourth, four hydraulic jacks had been installed on either side of the two steel beams. Fifth, the uppermost layers had been removed from the lumber stacks. Sixth, hydraulic jacks had been leveled down to match the height of the lumber stacks. Seventh, the axle dollies had been removed. Eighth, the fifth, and sixth steps had been repeated until the modular house was lowered enough to be rested on top of the piers. Ninth, the modular house rested on top of the fourteen piers. Each pier was screwed to a concrete plate. Last, the two steel beams were removed. The above modular house offloading steps are summarized in Figure 15.

Figure 15. Fence removed (a), Truck removed (b), Axle dollies removed (c), Modular house rested on piers (d), Offloading completed, and walkway attached (e)

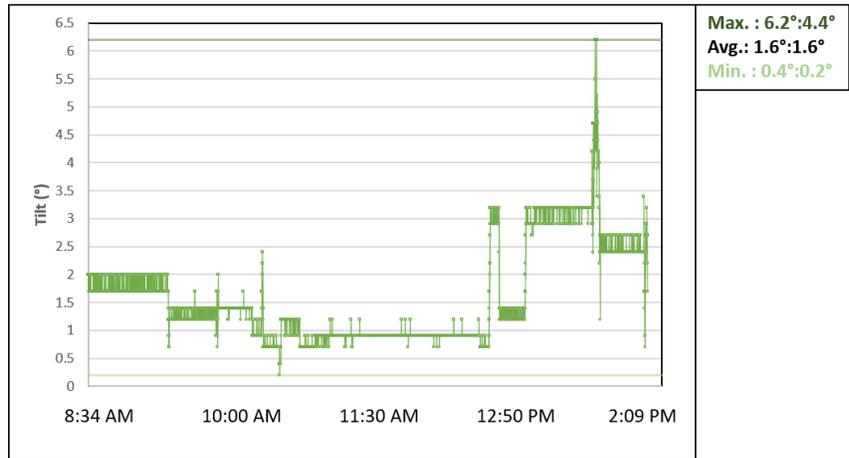
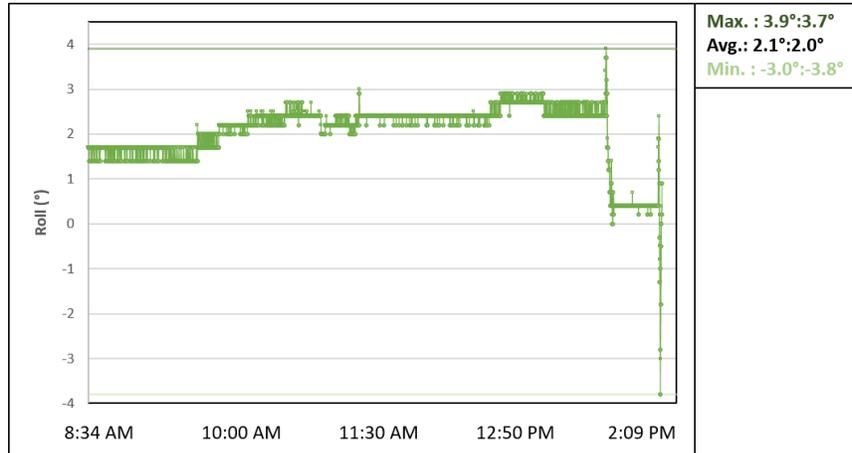
Figure 16. Lifting phase: Front-to-Back tilt (a), Left-to-Right roll (b)

The overall maximum Front-to-Back tilt recorded was 6.2 degrees and occurred at 1:38 PM. The minimum tilt at this instance was 4.4 degrees. The average of maximum/minimum Front-to-Back tilts were 1.6 degrees to 1.6 degrees. The overall minimum tilt recorded for Front-to-Back movements was 0.2 degrees, and the maximum tilt at this instance was 0.4 degrees. The overall minimum tilt occurred between 8:34 AM and 12:34 PM when the contractors and subcontractors finished attaching the two tandem axle dollies and were beginning to lift the front side of the modular house to level it to the truck. From then on, it can be seen in the graph that the tilt values go up significantly. The overall maximum tilt occurred when the modular house was turning left to leave the fabrication yard. (As shown in figure 12 (a), the front side of the modular house was facing the opposite direction from the exit. Making a U-turn was prohibited due to its size and the limited space, so the modular house had to drive around the fabrication yard). The view of the modular house making a left turn is shown in Figure 17.

For Left-to-Right roll movements, the overall maximum values were recorded about 1 minute before the overall maximum Front-to-Back tilt at 1:37 PM, as shown in Figure 16 (b), and it was 3.9 degrees. The minimum value at this instance was 3.7 degrees. The average of maximum/minimum Left-to-Right roll movements was 2.1 degrees to 2.0 degrees. Like Front-to-Back tilts, Left-to-Right roll movements between 8:34 AM to 12:28 PM were uneventful with a few spikes. The overall minimum Left-to-Right roll was -3.8 degrees, with a maximum of -3.0 degrees, and they occurred at 2:08 PM while the modular house was making a wide right turn after completing the left turn to exit the fabrication yard. The view of the modular house making a right turn is captured in Figure 18 (left) (the modular house maneuver in Figure 12 (c) followed upon the completion of the right turn).

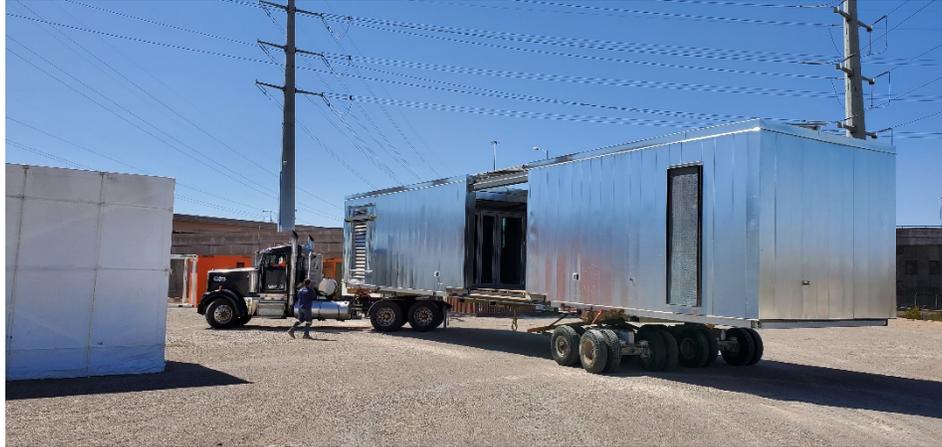
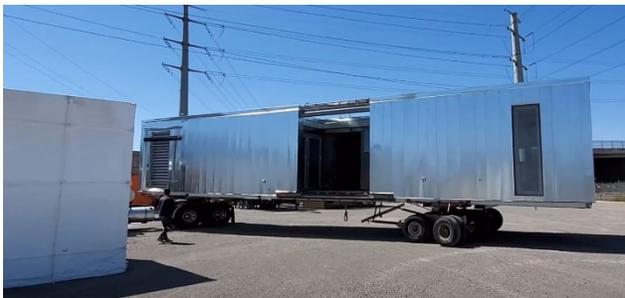
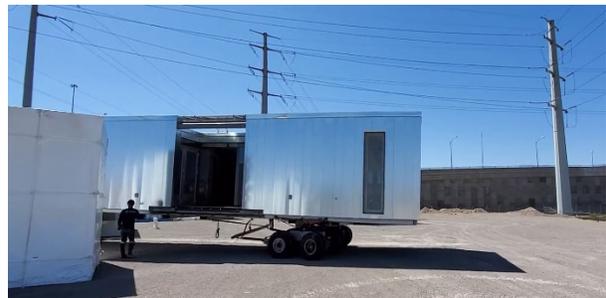
Figure 17. Modular housing turning left (1:37 PM) (a), Modular house turning left cont. (1:38 PM) (b), Modular house turning left cont. (1:38 PM ~) (c)

Contrary to what is shown in Figure 17 (b), Figure 18 (left) indicates the wooden beam rolled upward towards the left, hence causing an off-balance between the tandem axle dollies in the opposite direction from Figure 17 (b). The overall minimum Left-to-Right roll, as well as a

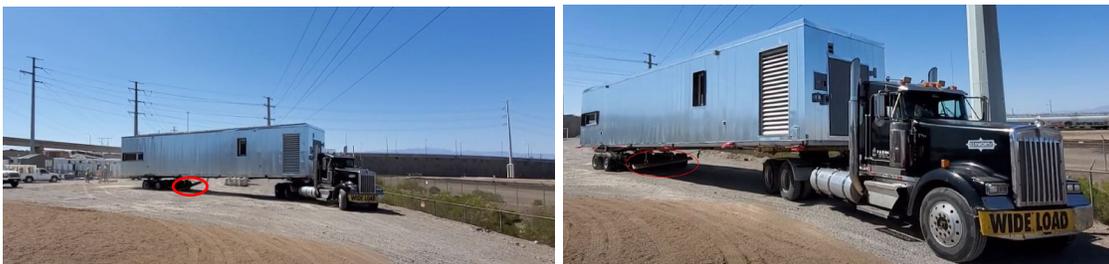
Figure 18. Modular House Making a right turn (left), Modular House completing a right turn (right)

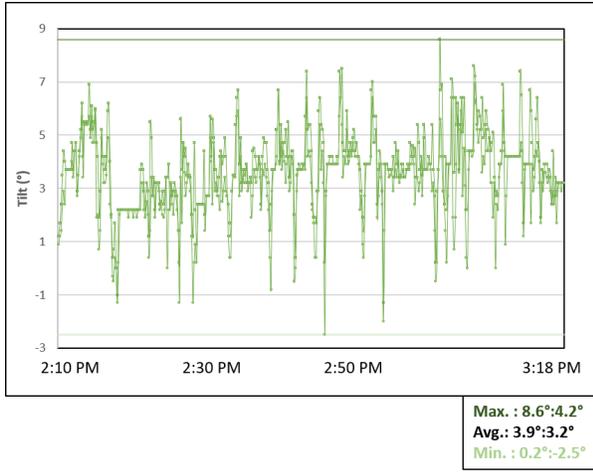
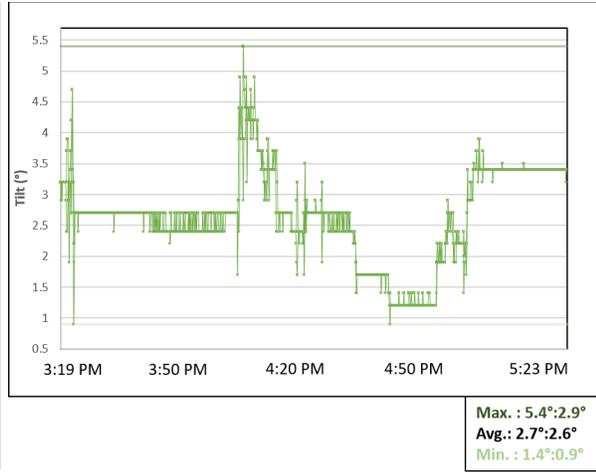
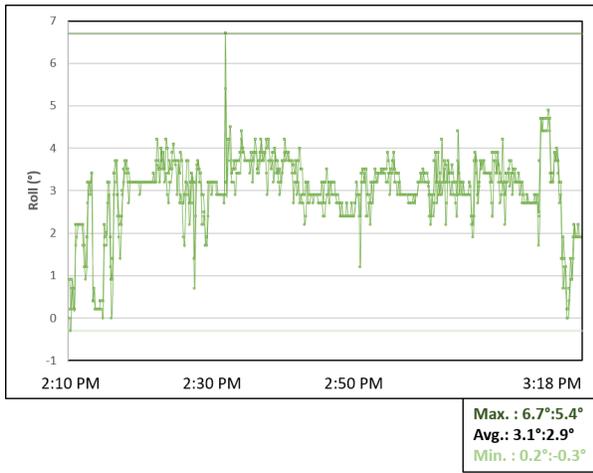
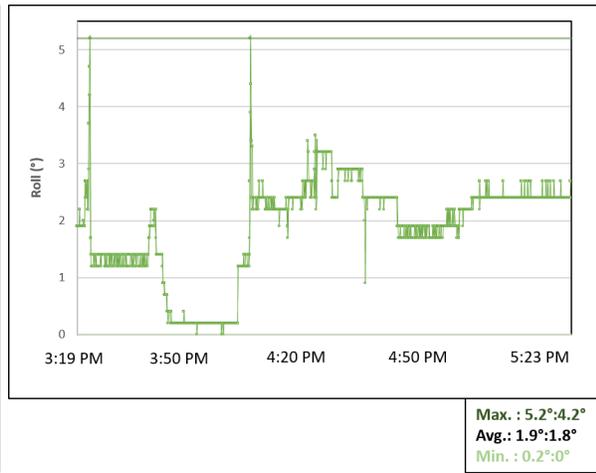
Despite all events or accidents that occurred that are denoted in Table 1, no impact was recorded in the X, Y, and Z axes according to the ShockLog sensor during the Transportation phase. Although the two phases (Lifting and Transportation) can be said to be equivalent in terms of impact recorded, Front-to-Back tilt and Left-to-Right roll data show how the transportation and being on the road affected the modular house to a greater extent than it was on the fabrication yard getting lifted. Tilt and roll graphs have been constructed using the data recorded and are represented in Figure 19.

Figure 19. Phase (Road): Front-to-Back tilt (a), Phase (Jobsite): Front-to-Back tilt (b)

For Transportation (Road), the overall maximum and minimum (at this instance) Front-to-Back tilts were 8.6 degrees to 4.2 degrees, and they occurred at 3:02 PM. The modular house was on E. Fremont St., and on its right side was a Lowe's mall. At this point, the Left-to-Right rolls were 3.2 degrees to 2.7 degrees. The modular house was driving in a straight line and made no noticeable maneuvers such as a wide turn or a sudden stop that may have caused the high tilts. However, according to the dashcams, the modular house was driving at 49 km/h (30.4 mi/h), which was a lot faster than the usual range of 25km/h (16mi/h) to 30 km/h (19 mi/h). In the dashcam footage, it was also noticeable that the ceiling light and faucet line were swaying a lot, implying a high vibration. The average Front-to-Back tilts were 3.9 degrees to 3.2 degrees. The overall minimum and maximum (at this instance) tilts were -2.5 degrees and 0.2 degrees, and it occurred at 2:46 PM when the modular house was traveling at 31 km/h (19.3mi/h) on the Boulder Hwy going past the Las Vegas Gambling Hall on its right side.

For Transportation (Jobsite), moments after modular house's arrival at the Jobsite, there was a spike of 4.7 degrees to 3.7 degrees tilts at 3:22 PM when the modular house was making a wide left turn into an empty lot to pull back in a straight line into the garden (Figure 13 (a)). As the modular house was turning, it went over a 6-inch curb. Therefore, after the turn, the misalignment between the modular house and the two tandem axle dollies was easily distinguishable and is depicted in Figure 20.

In Figure 19 (b), the spike is followed by a sudden drop, which maintains and forms a straight line-like trajectory or a ‘stable state.’ The stable state lasted from 3:22 PM to 4:05 PM. During this time, the wooden beam was removed and installed it in the rear of the two axle dollies to help them maintain stability while the modular house pulled back into the garden and re-aligned the axle dollies to the modular house. Immediately upon finishing the re-alignment, the driver pulled back and came down the curb (Figure 12 (d)), and directly caused another spike (overall maximum tilt and minimum) of 5.4 degrees to 2.9 degrees that occurred at 4:07 PM. From that point onward, the graph makes a moderate trajectory despite the troublesome processes of placing the modular house at its installation location. As shown in Figure 13 (f), the concrete platform was not wide enough for the two axle dollies. Thus, a stack of wooden beams was made adjacent to it to provide extra space for the axle dollies. Also, it is visible that the axle dollies are misaligned from the modular house due to having gone over two consecutive 6-inch curbs in rear motion.

For roll during Transportation (Jobsite), like tilt, spike of 5.2 degrees to 4.2 degrees rolls were observed at 3:22 PM before the stable state. Another spike occurred moments before the second spike in the tilt graph occurred at 4:06 PM due to the same cause. The roll graph makes an even more moderate trajectory after the second spike occurred.

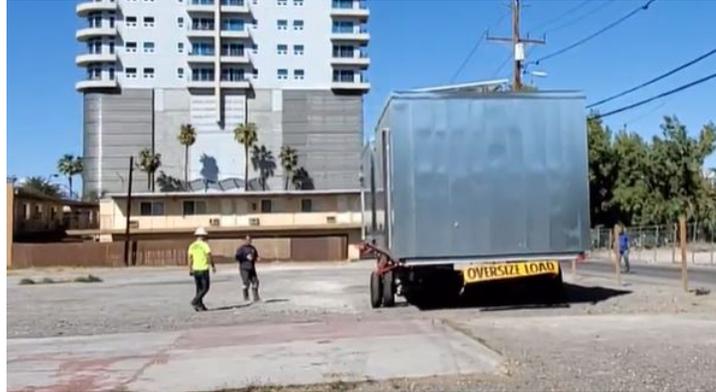
Figure 20. Misaligned axle dollies

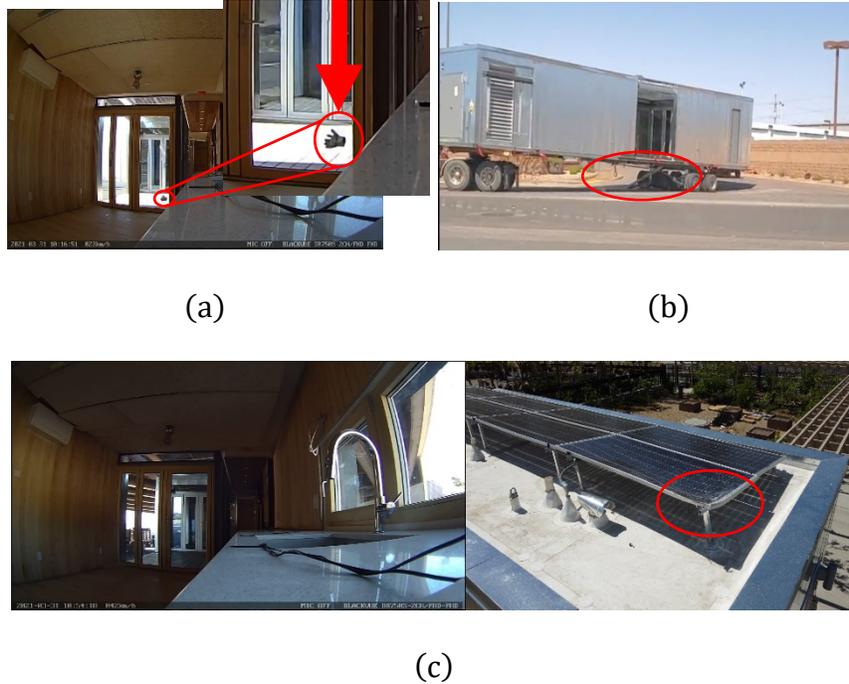
Figure 21. Transportation Phase: Glove falling (a), Wooden beam failure (b), Solar panel damaged (c)

As one could expect, both tilt and roll graphs did not reflect the fallen glove in Figure 21 (a) due to its relative insignificance compared to the modular house. Wooden beam failure shown in Figure 21 (b) holds much greater significance, and both graphs did reflect wooden beam failure. The tilts recorded were -1 degrees to -1.3 degrees, and the rolls were 3.4 degrees to 2.7 degrees. These values can be valuable in themselves. However, when they are put into the graphs and placed next to other values recorded, they do not stand out. Surprisingly, this was also true for the damaged solar panel. The modular house was driving at 42 km/h (26 mi/h) as it went under the overpass and resulted in 3.9 degrees to 3.4 degrees Front-to-Back tilts and 3.4 degrees to 3.2 degrees rolls, which were not noticeably different from the values recorded before and after the

accident. Moreover, dashcam footage also did not provide any visual evidence of the unusual impact that can be associated with the damaged solar panel.

Despite the above-described instability of the modular house during transportation, no visible damage has occurred to the volumetric module, except for one of the solar panels installed on top of the modular house (Figure 21 (c)). The default backward tilted configuration of the modular house raised its front side by a few inches, making it slightly go over the height clearance of one of the overpasses on the transportation route. However, in this instance, neither the numerical data nor the video footage reflected the impact/vibration. The tilt of 3.9 degrees to 3.4 degrees and the roll of 3.4 degrees to 3.2 degrees were recorded, which are within the interquartile ranges (IQR).

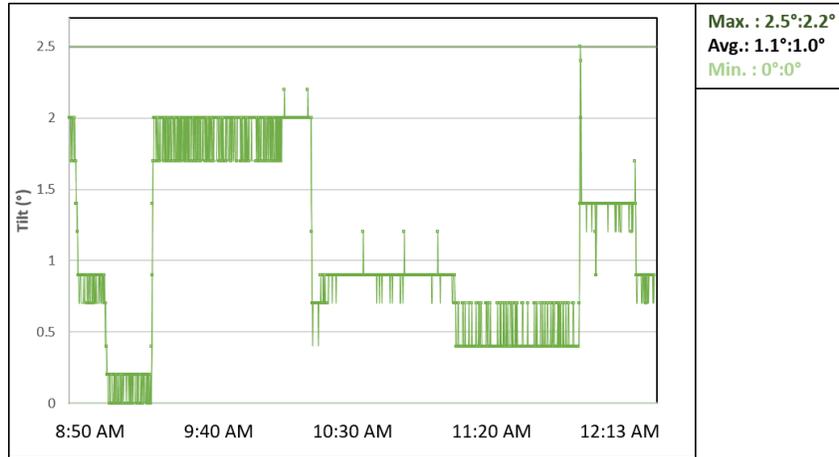
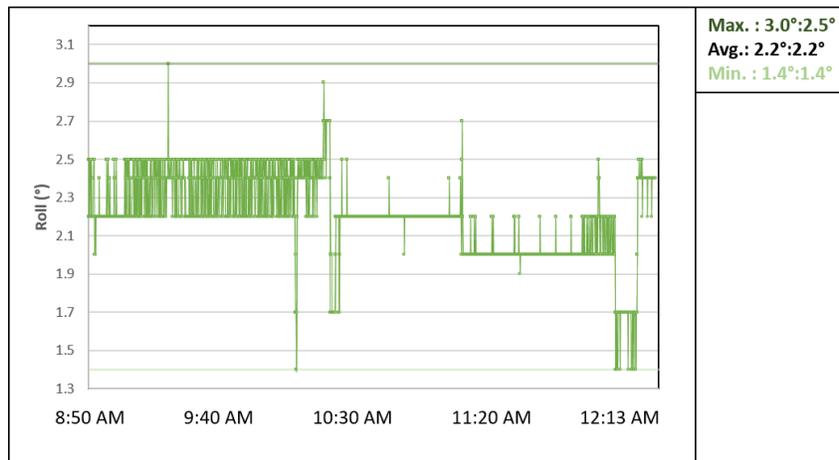
The modular house offloading process took approximately 6 hours and 30 minutes to complete, and its first 3 hours and 23 minutes were recorded with no impact in all three axes, meaning all the impacts the modular house felt throughout all three phases of the transportation were below the minimum impact threshold of 1G. The Front-to-Back tilt and Left-to-Right roll graphs for Offloading phase are presented in Figure 22.

Figure 22. Offloading Phase: Front-to-Back tilt (a), Left-to-Right roll (b)

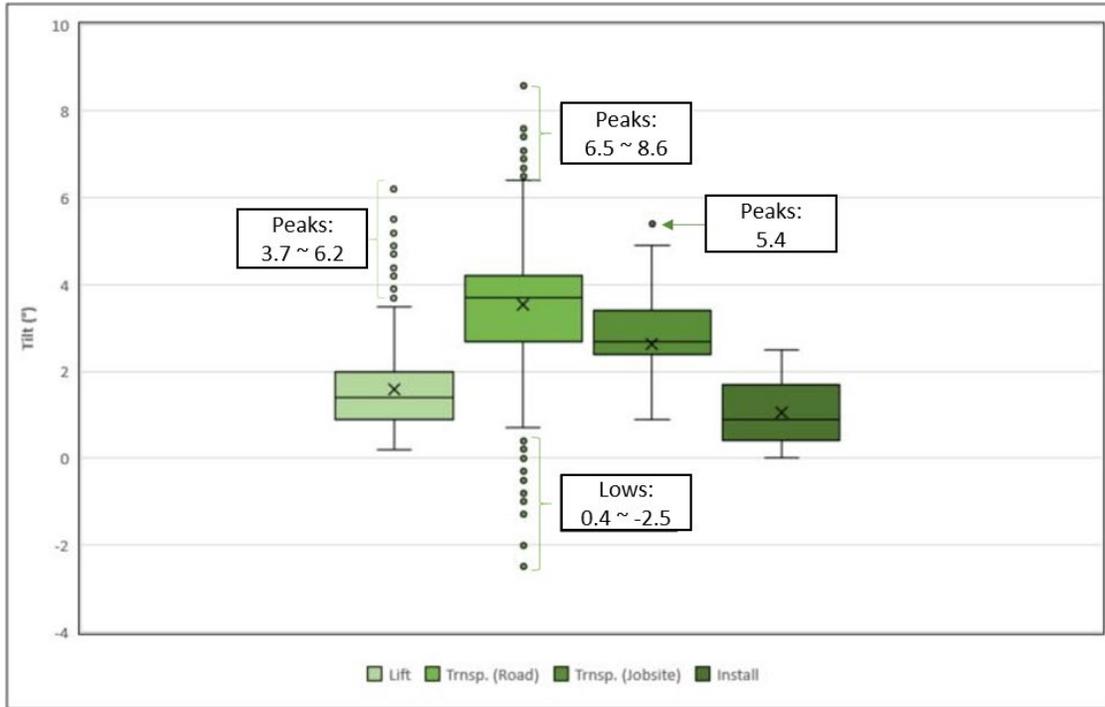
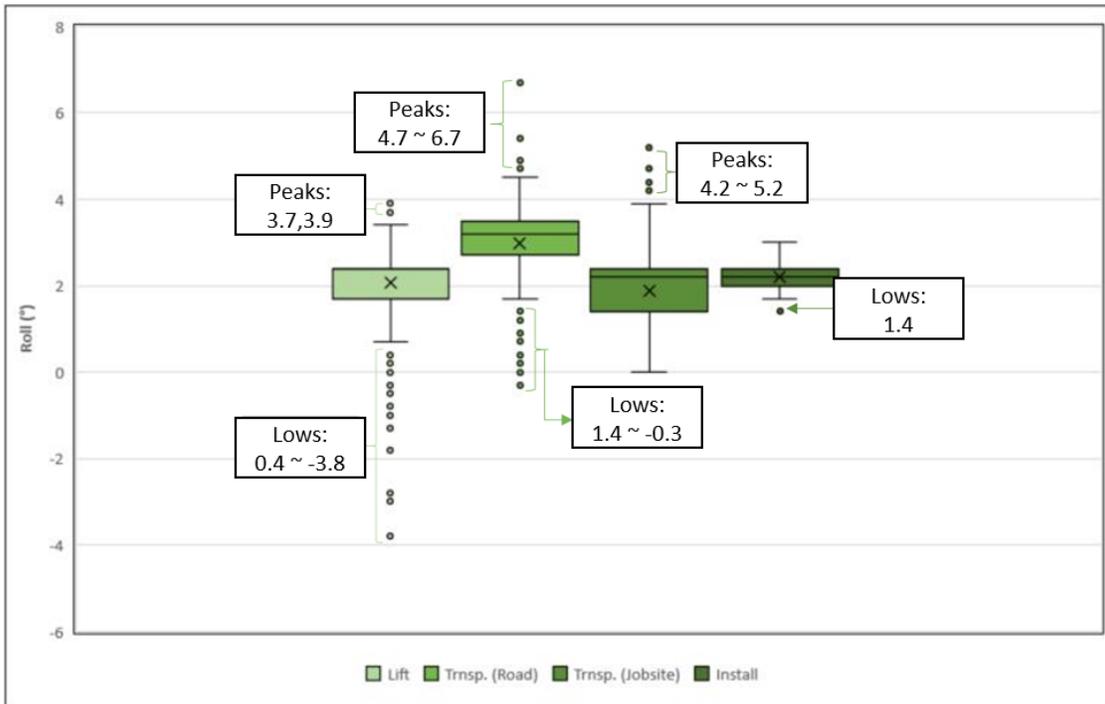
Tilt and roll data gathered from modular house Lifting, Transportation, and Offloading revealed the modular house, at its default position, was slightly titled backward and rolled to the left. The data suggested that the modular house was at its most stable state while it was getting lifted at the fabrication yard and when it was getting placed on top of the concrete slab inside the garden and offloaded/installed. Under the above conditions, the peaks in data, if there were any, incurred from distinctive and unordinary module maneuvers. When the modular house was on the road, the number of peaks increased with lesser distinctiveness, meaning it was more difficult to pin down one module maneuver that caused the peaks. The box plots of tilt and roll data recorded are shown in Figure 23.

Figure 23. Tilt data from transportation (a), Roll data from transportation (b)

For the Lifting phase, two different module maneuvers caused all the peaks and lows for tilt and roll data illustrated in Figures 23 (a) and (b). Given tilt, all peaks and lows, including the overall maximum peak of 6.2 degrees, occurred as the modular house was making a left turn at 1:37 PM (Figure 17). The peaks for the roll of 3.9 degrees and 3.7 degrees occurred about a minute before. The lows ranged from 0.4 degrees to -3.8 degrees and occurred when the modular house was making a wide right turn to exit the fabrication yard at 2:08 PM (Figure 18). For the Transportation (Road) phase, the overall maximum peak for tilt and roll were 8.6 degrees and 6.7 degrees, respectively. The overall maximum peak for tilt occurred at 3:02 PM when the modular house was driving at a relatively faster speed of 49 km/h in a straight line. The roll occurred at 2:31 PM when the modular house was making a wide left turn. As stated, the tilt and roll peaks and lows recorded in the Transportation (Road) phase were incurred from sources independent from each other. For the Transportation (Jobsite) phase, while not a peak, a spike of 4.7 degrees occurred at 3:22 PM as the module went over the 6-inch curb. Another peak of 5.4 degrees for tilt occurred at 4:07 PM due to the impact the module felt as it came down the 6-inch curb. The maximum peak of 5.2 degrees for the roll and other peaks also occurred at or around 3:22 PM and 4:07 PM. The number of peaks and lows and other notable values from box plots are included in Tables 2~5.
