Measuring Impacts and Vibrations on a Volumetric Modular House During Transportation

MEASURING IMPACTS AND VIBRATIONS ON A VOLUMETRIC MODULAR HOUSE
DURING TRANSPORTATION

Master of Science in Engineering – Civil & Environmental Engineering

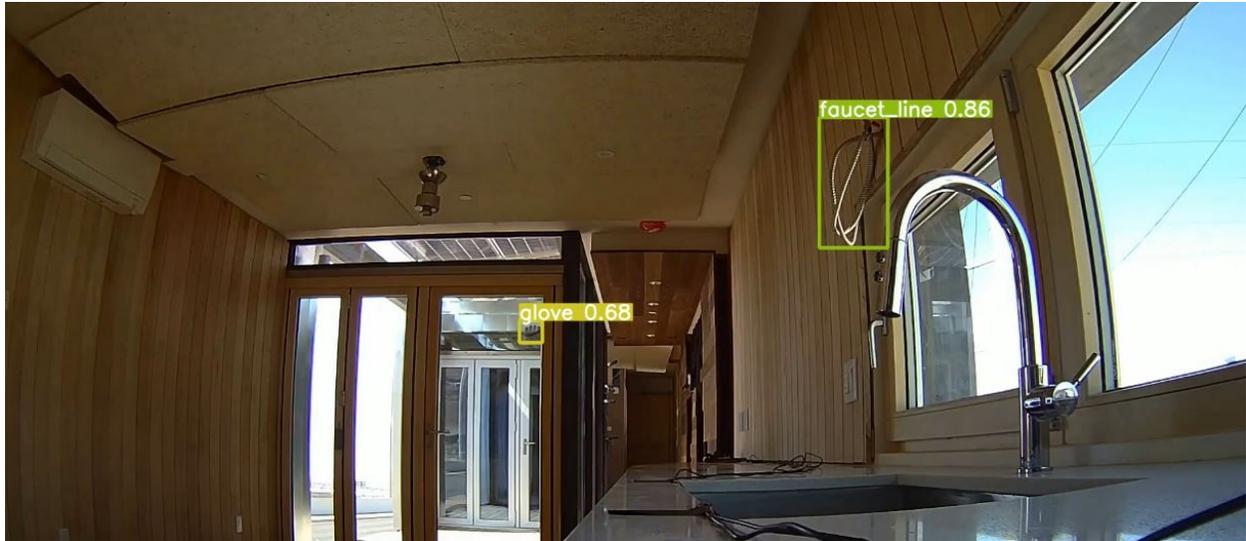
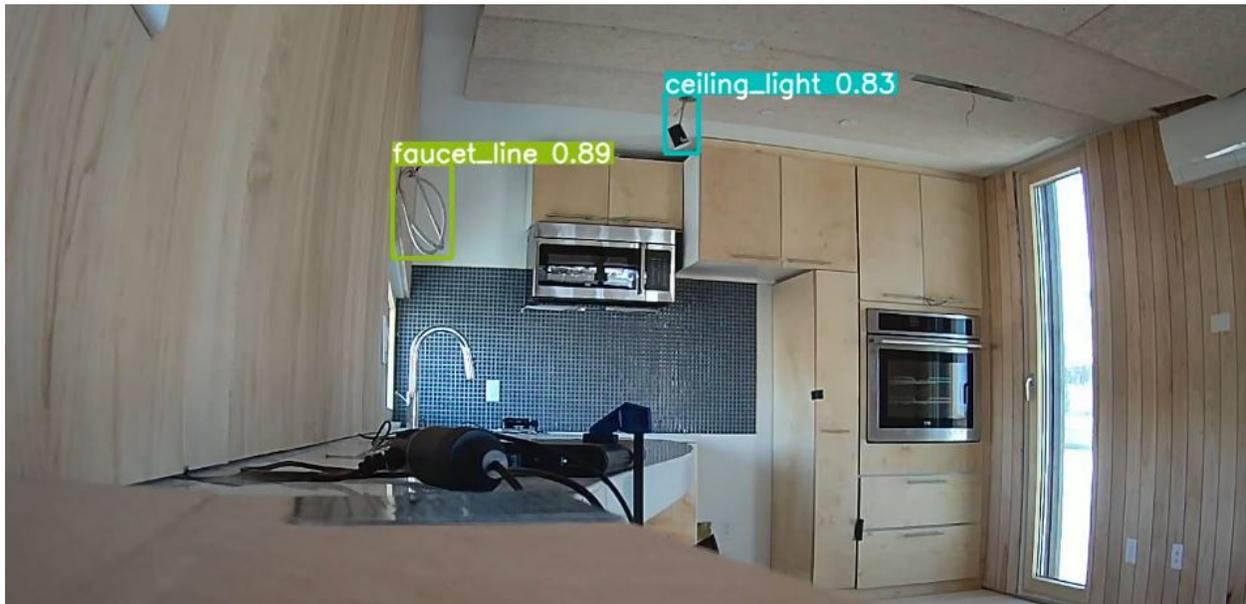
This case study examined the Object Tracking method with a custom-trained object detection model called YOLOv5 to track the movements of the furniture inside the module. Utilizing the dashcam and 360 camera footage, the ceiling light, faucet line, and even a falling glove were detected and tracked as shown in Figure 24.

Figure 24. Glove & Faucet line detected (a), Faucet line & Ceiling light detected (b)
