Experimental determination of stiffness of joints in welded Tuff

Final Technical Report – Part 1

Experimental Determination of Stiffness of Joints in Welded Tuff

Document ID: TR-03-018

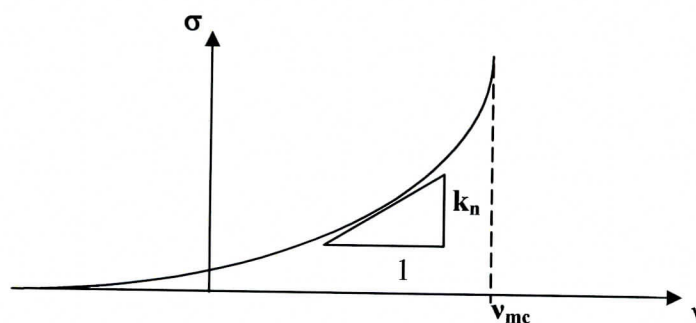
Figure 1.1 Normal stress vs. normal displacement curve for a joint
Source: Goodman (1976, Figure 5-9 b, p. 172)

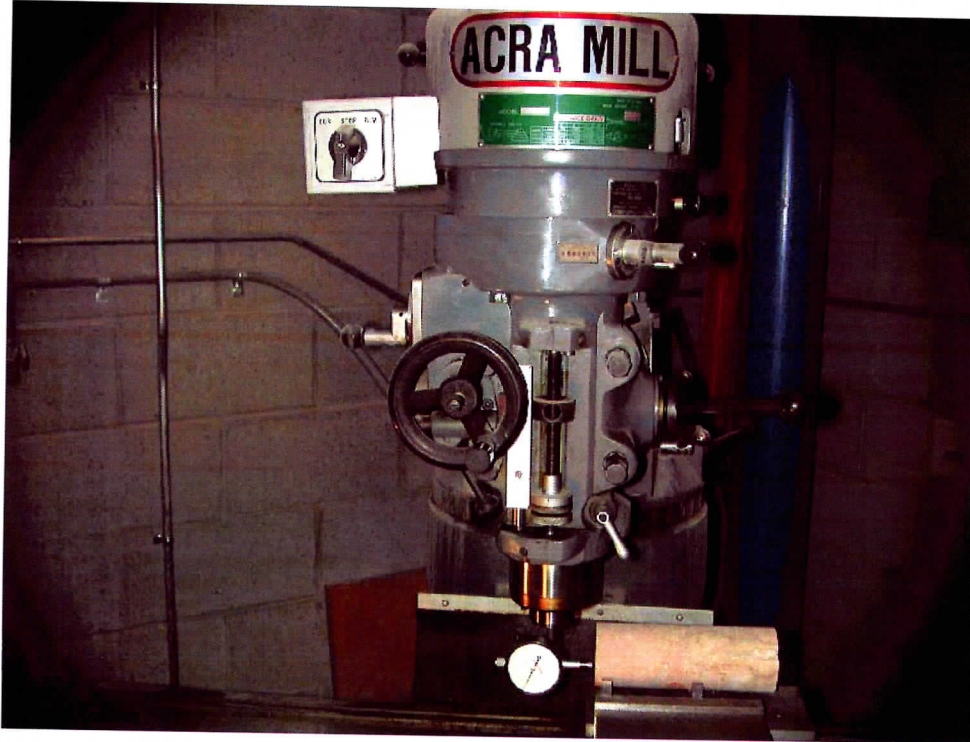
Figure 2.4. Equipment for determination of smoothness. A displacement dial gage is run across specimen ends and along its side.

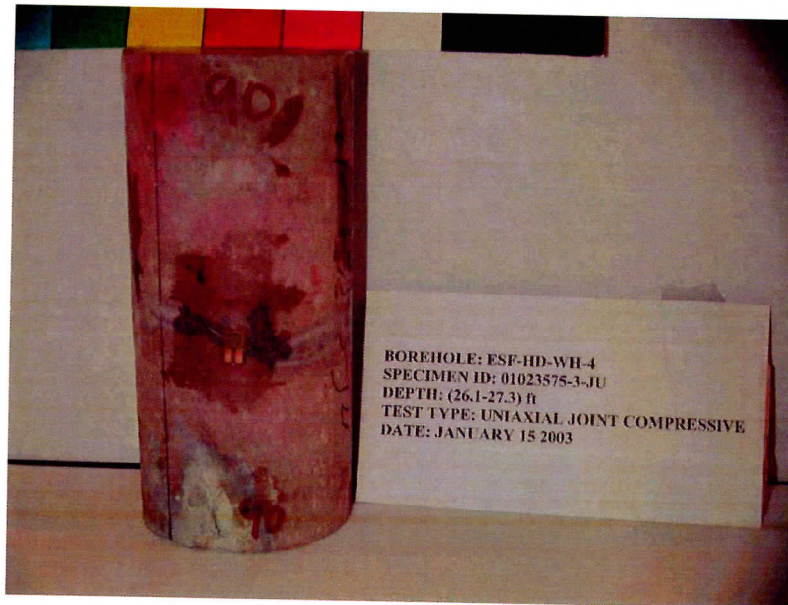
Figure 2.5 Specimen 01023575-3-JU with a strain gage at the 90° axis. Note that strain gage is installed across a joint.

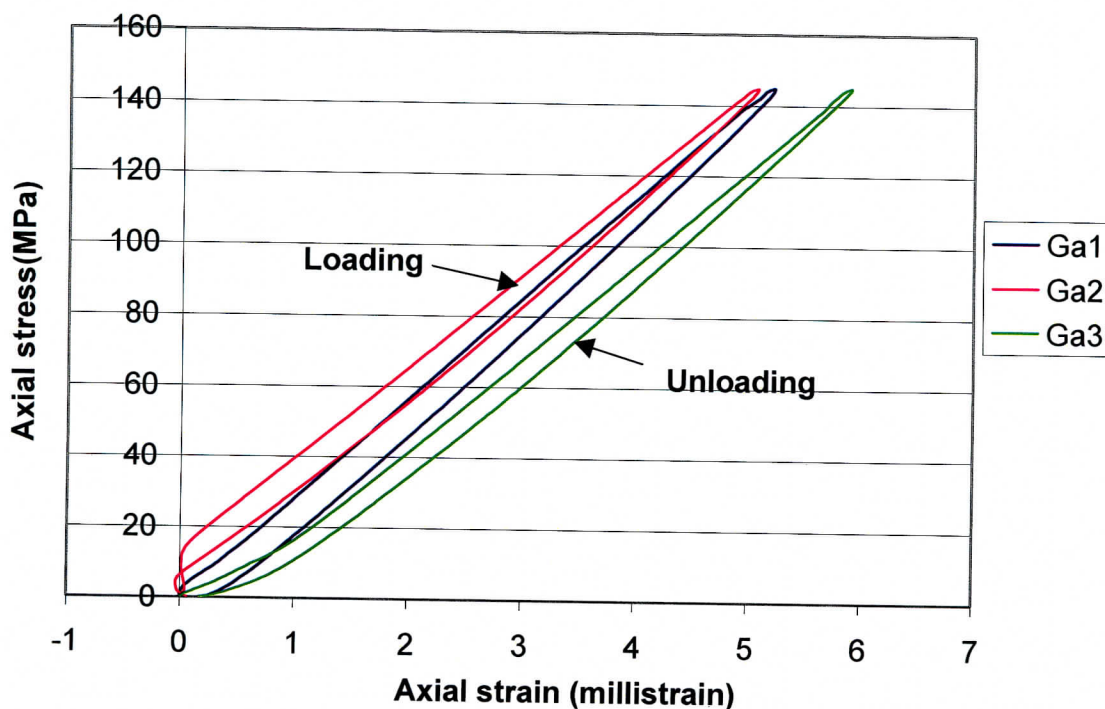
Figure 3.1 Stress-strain curves showing the loading and unloading of axial gages 1, 2 and 3 installed across the joint of specimen 01023575-3-JU from borehole ESF-HD-WH-4. (Refer to Appendix A7 for details).

Figure 3.1 shows typical loading and unloading curves of one of the specimens tested.

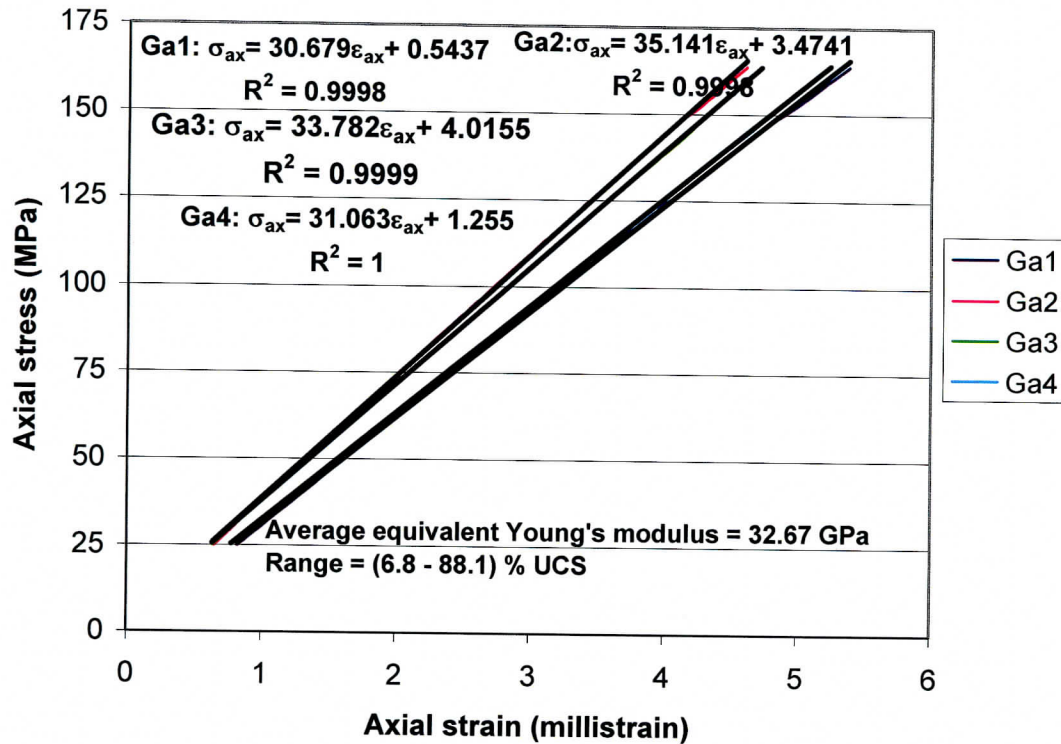
Fig. 3.3 B: Determination of equivalent Young's modulus from the linear best-fit line of the axial stress-strain curves shown in Fig. 3.3 A. (See Appendix A12 for complete analysis).

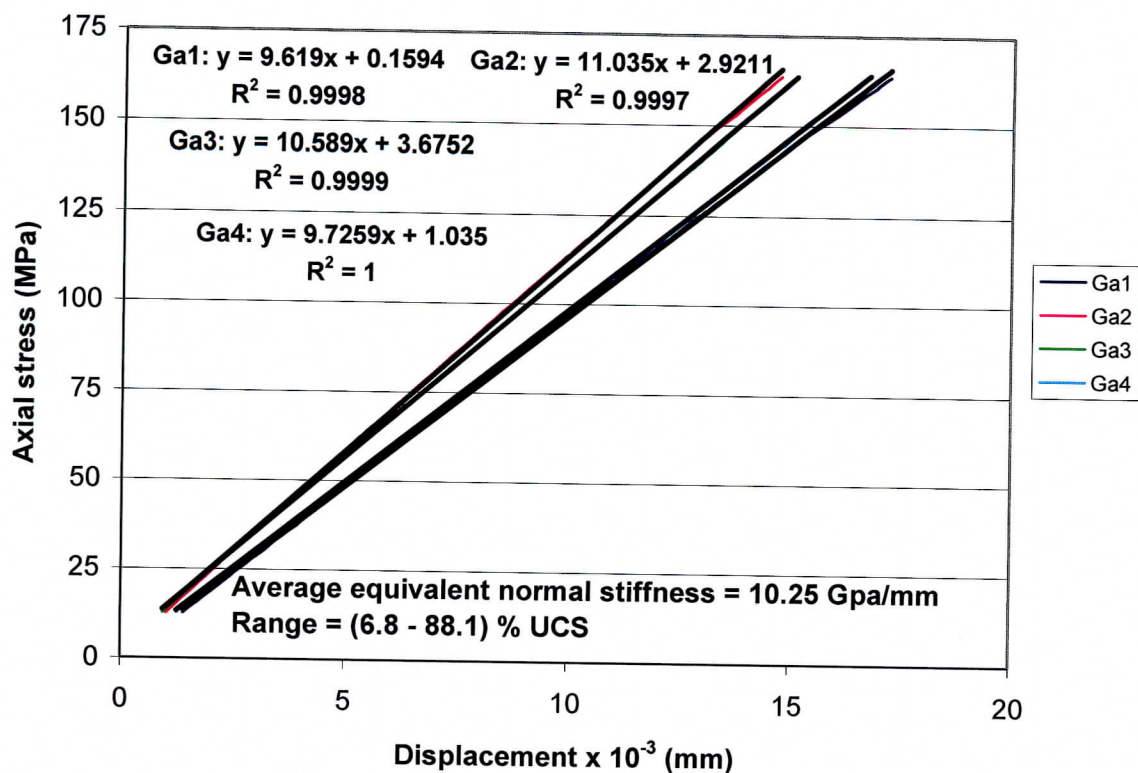
Figure 3.3 C: Determination of equivalent normal stiffness from the linear best-fit line of the axial stress-strain curves shown in Fig. 3.3A. (See Appendix A12 for details).

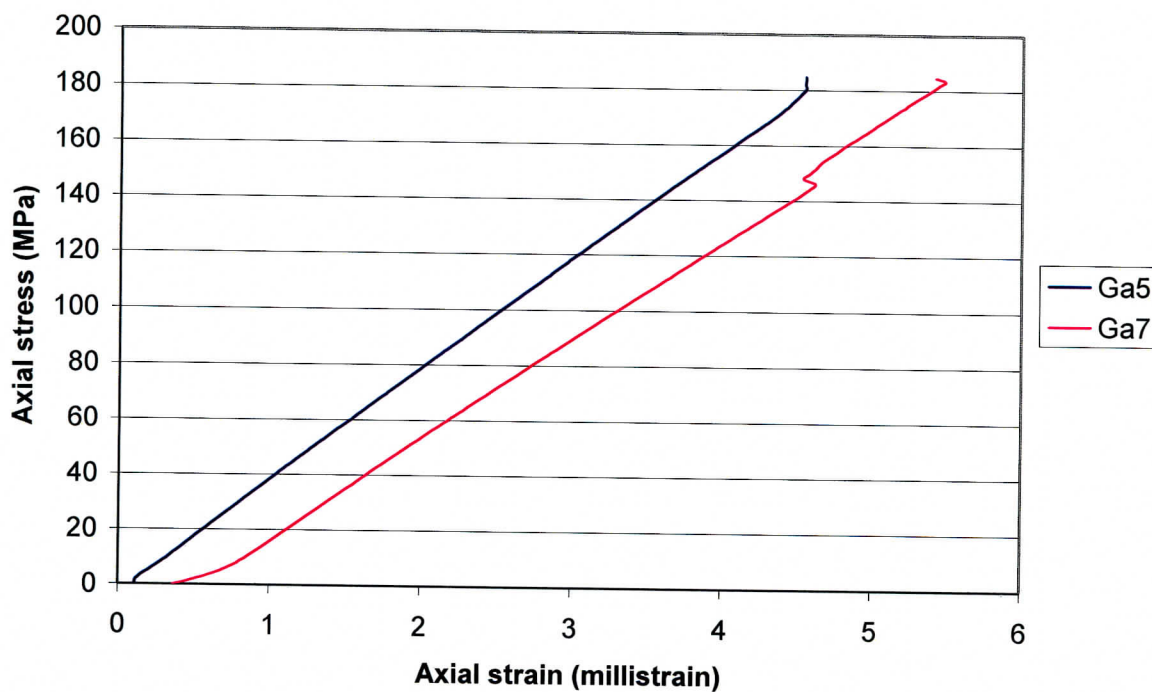
Figure 3.4 A: Typical axial stress-strain curves for two strain gages (Ga5 and Ga7) installed on intact rock

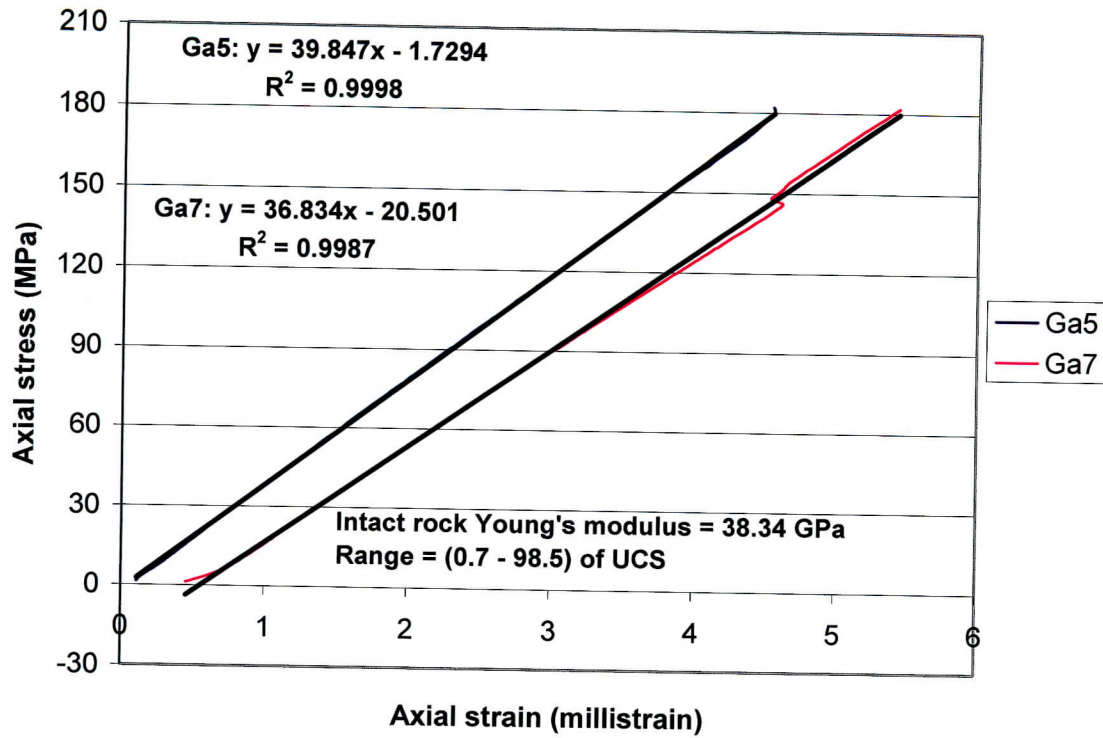
Fig. 3.4 B: Determination of intact rock Young's modulus from the linear best-fit line for the stress-strain curves shown in Fig. 3.4.A. (See Appendix A7 for complete analysis).

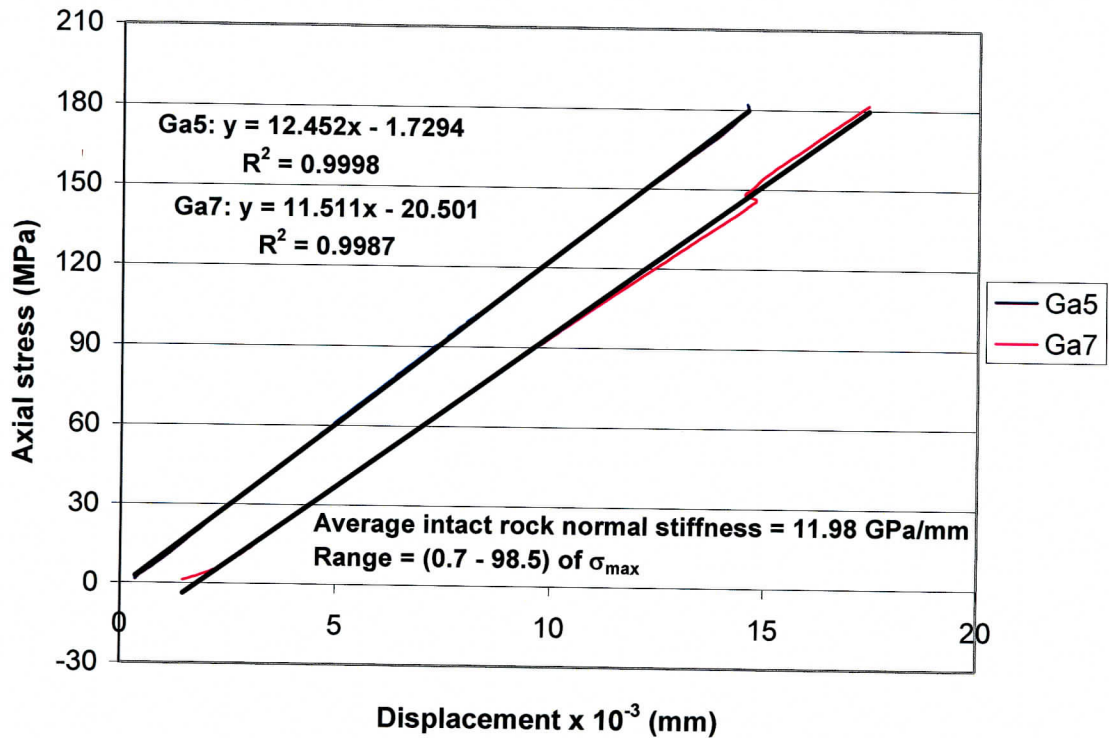
Fig. 3.4 C: Determination of intact rock stiffness from the linear best-fit line for the stress-strain curves shown in Fig. 3.4.A.

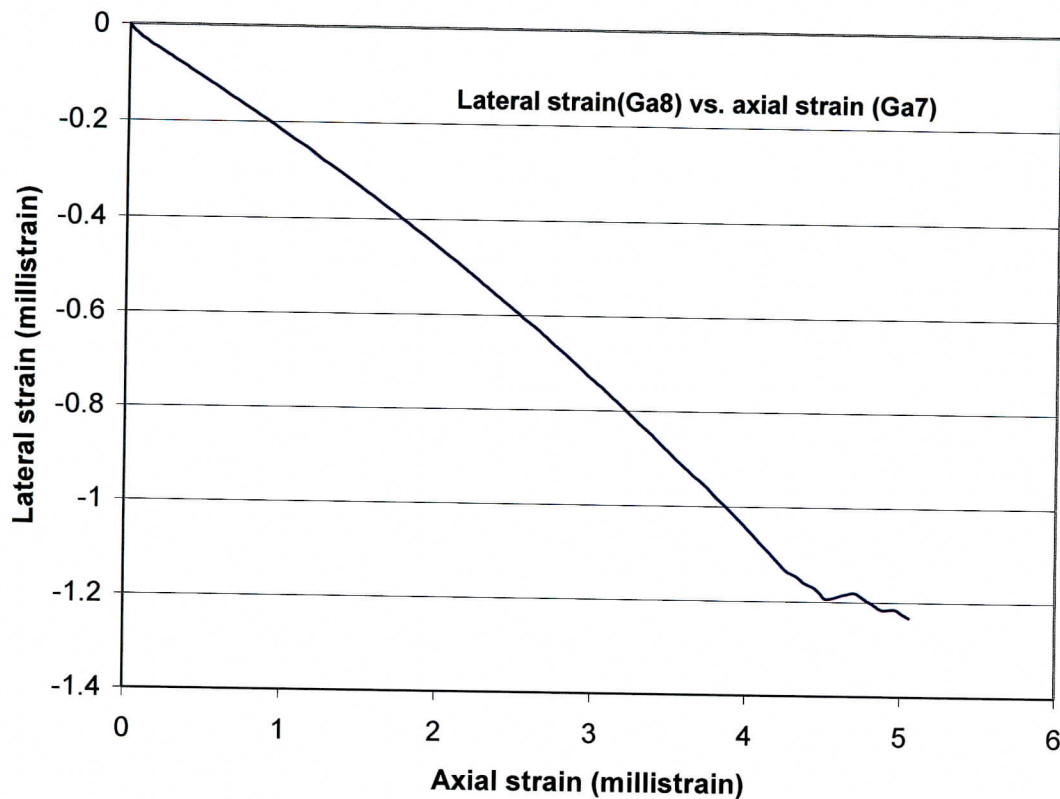
Figure 3.5 A: Typical lateral-axial strain curve for two strain gages (Ga7 and Ga8) installed on intact rock.

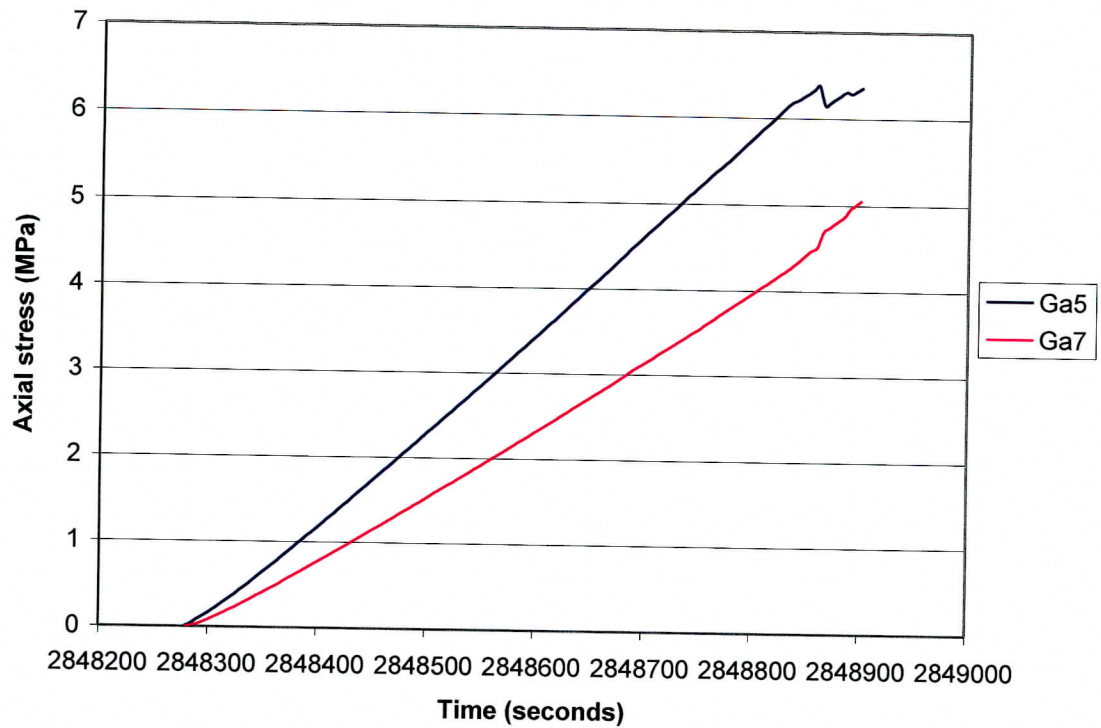
Figure 3.6 A: Typical axial strain-time curves for two strain gages (Ga5 and Ga7) installed on intact rock.

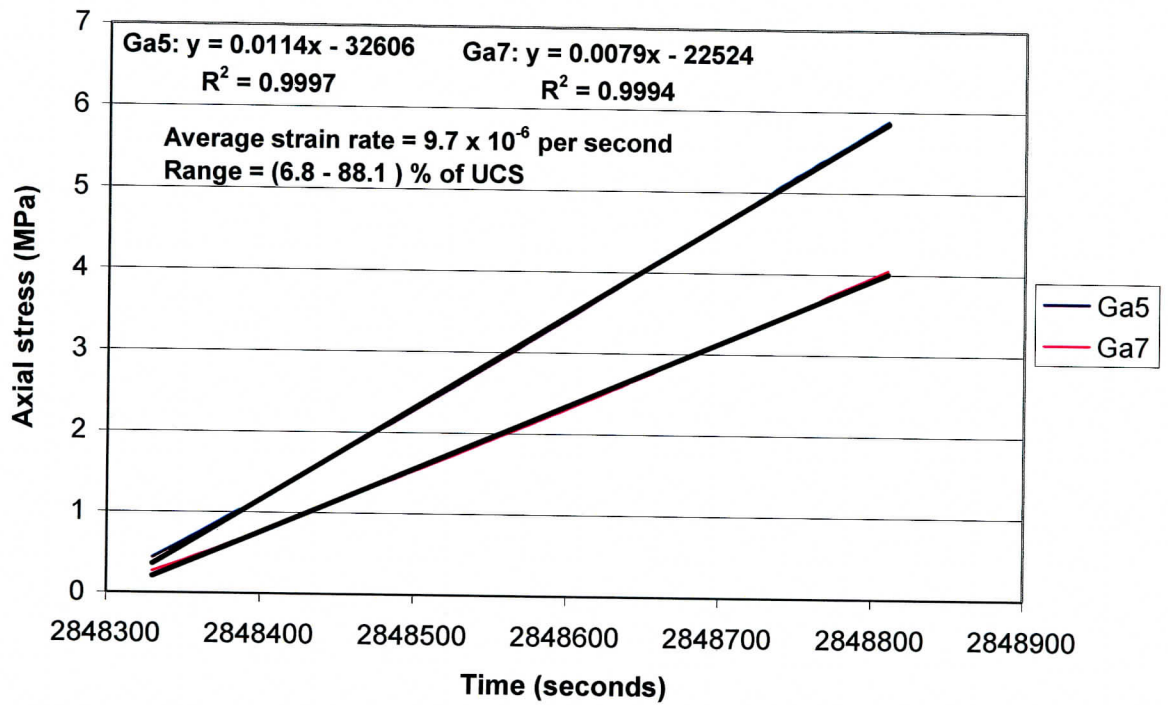
Figure 3.6 B: Determination of strain rate from the linear best-fit line for the axial strain-time curves shown in Fig. 3.6 A.

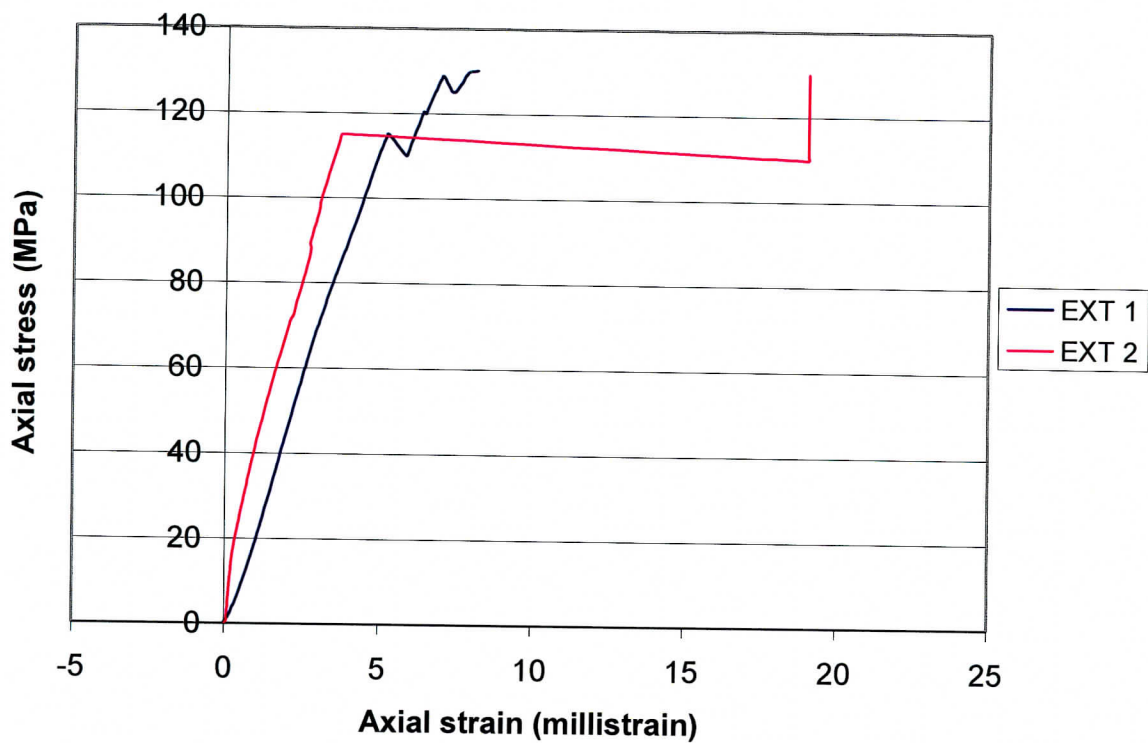
Figure 3.7 Typical axial stress-axial strain curves for two extensometers (EXT 1 and 2) installed across a joint.

Axial extensometers were installed across the joint in addition to the strain gages in some cases to compare the joint properties as determined by the two measurement methods. The determination of Young's modulus and normal stiffness is the same as described above for the strain gage measurements. Figures 3.7, 3.8 and 3.9 show graphs from extensometer measurements and the determination of the parameters.

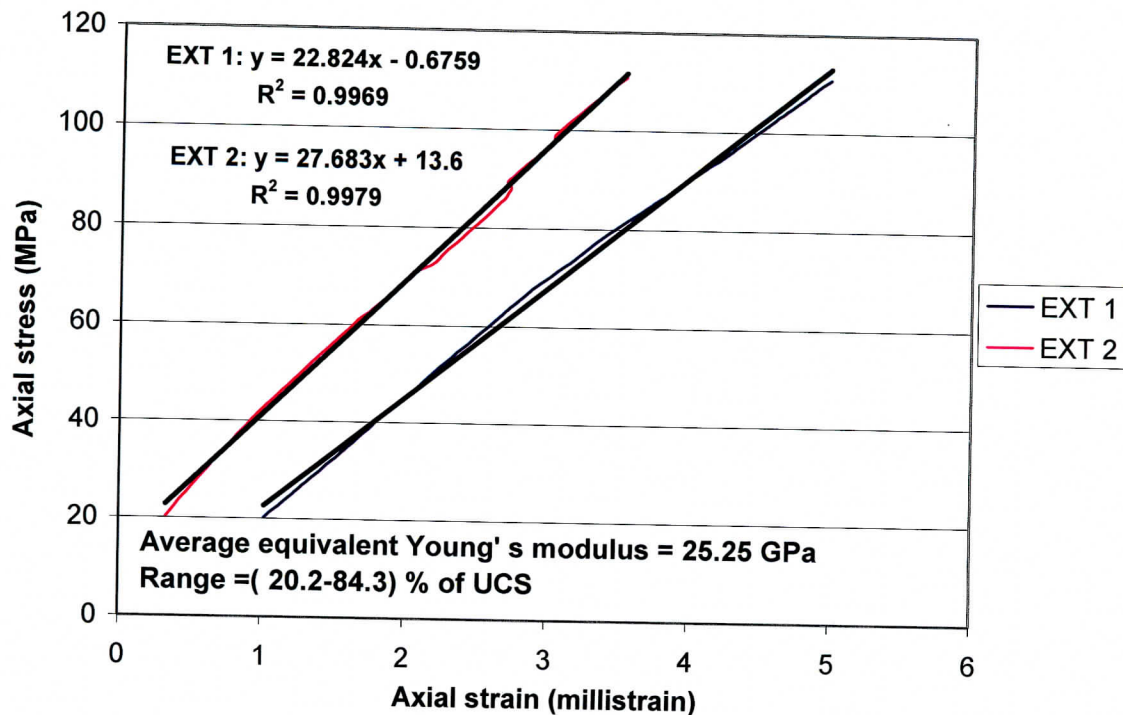
Figure 3.8 Determination of equivalent Young's modulus from the linear best - fit line of the axial stress-axial strain curves shown in Fig. 3.7. (See Appendix A6 for complete analysis).

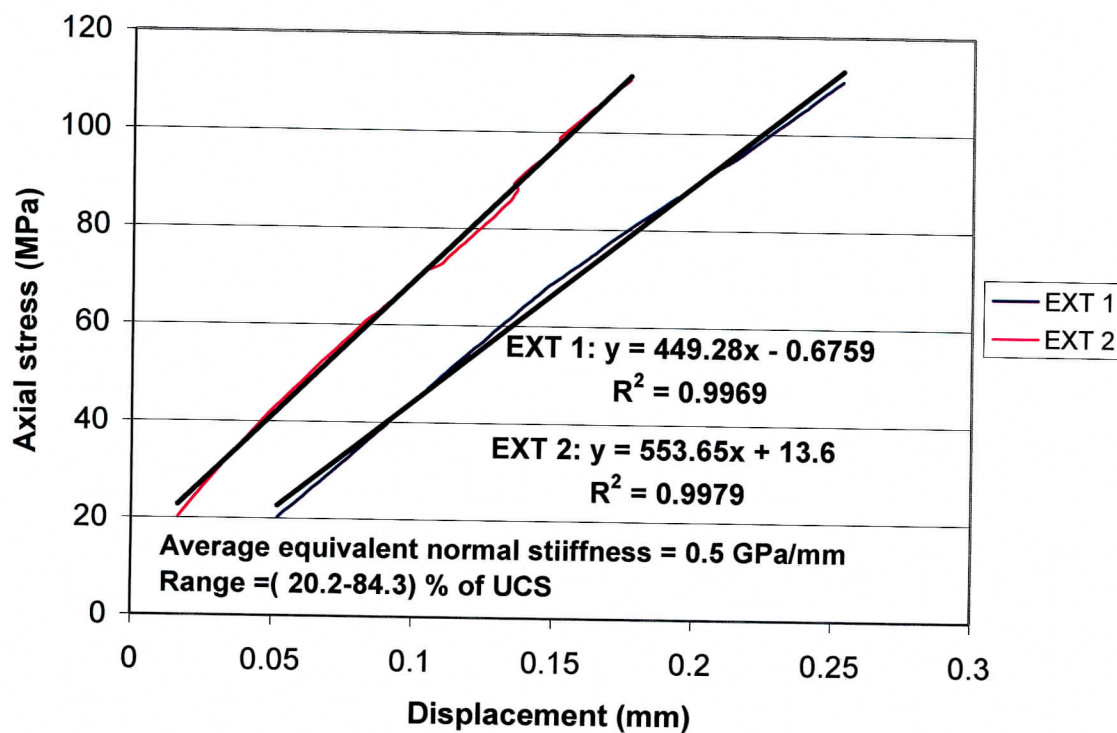
Figure 3.9 Determination of equivalent normal stiffness from the linear best – fit line of the axial stress-axial strain curves shown in Fig 3.7.

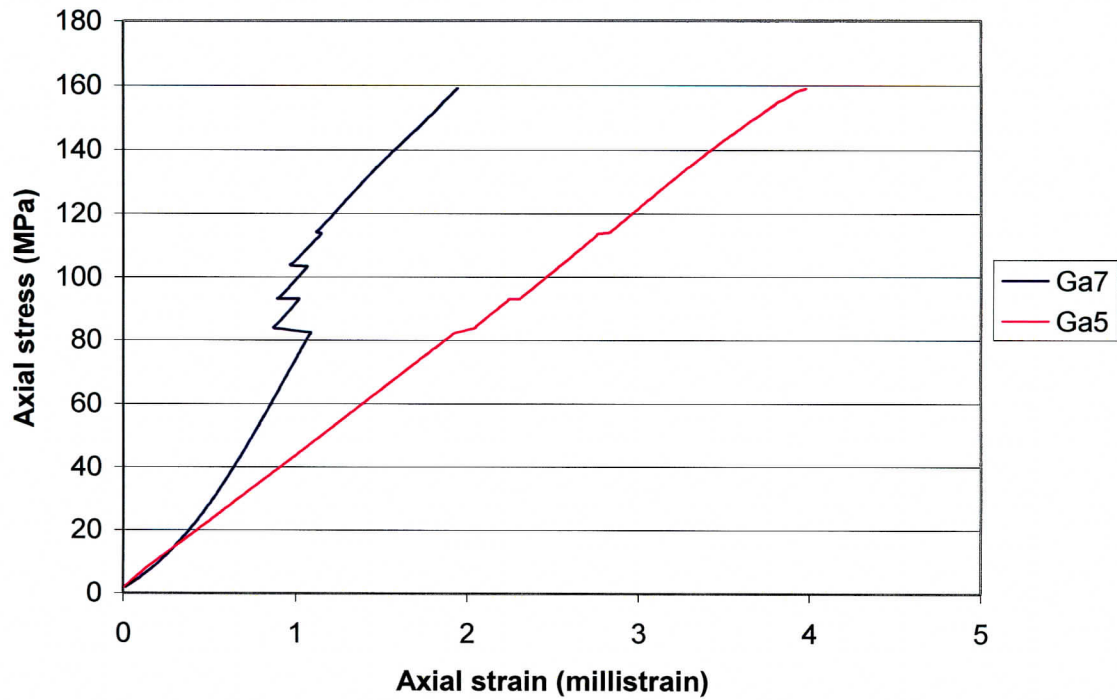
Fig A1.3 Axial stress vs. axial strain for gages 5 and 7 installed on intact rock

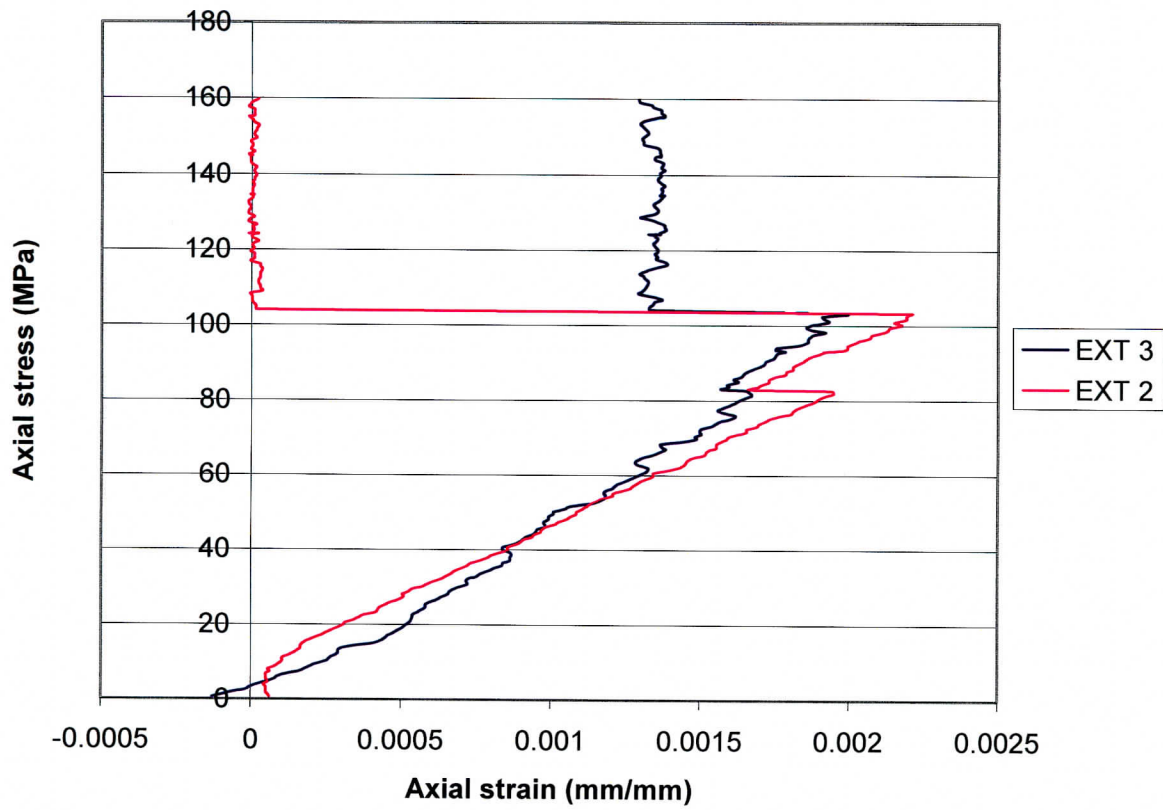
Fig. A1.5 Axial stress vs. axial strain for extensometers 2 and 3

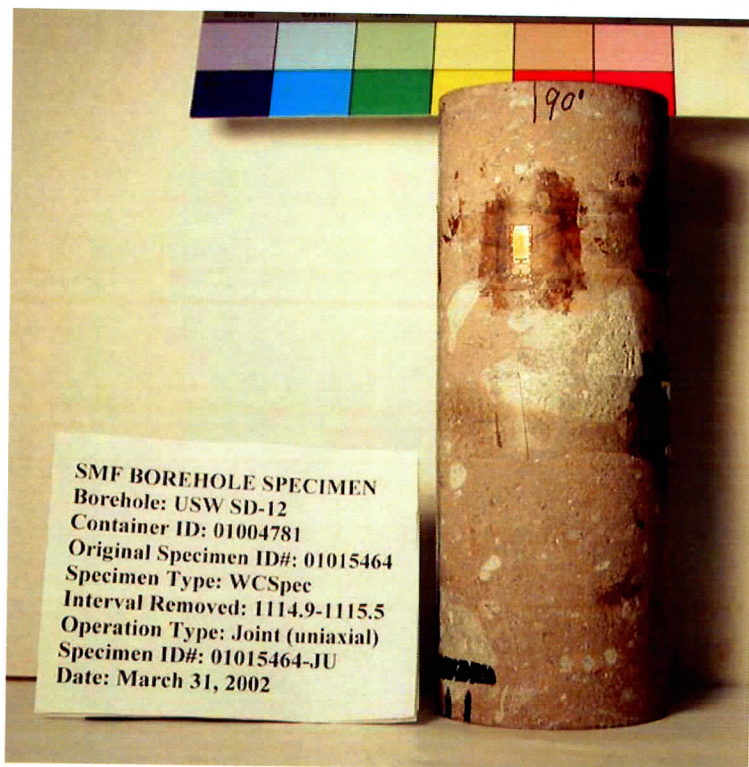
**Fig. A1.6** Pre-failure photograph of specimen 01015464-JU with an axial strain gage along the 90° axis

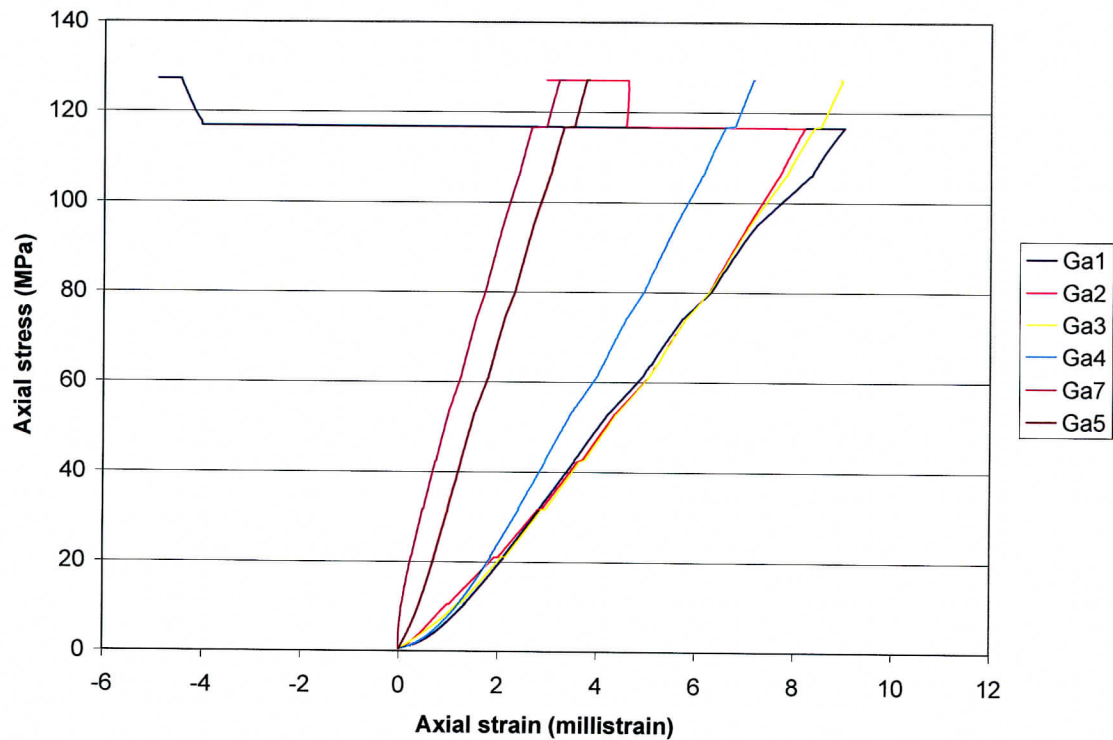
Fig. A2.1 Axial stress vs. axial strain for strain gages 1, 2, 3, 4 installed across the joint and 5 and 7 installed on intact rock.

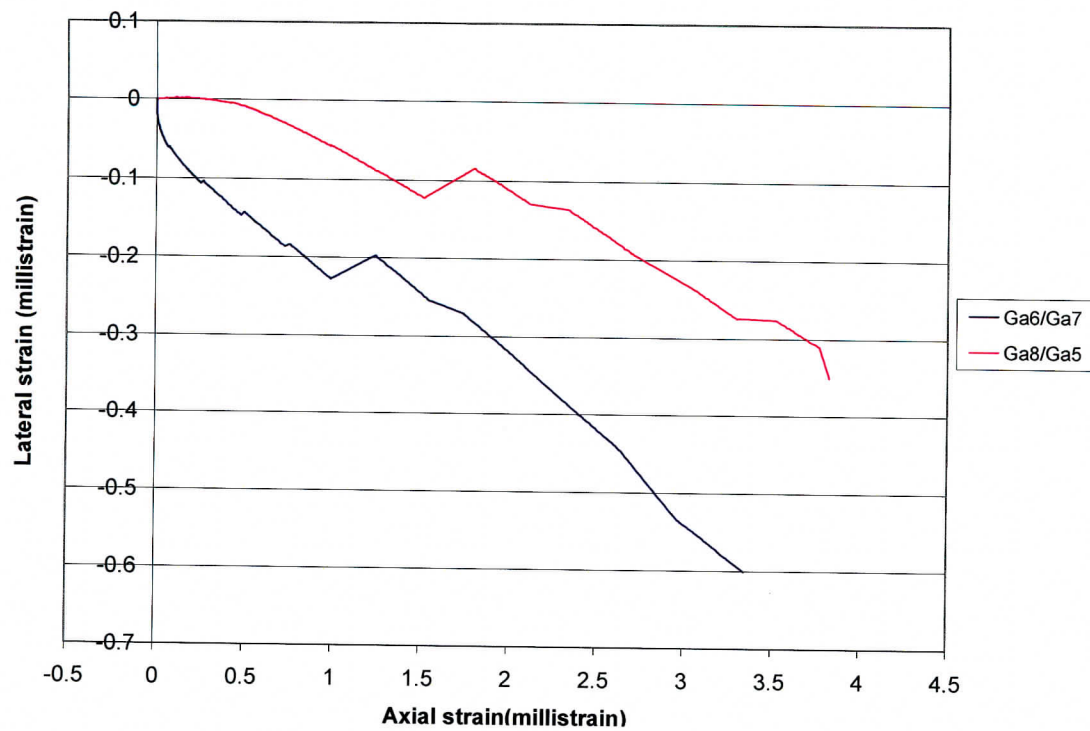
Fig. A2.2 Lateral strain (gage 6) vs. axial strain (gage 7) and lateral strain (gage 8) vs. axial strain (gage 5).

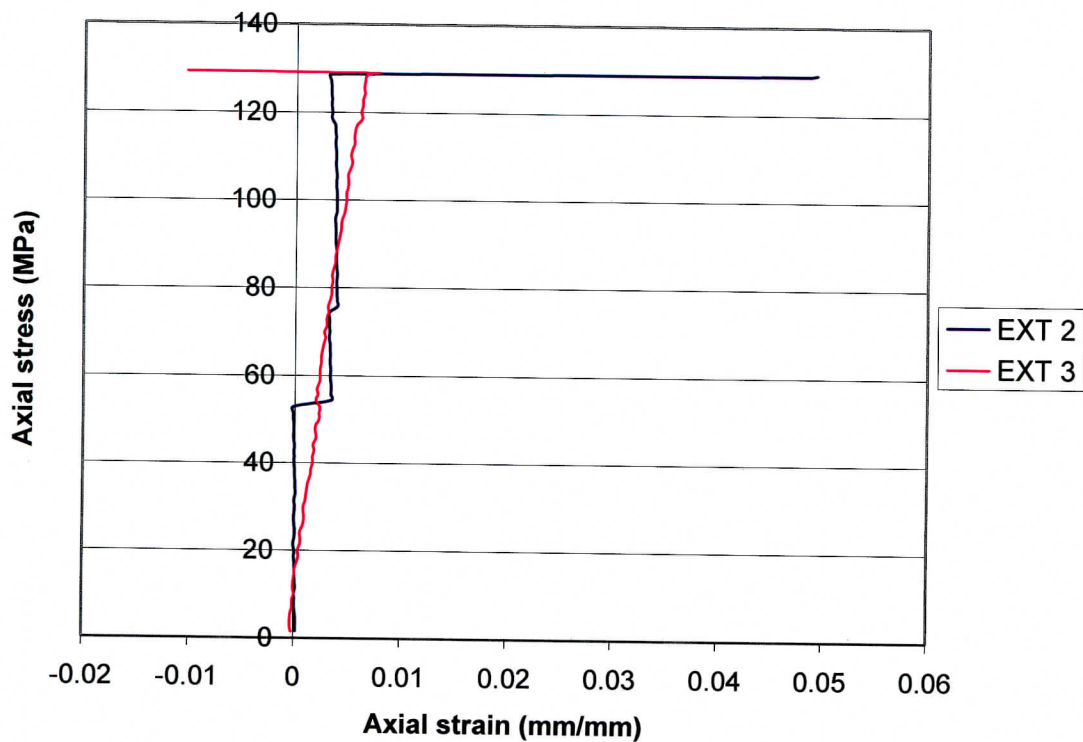
Fig A2.3 Axial stress vs. axial strain for extensometers 2 and 3

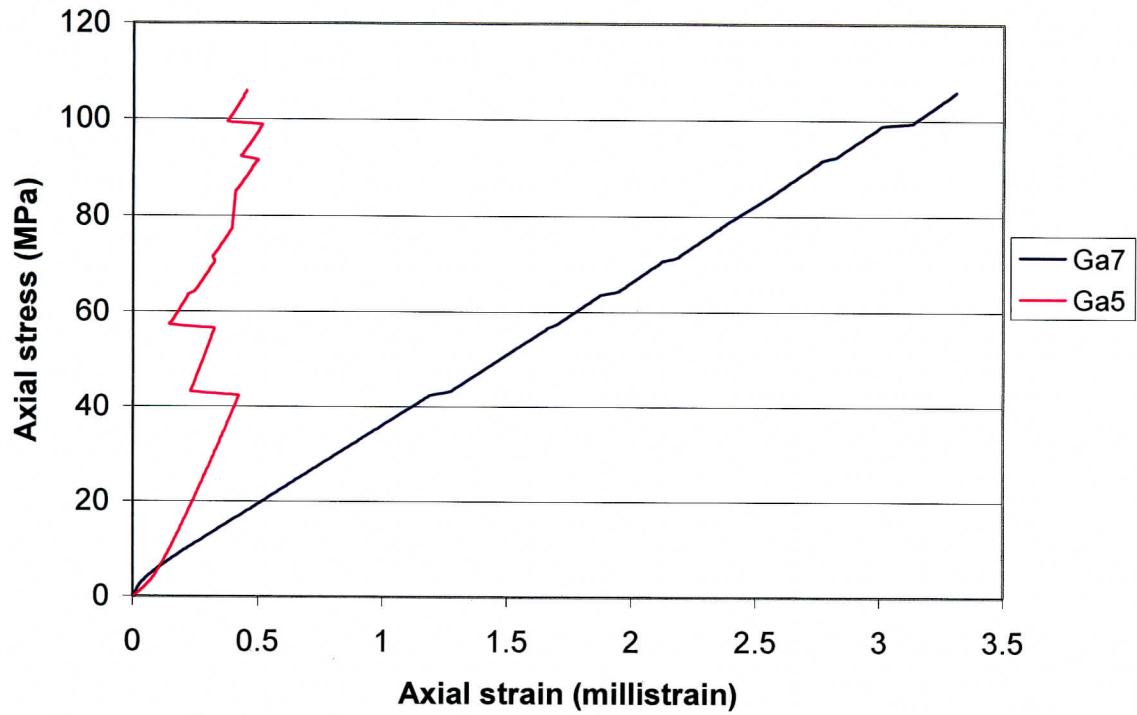
Fig. A3.2 Axial stress vs. axial strain for gages 5 and 7 installed on intact rock

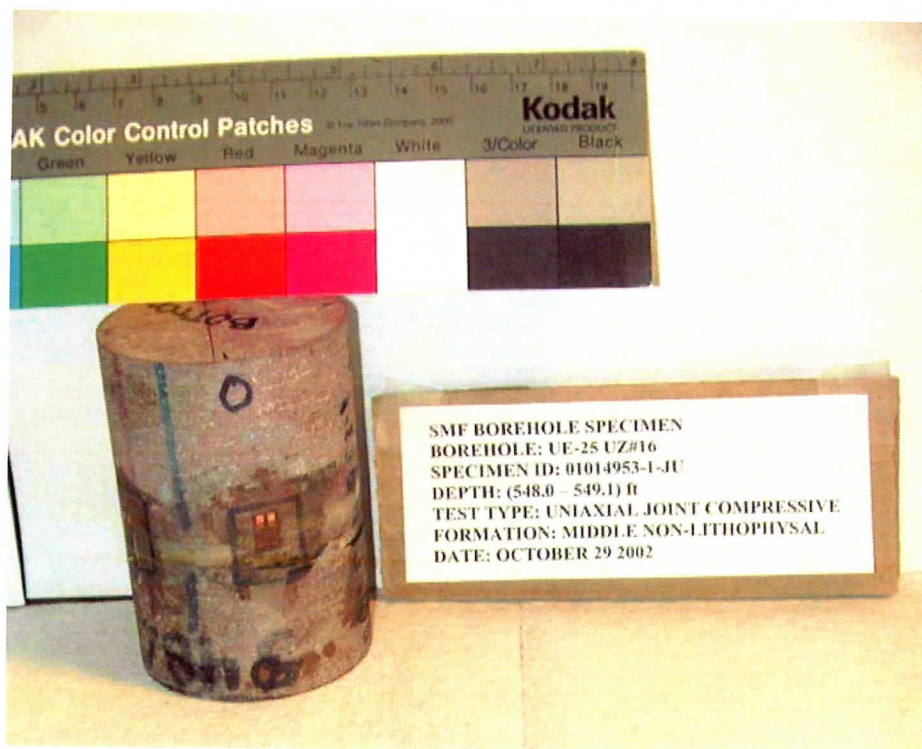
Fig. A4.3 Pre-failure photograph of specimen 01014953-1-JU with an axial gage along the 0° axis.

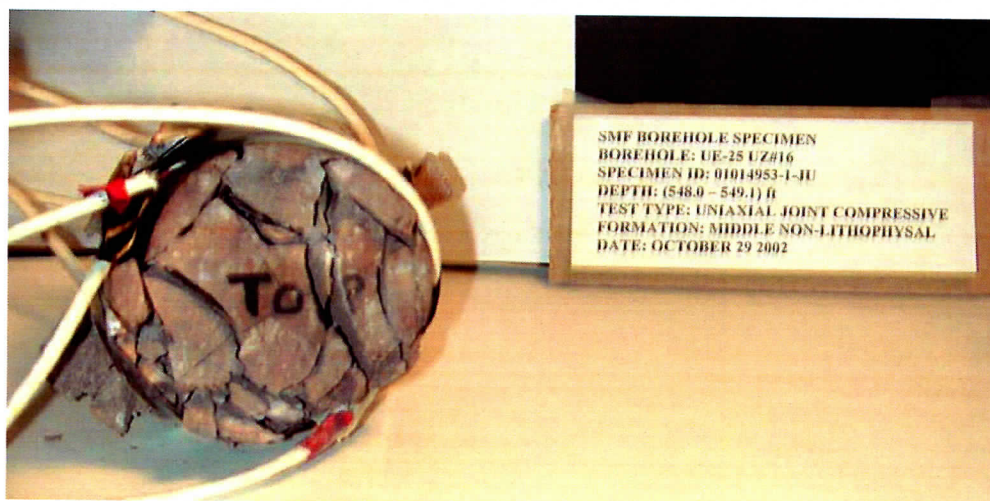
Fig. A4.4 Post-failure top view of specimen 01014953-1-JU

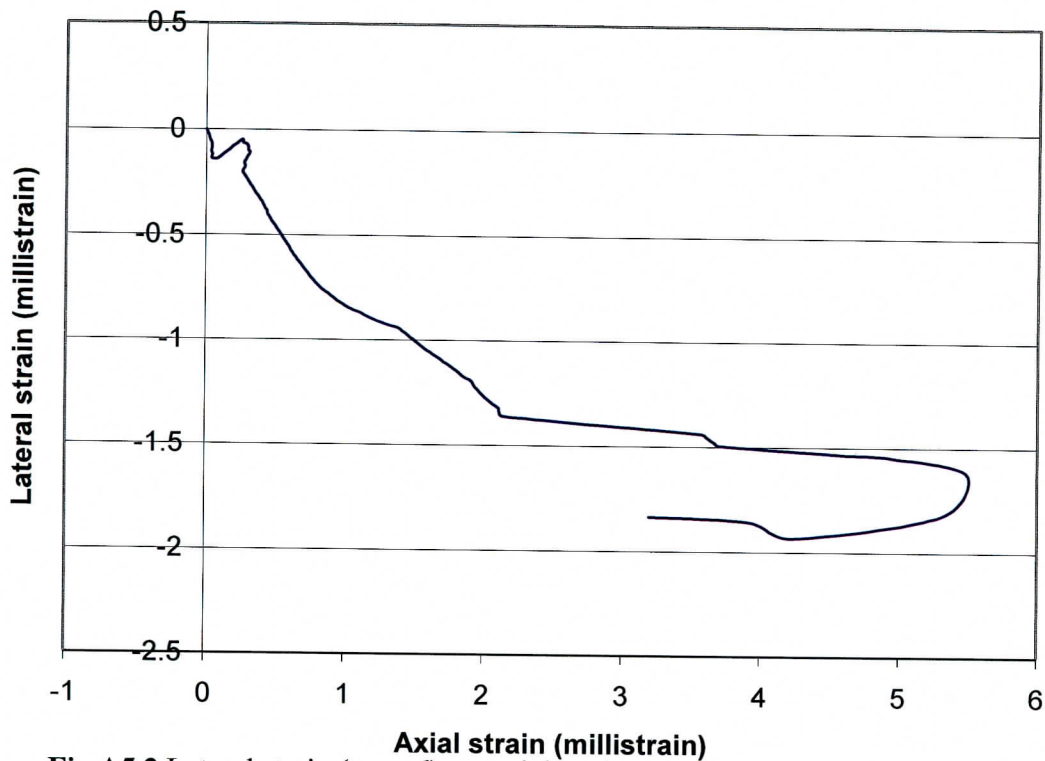
Fig A5.2 Lateral strain (gage 6) vs. axial strain (gage 5)

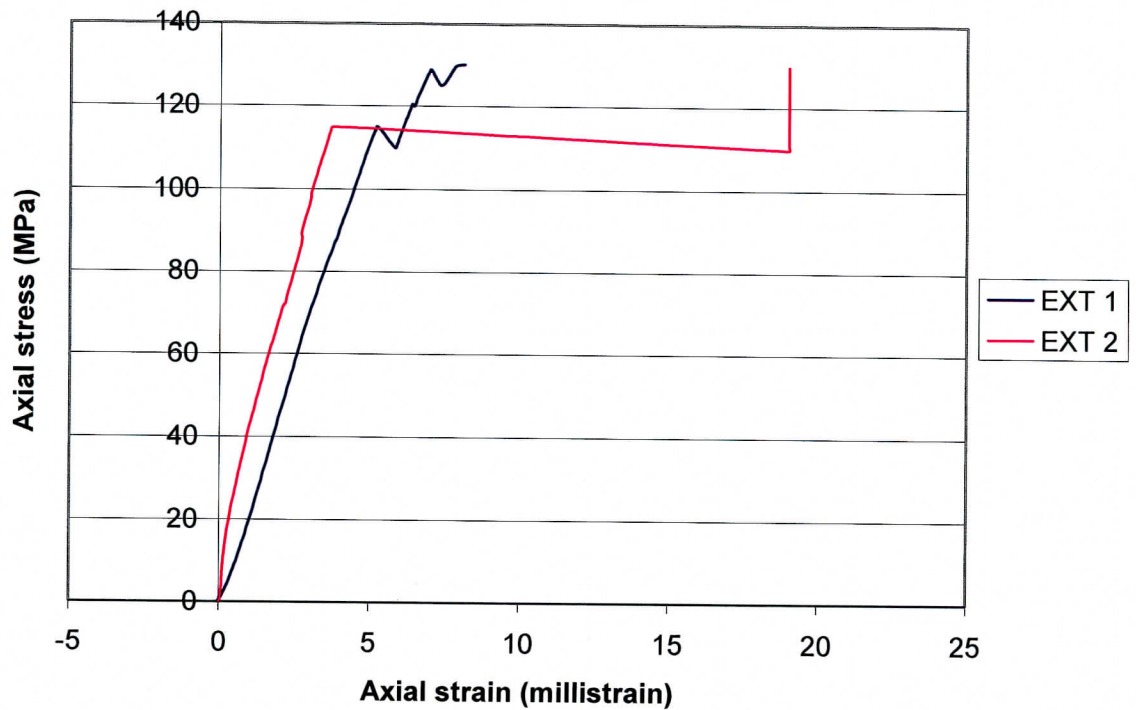
Fig. A6.5 Axial stress vs. axial strain for extensometers 1 and 2

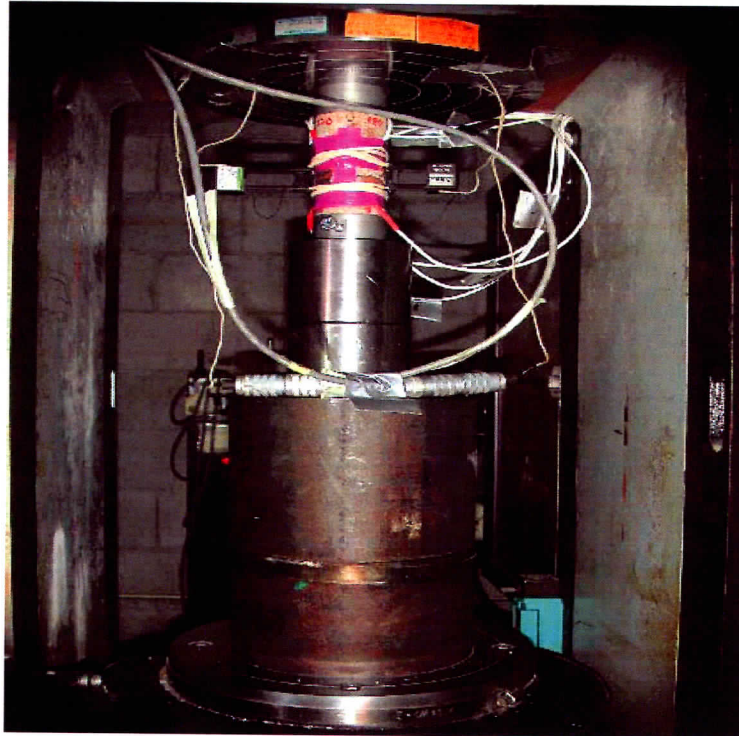
**Fig.A7.13** Specimen 01023575-3-JU with sensors installed before testing

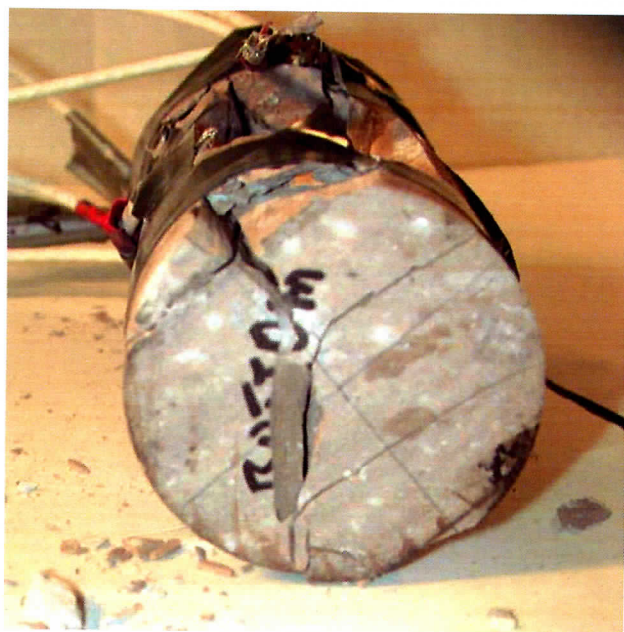
Fig A8.8 Post-failure bottom view of specimen 01023682-1-JU

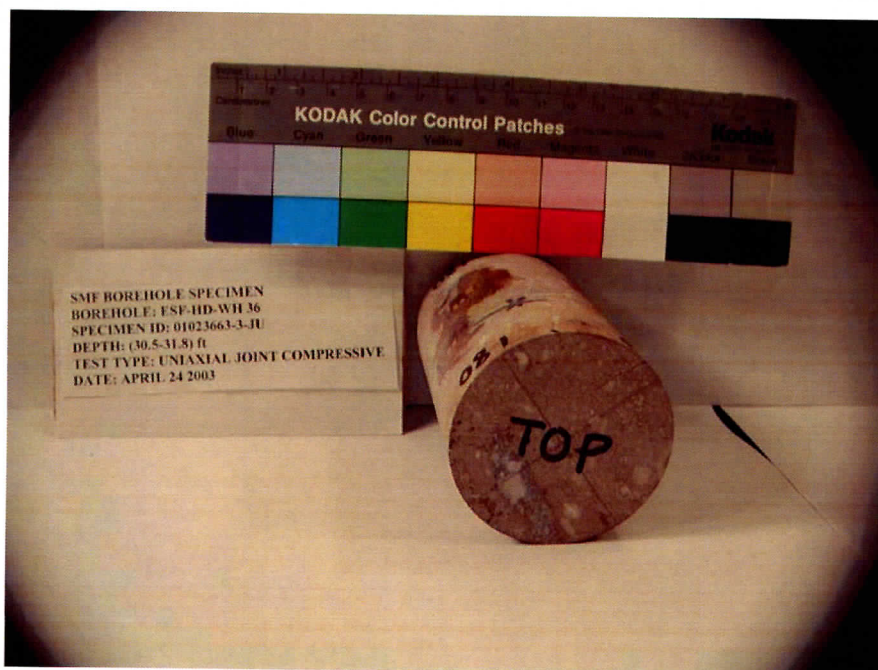
**Fig A9.5** Pre-failure top view of specimen 01023663-3-JU

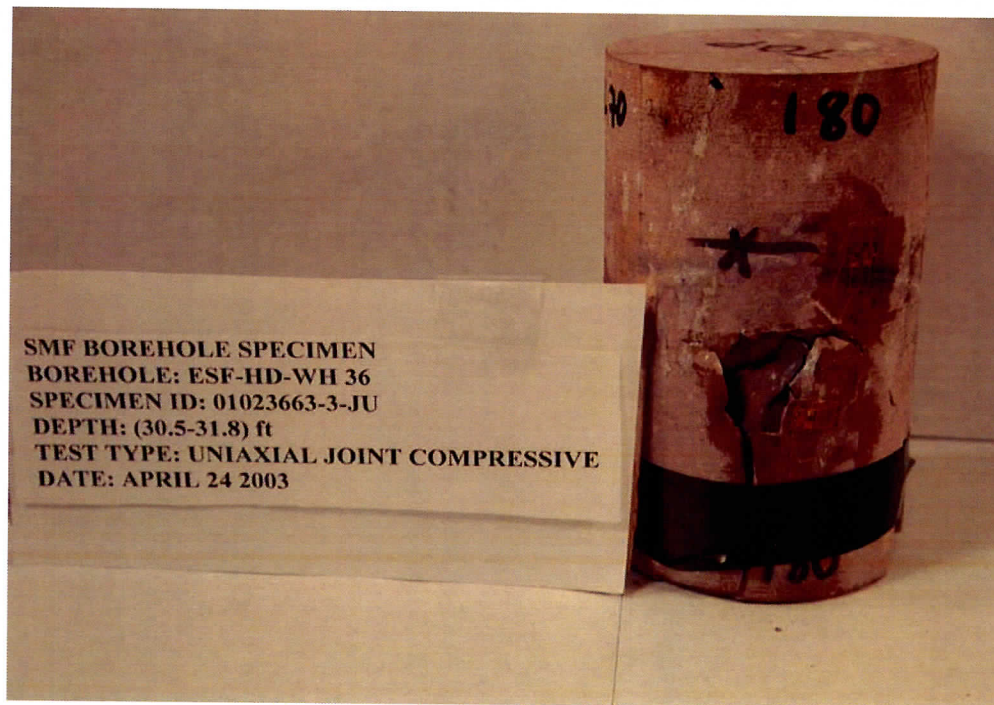
Fig A9.6 Post-failure photograph of specimen 01023663-3-JU
