Experimental determination of stiffness of joints in welded Tuff

Final Technical Report – Part 1

Experimental Determination of Stiffness of Joints in Welded Tuff

Document ID: TR-03-018

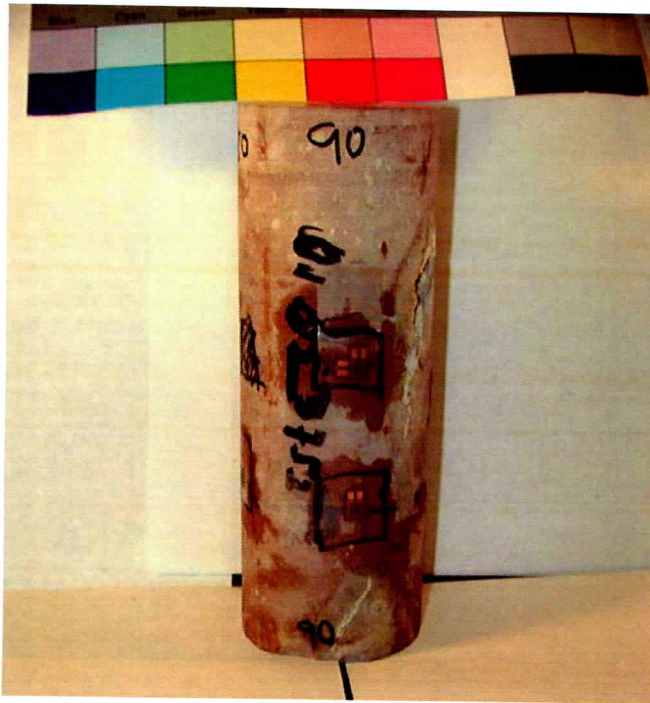
Fig A10.1 Pre-failure photograph of specimen 01023752-JU showing gages along the 90° axis and the more shallow lithophysal cavities.

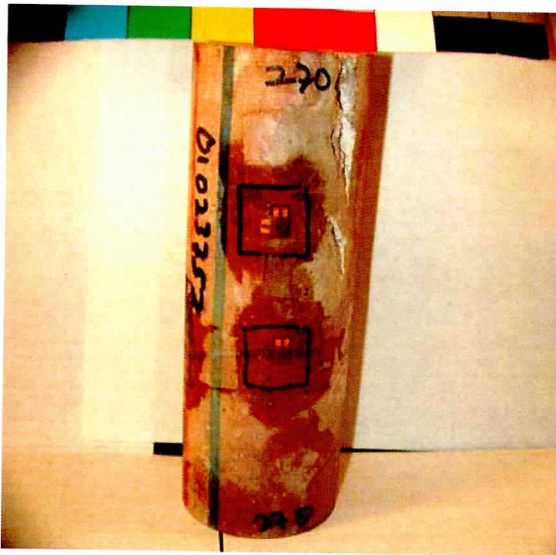
Fig A10.2 Pre-failure photograph of specimen 01023752-JU showing deeper lithophysal cavities and the gages installed along the 270° axis

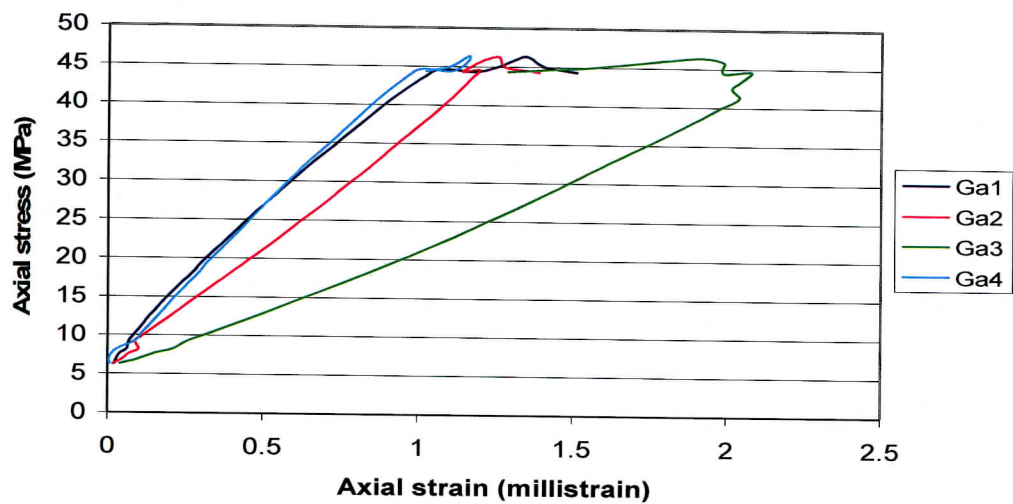
Fig A10.3 Axial stress vs. axial strain for gages 1, 2, 3 and 4 installed across the joint

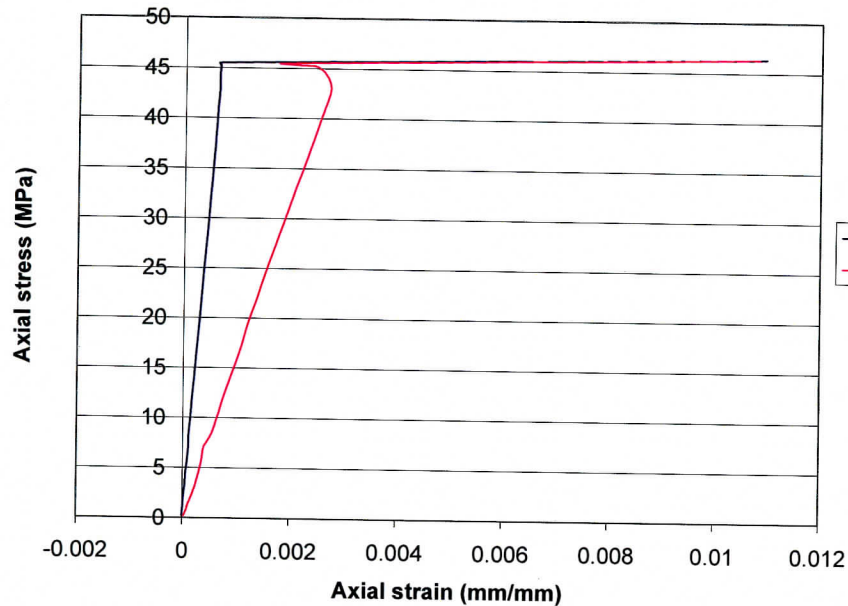
Fig A10.8 Axial stress vs. axial strain for extensometers 1 and 2 installed across the joint

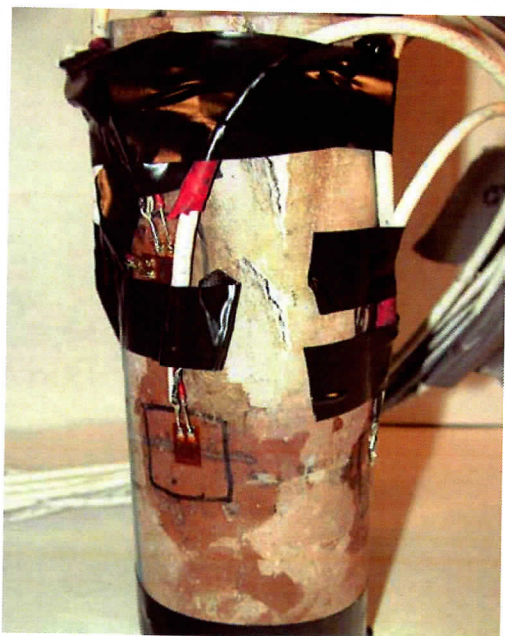
Fig A10.9 Post-failure photograph showing non-affected deeper lithophysal cavities

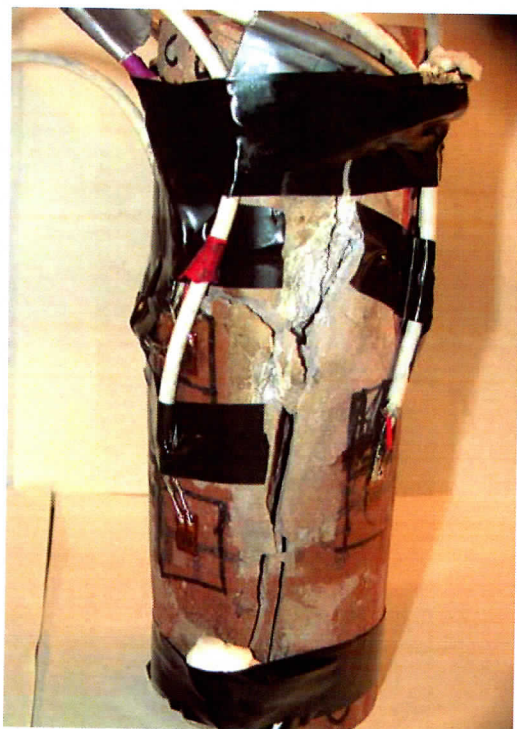
Fig A10.10 Post-failure photograph showing axial splitting through more shallow lithophysal cavities.

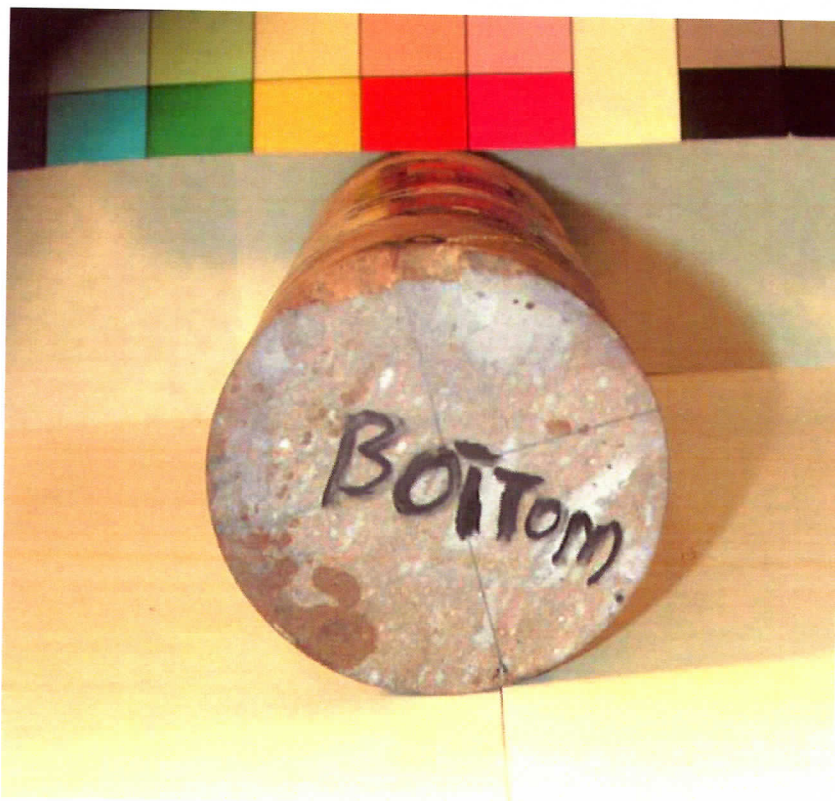
Fig A10.11 Pre-failure bottom view of specimen 01023752-JU

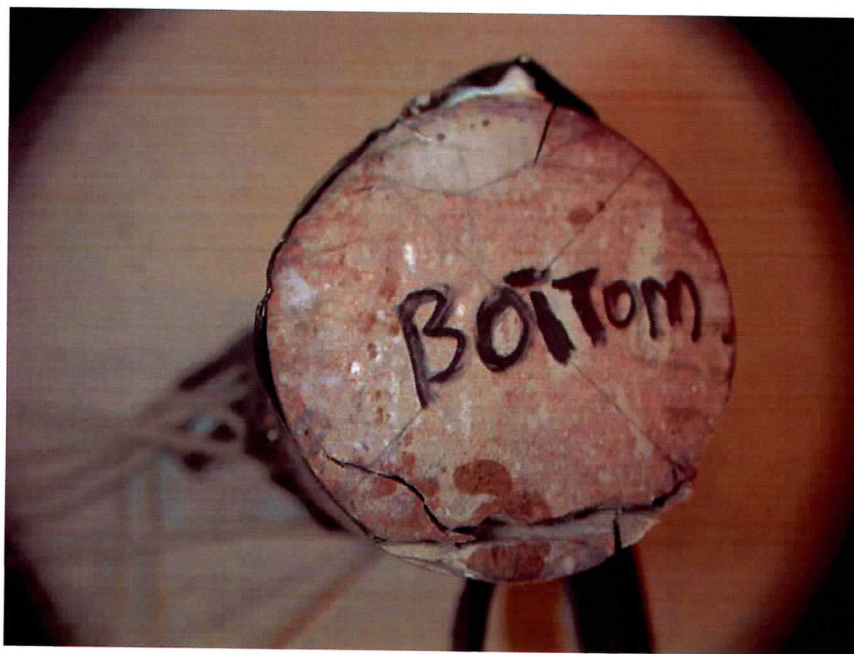
Fig A10.12 Post-failure bottom view of specimen 01023752-JU

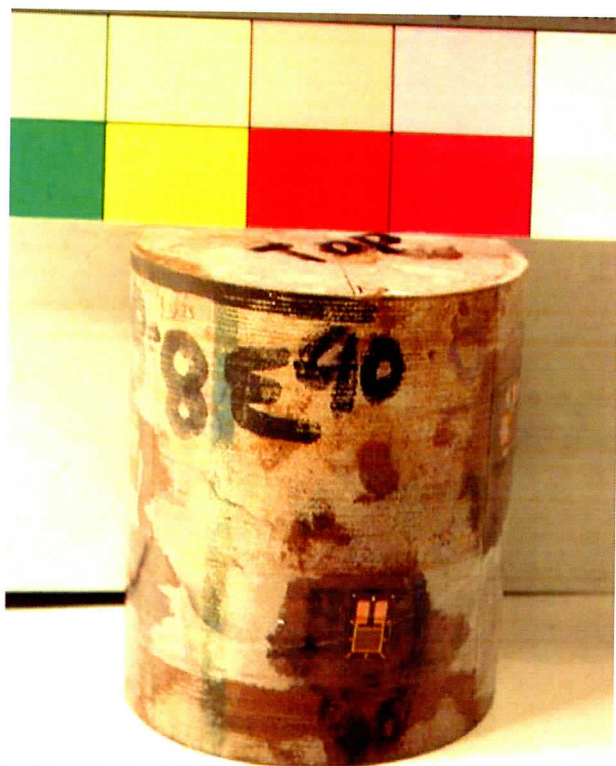
Fig. A11. 5 Pre-failure photograph of specimen 01023696-JU with an axial gage along the 90° axis, across a joint.

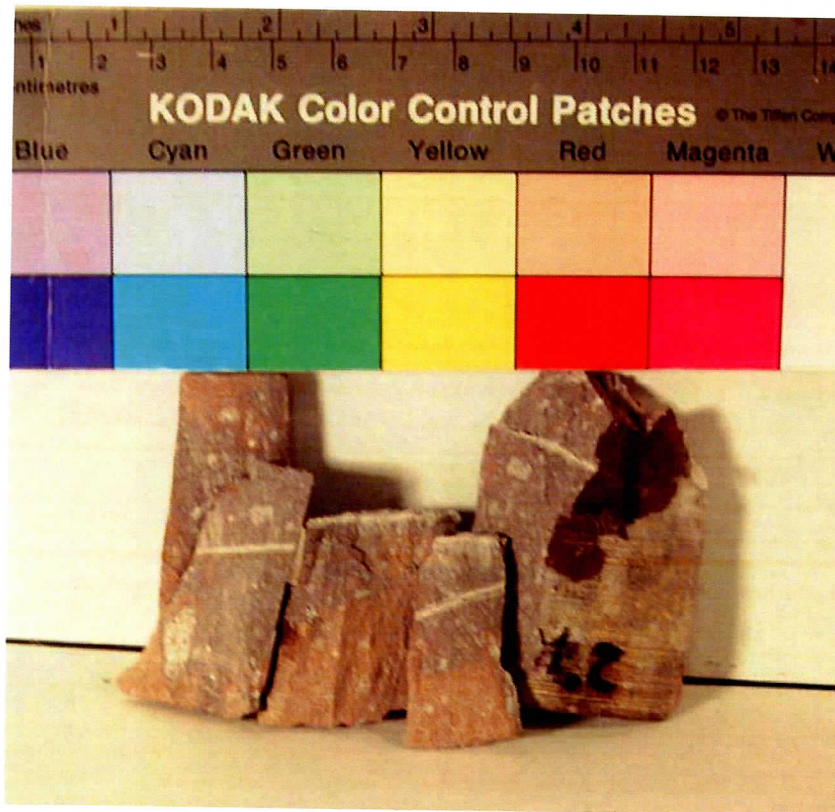
Fig A11. 6: Specimen 01023696-JU after testing. Fractures run through Joints in four pieces, but breakage has occurred along near horizontal Joints (in two central pieces).

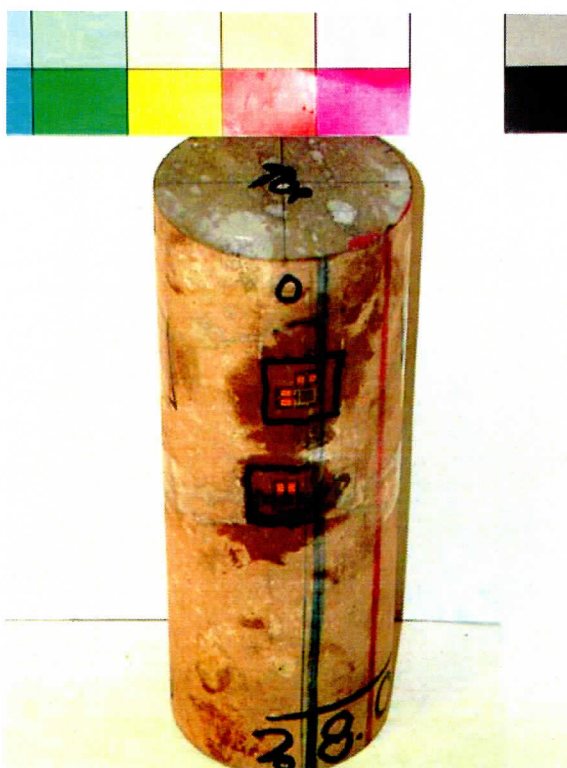
Fig A.12.5 Specimen 010235843-JU with strain gages along the 0° axis

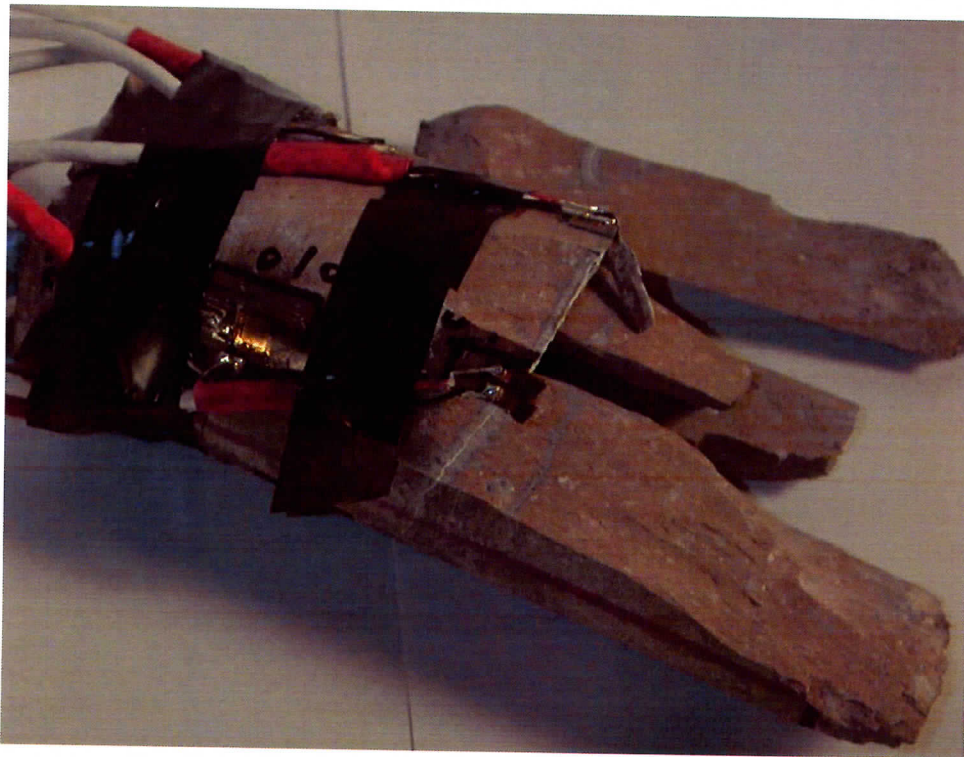
Fig.A12.7 Specimen 01023584-3-JU after testing. Typical characteristic failure pattern.

Mode of failure: This specimen failed along the loading axis (axial splitting) as shown in Figure A12.7. (A typical failure mode for most of the specimens tested).

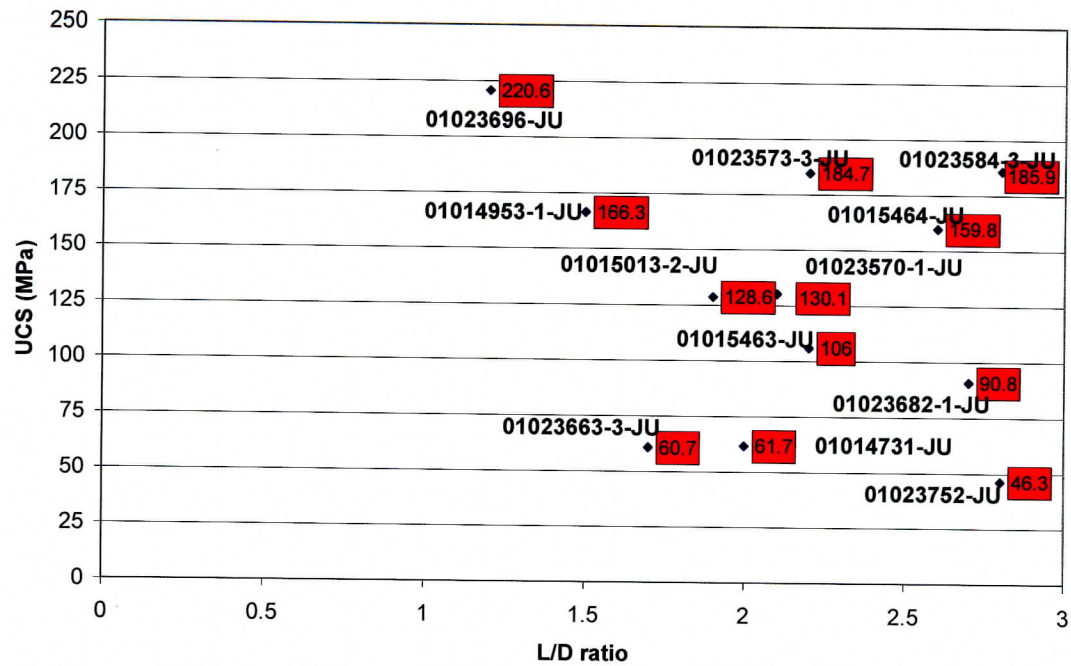
Fig. B1: Uniaxial compressive strength vs. length to diameter ratio with specimen identification.

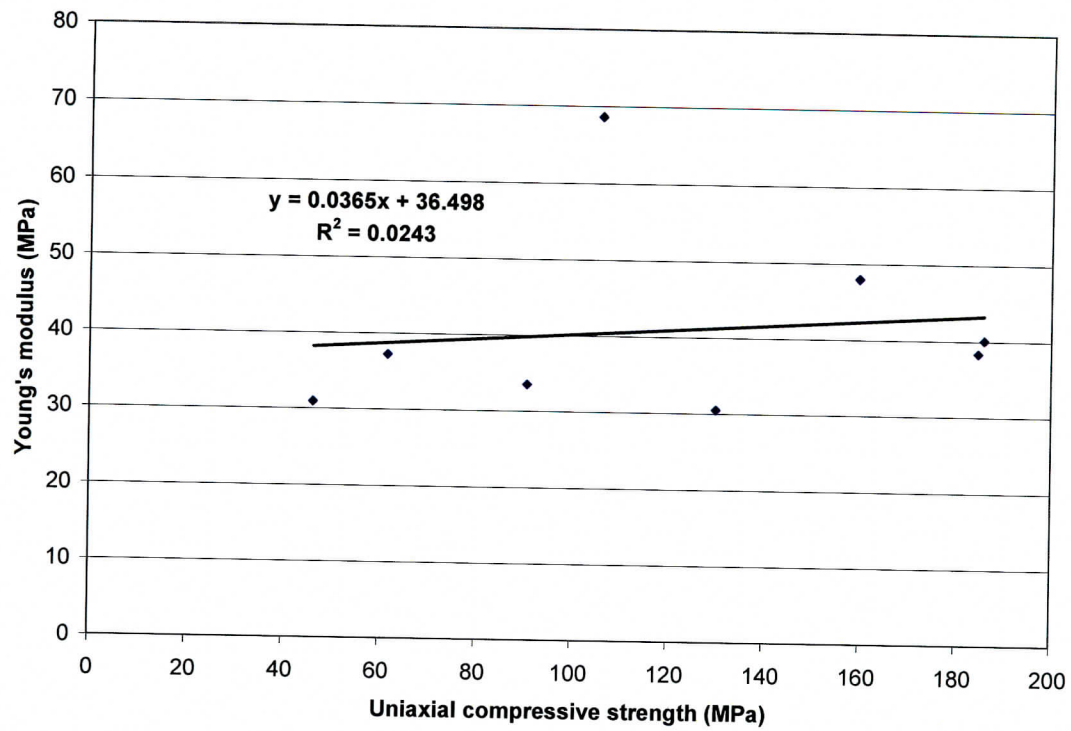
Fig. B9: Best fit linear regression plot of Young's modulus vs. uniaxial compressive strength according to ASTM and IRSM L/D ratio standards.

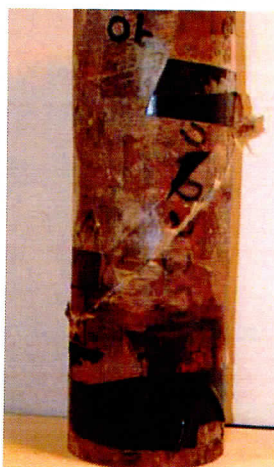
Fig C1.1 Specimen 01023540-2-JU after testing (joint “a” is above “b”).

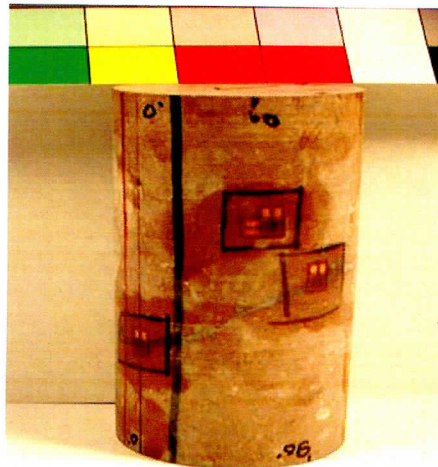
Fig C.2.1: Pre-failure photograph of specimen 01023540-5-JU with strain gages along the 0° and 90° axes. Note complex joint geometry.

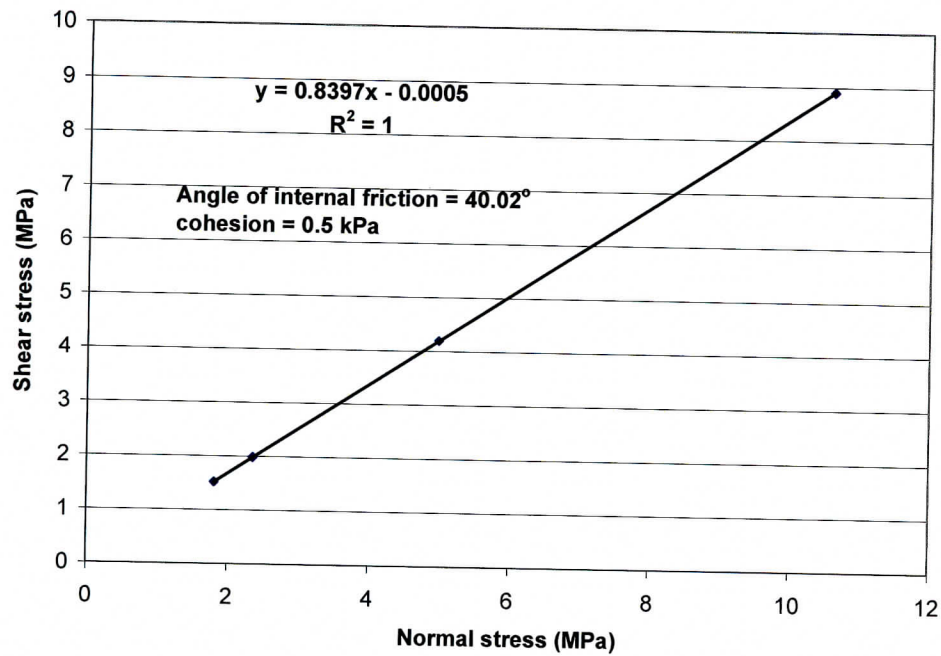
Fig. C2.2: Linear best fit plot of shear stress vs. normal stress.

The angle of friction (40°) and cohesion (0.5 kPa) were obtained from the linear best fit plot of shear stress versus normal stress as shown in Figure C2.2.

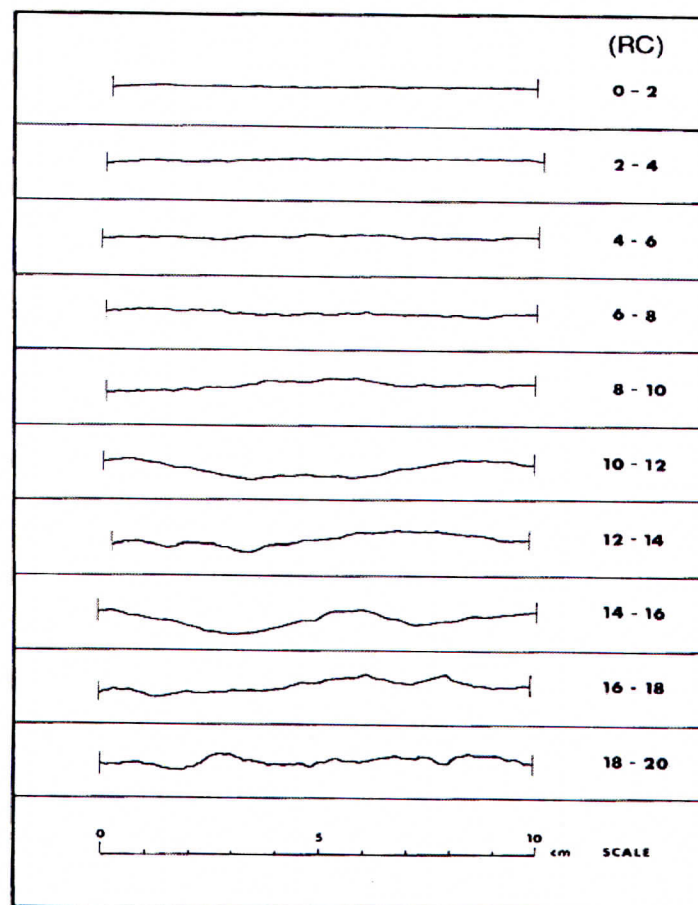
Fig D1: Profiles of fracture-surface roughness (Barton and Choubey, 1977, p.19).
(Non-Q, for information only)

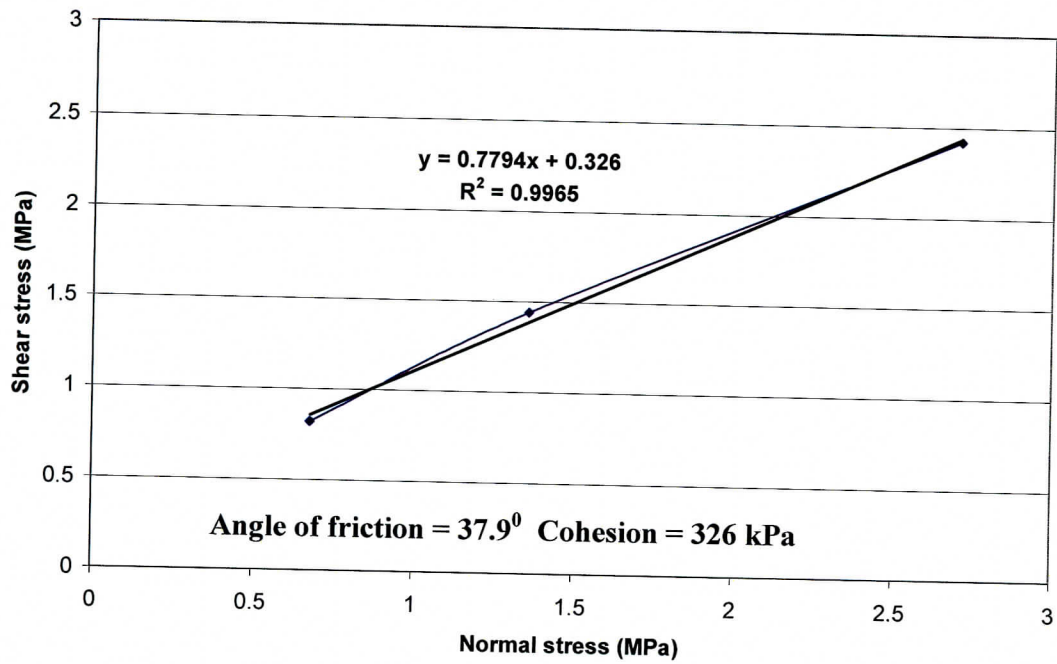
Fig. D2.1: Linear best fit plot of shear stress vs. normal stress.

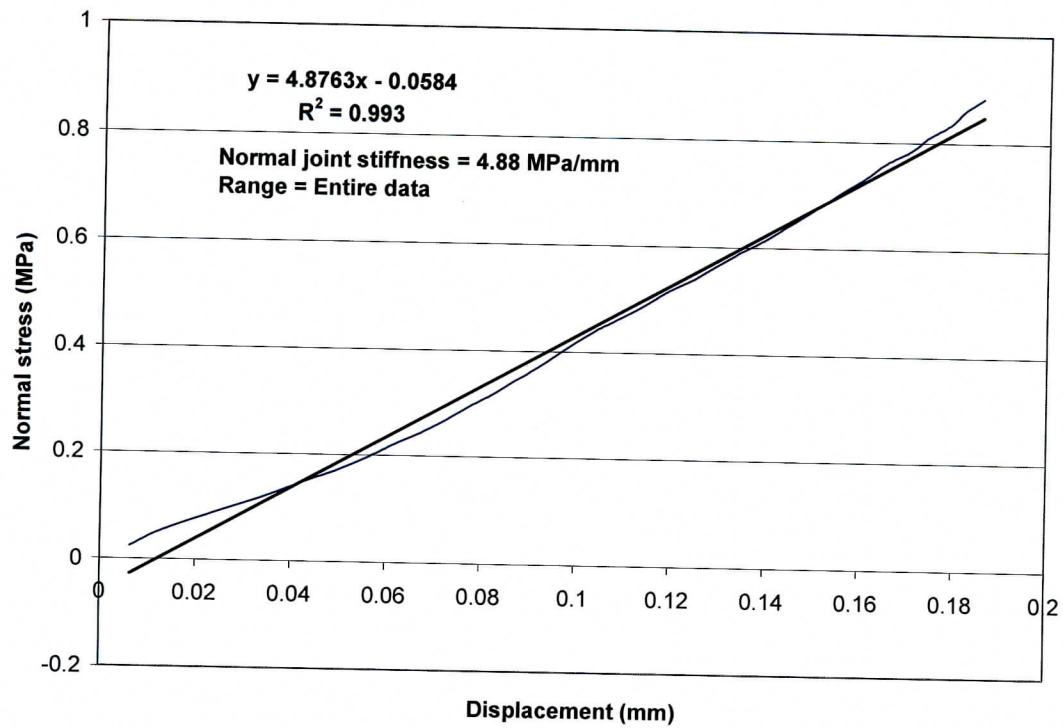
Fig. D1.3 Linear best fit plot of normal stress vs. normal displacement (third cycle)

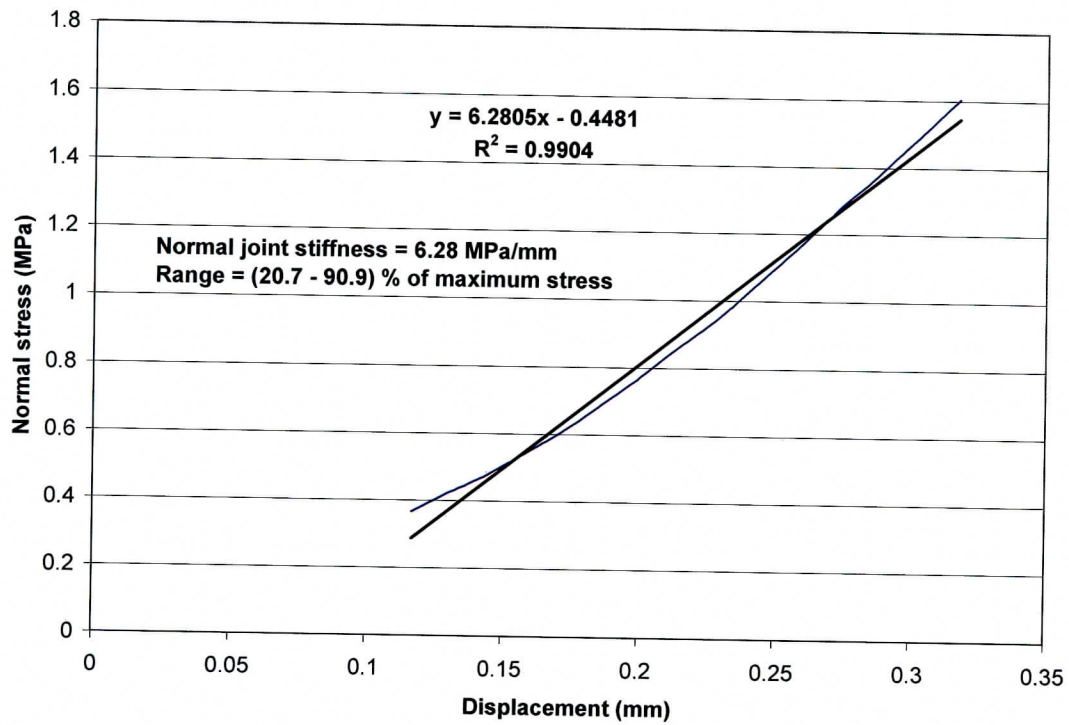
Fig. D1.4 Linear best fit plot of normal stress vs. normal displacement (fifth cycle)

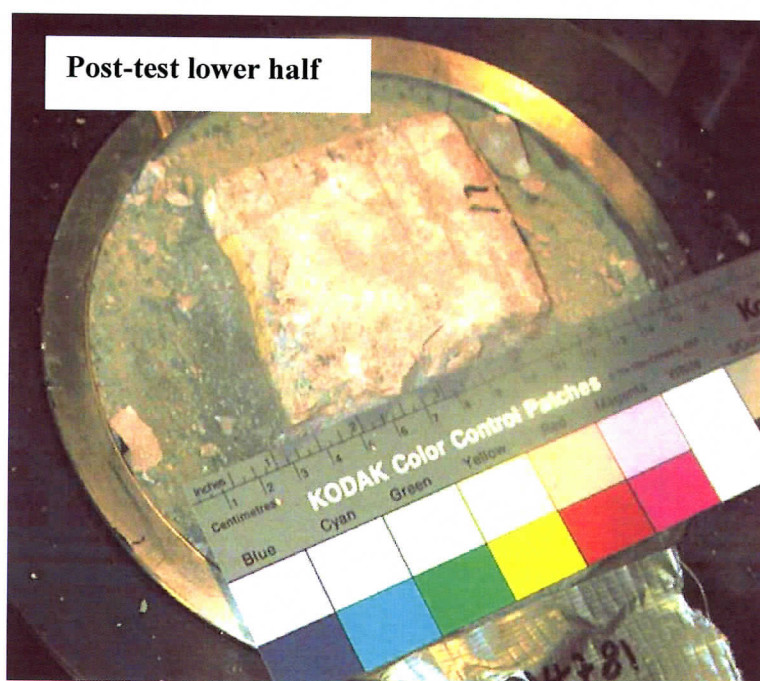
Fig. D2.8: Post-failure lower half of specimen 01014781-DS

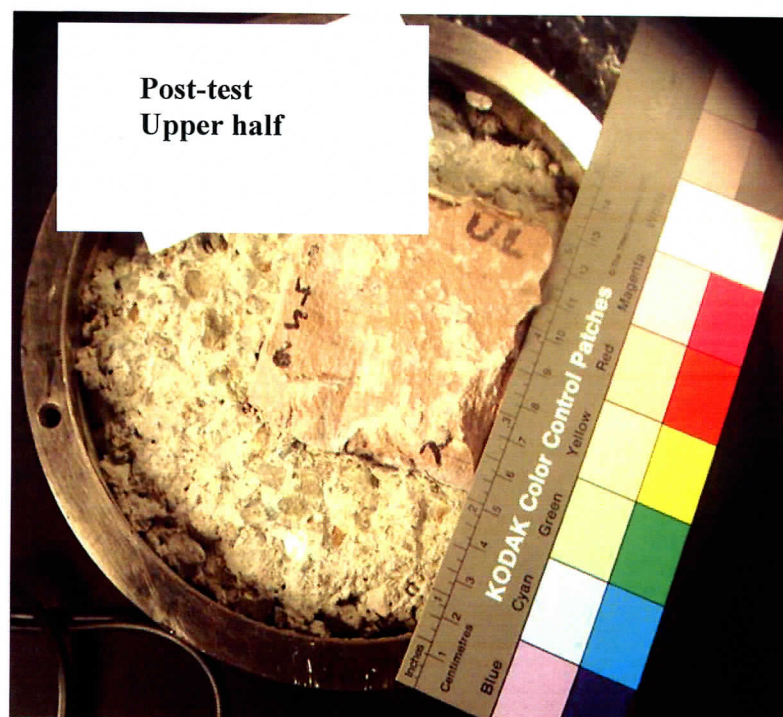
Fig D2.9: Post-failure upper half of specimen 01014781-DS

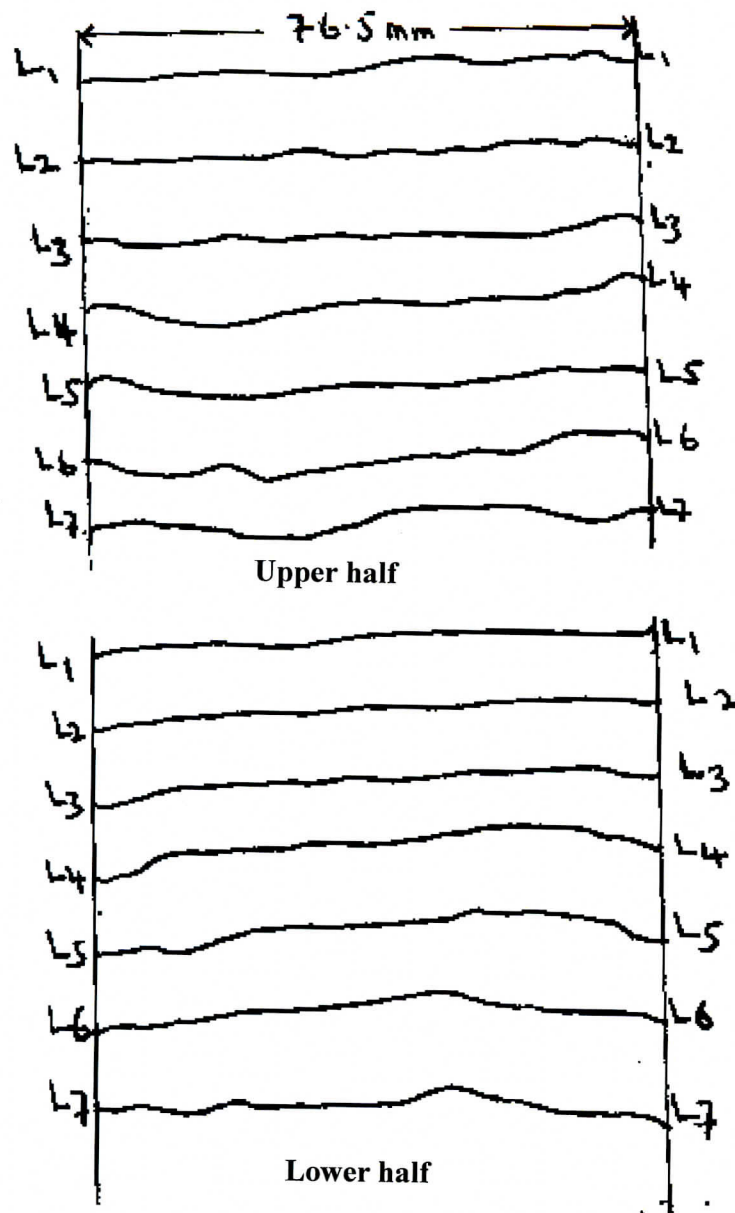
Fig. D2.10: Pre-test profiles of the fracture-surfaces of specimen 01014781-DS (Scale 1:1)
(Non-Q, for information only).

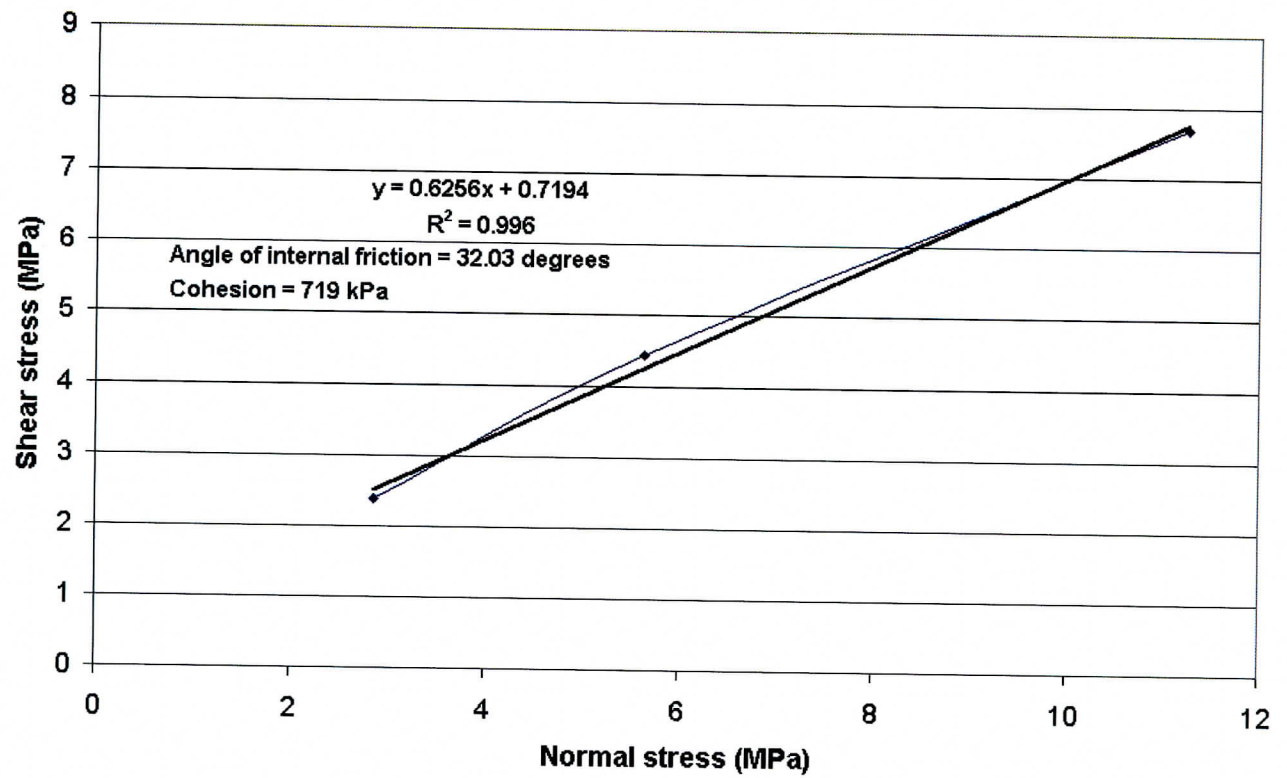
Fig. D3.1 Linear best-fit plot of shear stress vs. normal stress

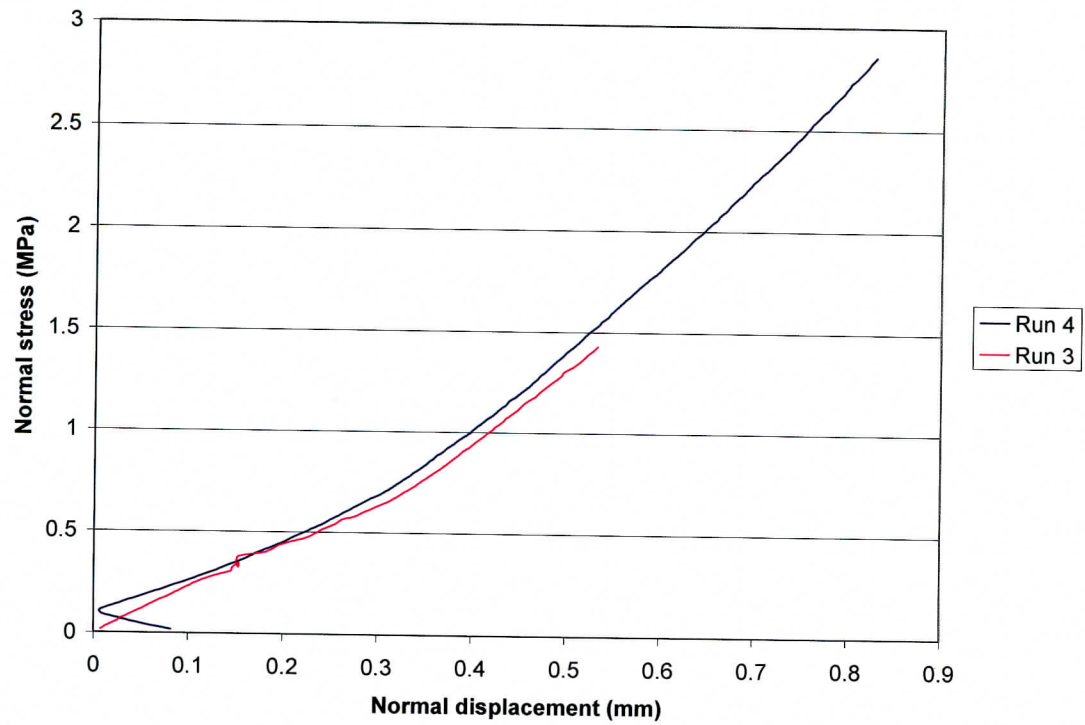
Fig D3.4 Normal stress-normal displacement curves for the third and fourth cycles

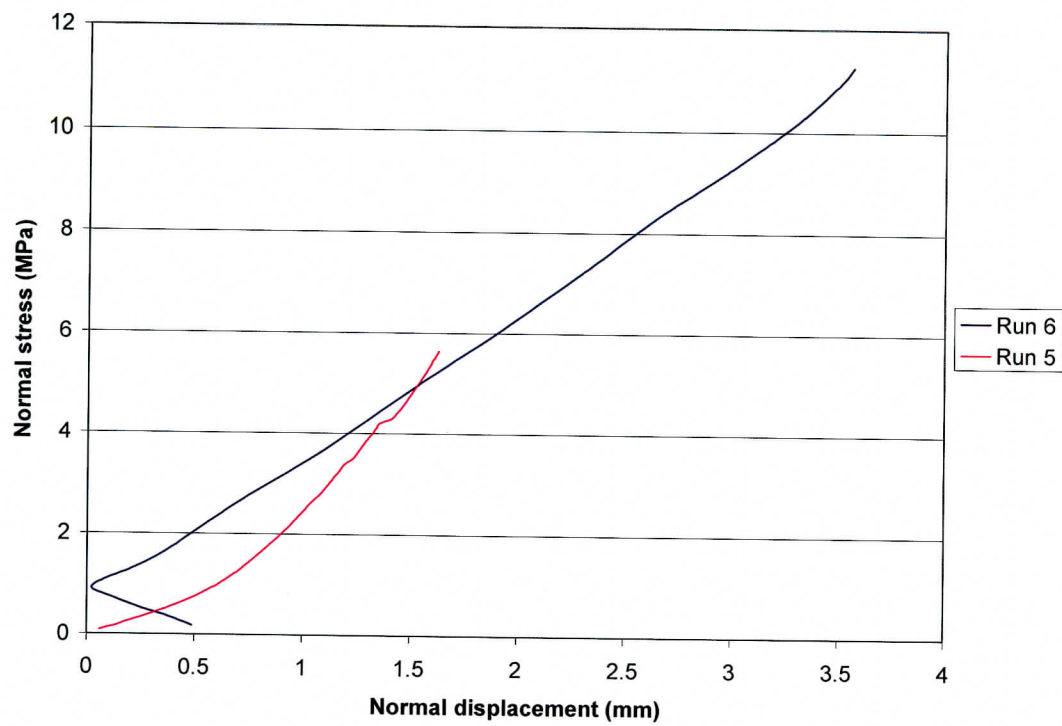
Fig D3.6 Normal stress-normal displacement curves for the fifth and sixth cycles

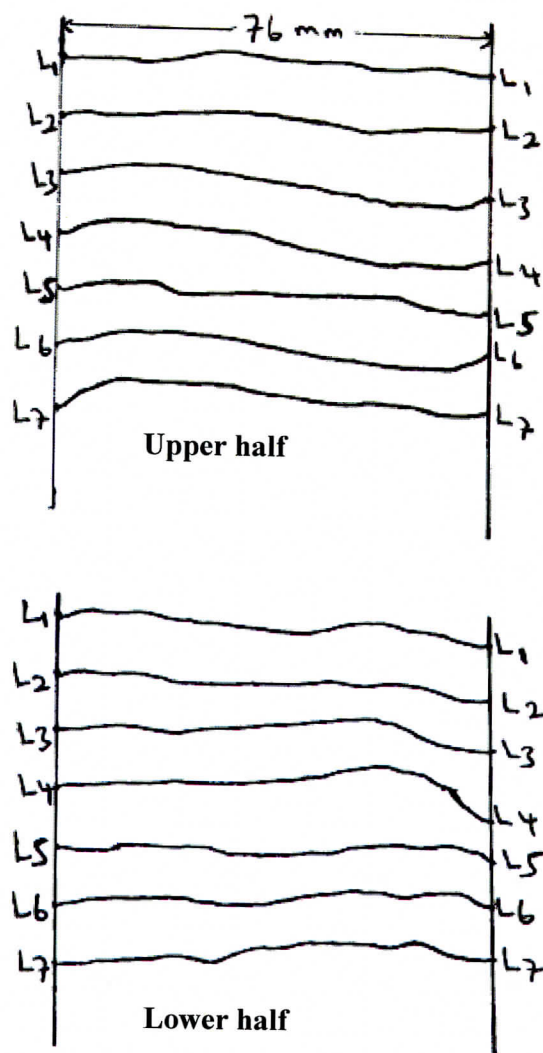
Fig. D3.12 Pre-test profiles of the fracture surfaces of specimen 01014782-DS (Scale 1:1).

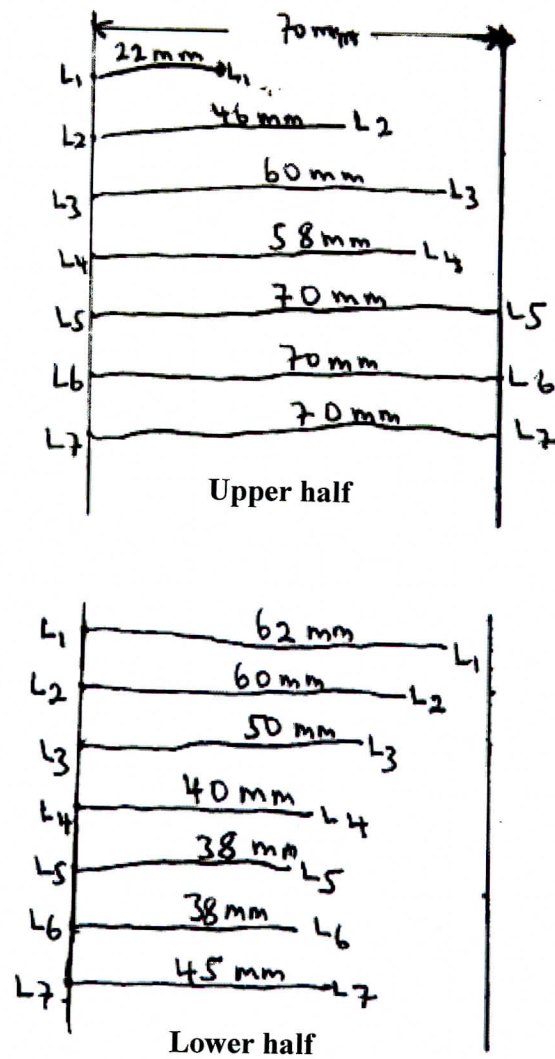
Fig. D3.13 Profiles of the fracture surfaces of specimen 01014782-DS after testing. Scale 1:1.

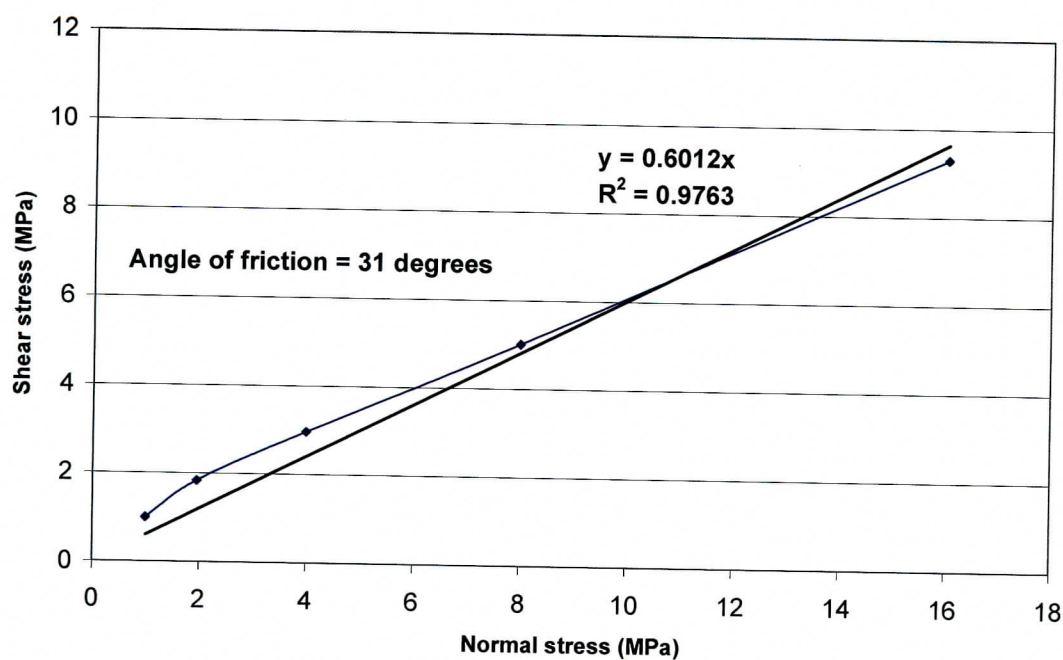
Fig. D4.1 Linear best-fit plot of shear stress vs. normal stress. Best fit straight line is forced through origin (i.e. cohesion assumed equal to zero).

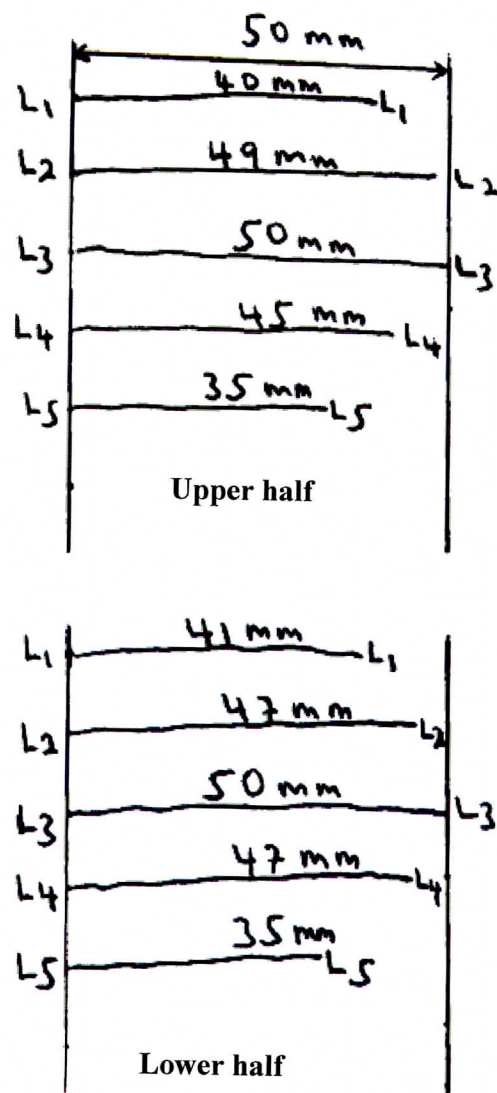
Fig D4.2 Profiles of fracture-surface roughness before testing.

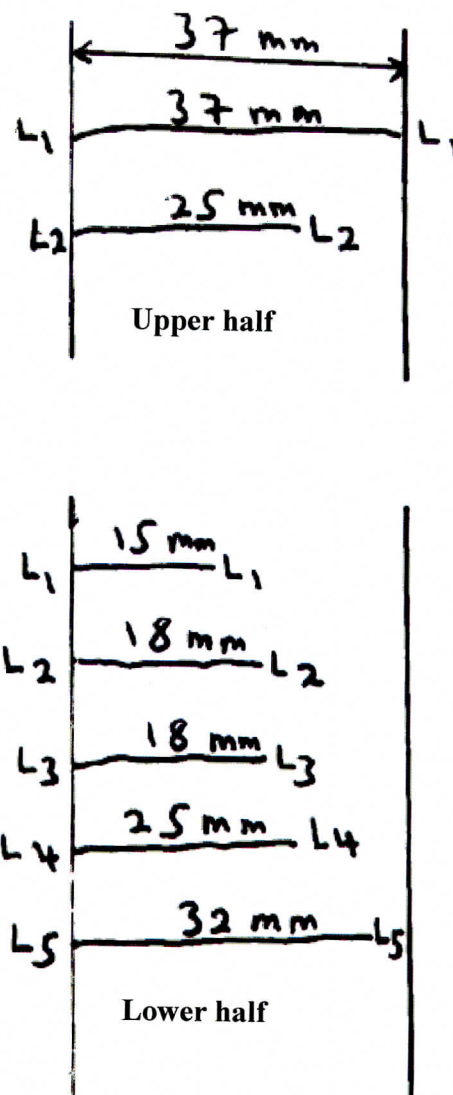
Fig D4.3 Profiles of fracture-surface roughness after testing.

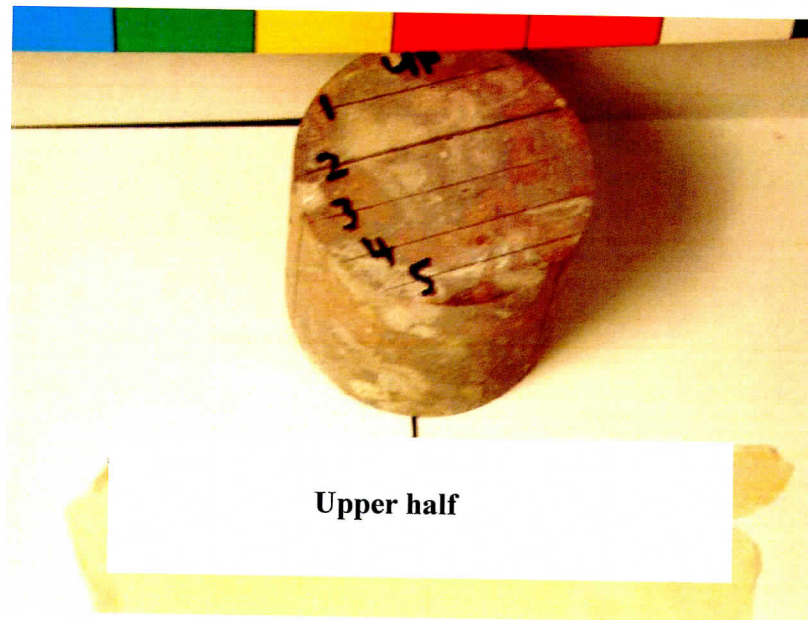
Fig D4.4 Pre-test upper half of specimen 01023540-3-DS

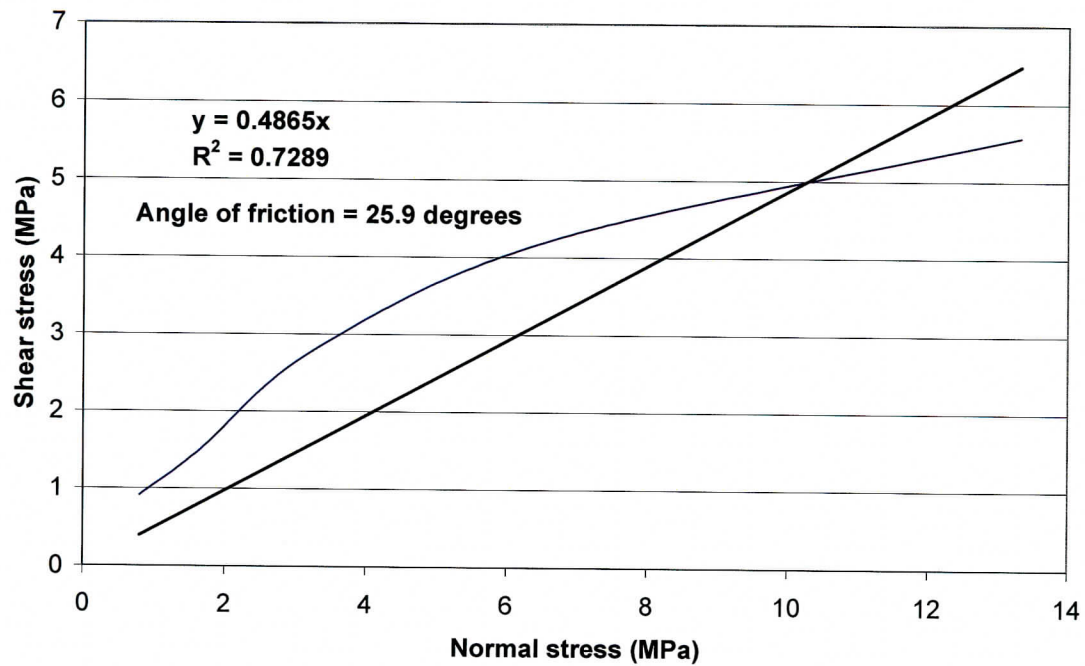
Fig. D5.1 Linear best-fit plot of shear stress vs. normal stress. Best fit straight line is forced through origin (i.e. cohesion assumed equal to zero).

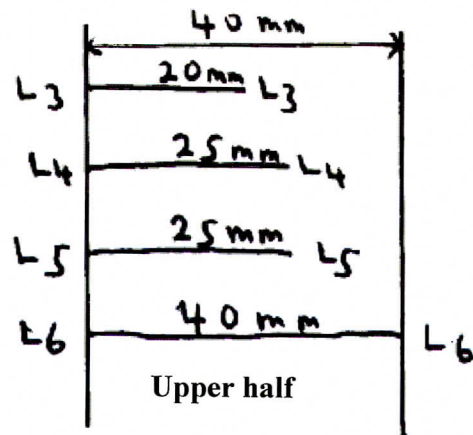
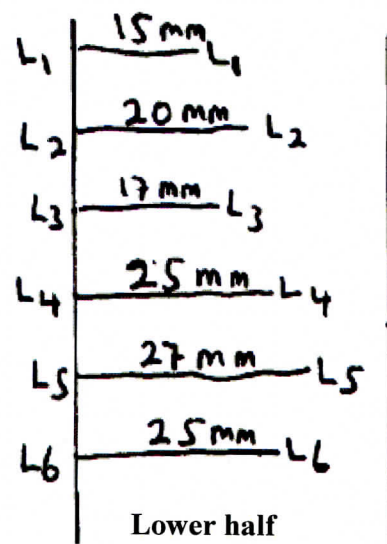
Fig. D5.3 Profiles of fracture-surfaces after testing.

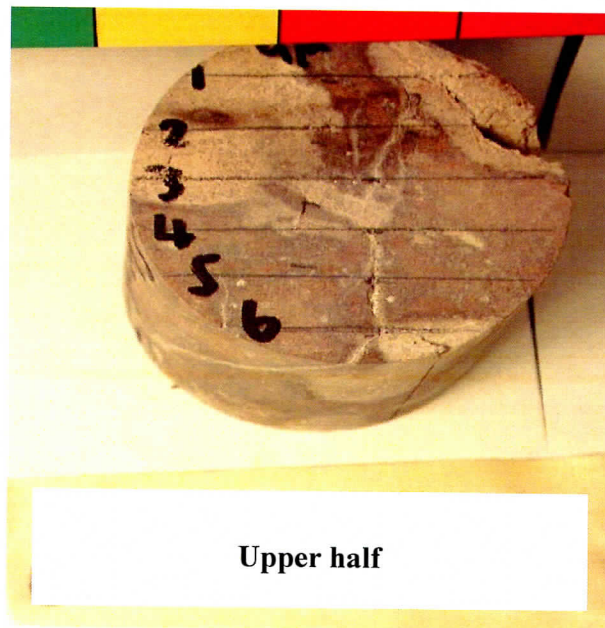
Fig. D5.4 Pre-test upper half of specimen 01023540-6-DS
