The Design and Testing of a Solar Autoclave with Broad Spectrum Sterilization Capabilities

Sarah S. Trabia

Honor thesis submitted in partial fulfillment
for the designation of Department Honors
Mechanical Engineering
Dr. Robert Boehm, Advisor
Dr. Ernesto Abel-Santos, Committee Member
Dr. Marta Meana, Committee Member
College of Engineering
University of Nevada, Las Vegas
November, 2012

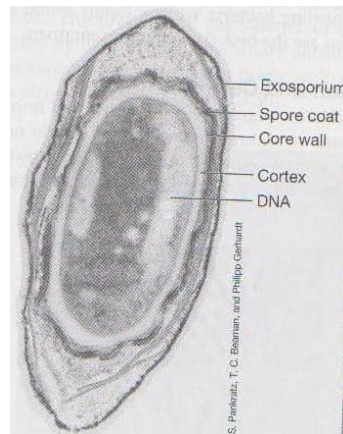
Figure 1: Spore Diagram

The outermost layer is the *exosporium*, a thin protein covering. Within this are the *spore coats*, composed of layers of spore-specific proteins. Below the spore coat is the *cortex*, which consists of loosely cross-linked peptidoglycan, and inside the cortex is the *core*, which contains the core wall, cytoplasmic membrane, cytoplasm, nucleoid, ribosomes, and other cellular essentials. (Madigan et al., 2012)

All of the layers listed above work together to protect the cell while it is in dormant state. This is illustrated below in Figure 1. "The complex intercalates (insert between bases) in DNA, which stabilizes DNA against heat denaturation" (Madigan et al., 2012).

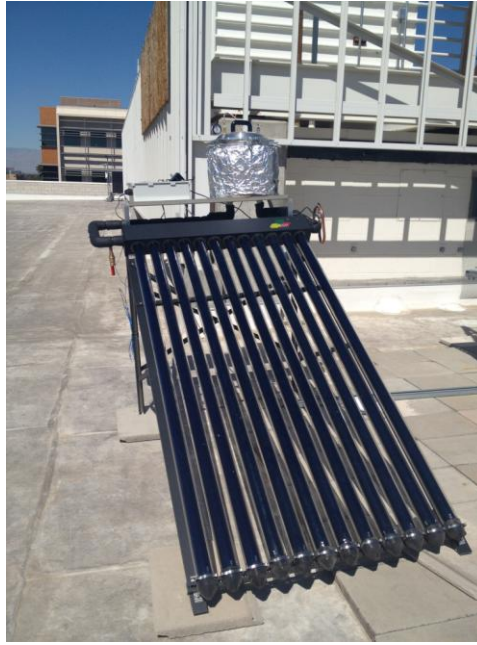
Figure 2: Final Design

Since one of the goals was to have no electrical input, pumps were out of the question. It was necessary to have each of the components at certain heights so that gravity could assist in creating the circulation. The autoclave was set up at the highest point, since steam rises. The collector header where the heat pipes are attached was at the lowest point. The water was poured directly into the autoclave, where it would drain down into the collector header to be heated. It was expected that the steam would rise into the autoclave and when it lost energy and cooled down, it would fall back down to the collector header to be reheated. The final design is shown

in Figure 2. The pipes were copper covered in insulation. The steam was allowed to flow freely throughout the system. It was directed by the slight slant of the collector header, pushing the steam into the direction towards the autoclave (shown in Figure 3).

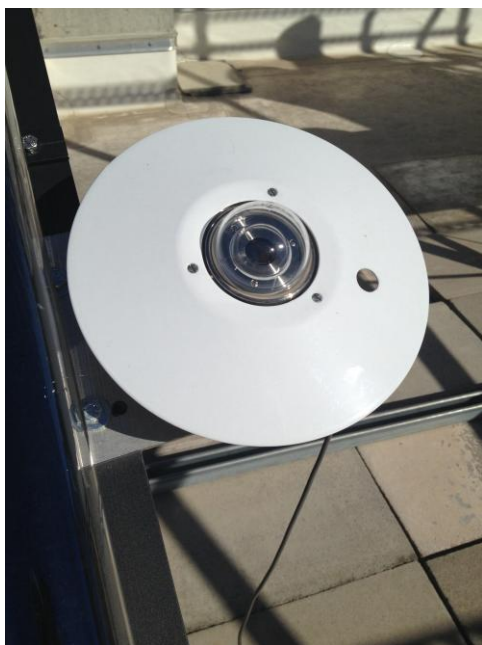
Figure 4: Pyranometer

In order to track events during the experiments, a data logger and many different sensors were used throughout the system. The data logger used was a Campbell Scientific CR 1000, which comes equipped with a computer program that assists in writing the program to read and collect all of the data from the different sensors. The program is easily written and can be imported to Excel to be analyzed. A laptop can be connected while an experiment is run and the data points can be plotted so that the user can see the changes. This feature makes it easy to see if the cycle is working during the experiment. There are thermocouples at the inlet and outlet of the collector header, for the ambient air, reference temperature (within the data logger and an additional one added to the data logger), and a final one that goes into the top of the lid of the autoclave to record internal the temperature (Model Number: CF-000-T-2-60-1). All of the thermocouples were purchased from Omega. The thermocouple that was in the autoclave reaches about a 1/4" into the autoclave. The thermocouples for the inlet and outlet were placed on the outside of the piping beneath the insulation, before the collector header and after. A pyranometer is an Eppley PSP used to measure the incident radiation of the sun (Figure 4). This was placed at the same angle as the heat pipes so that the pyranometer would be receiving the same amount of radiation as the heat pipes. A pressure transducer (Model Number PX309-100A5V), purchased from Omega, was added near the outlet of the collector header to keep track of the pressure changes throughout the experiment (Figure 5). It has a pressure range from 0-100 psia and a working temperature range of 4 to 185F.

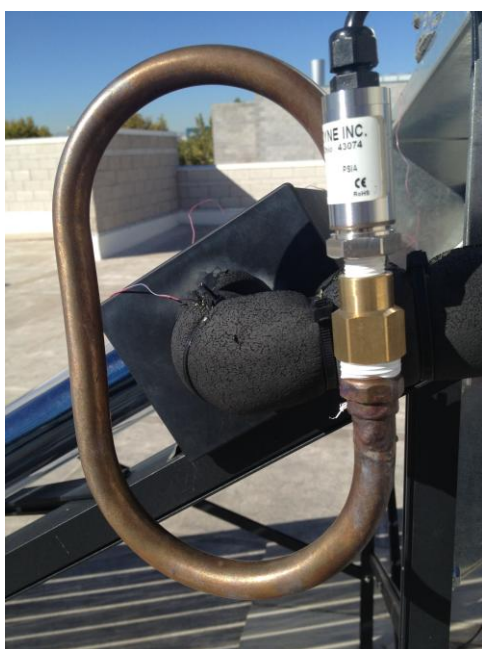
Figure 5: Pressure Transducer

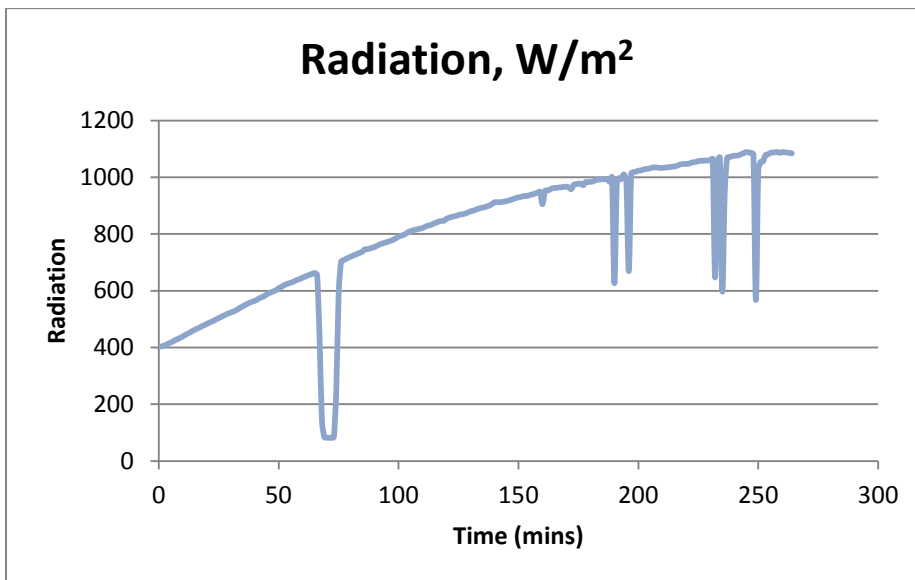
Figure 7: 1 L, Radiation

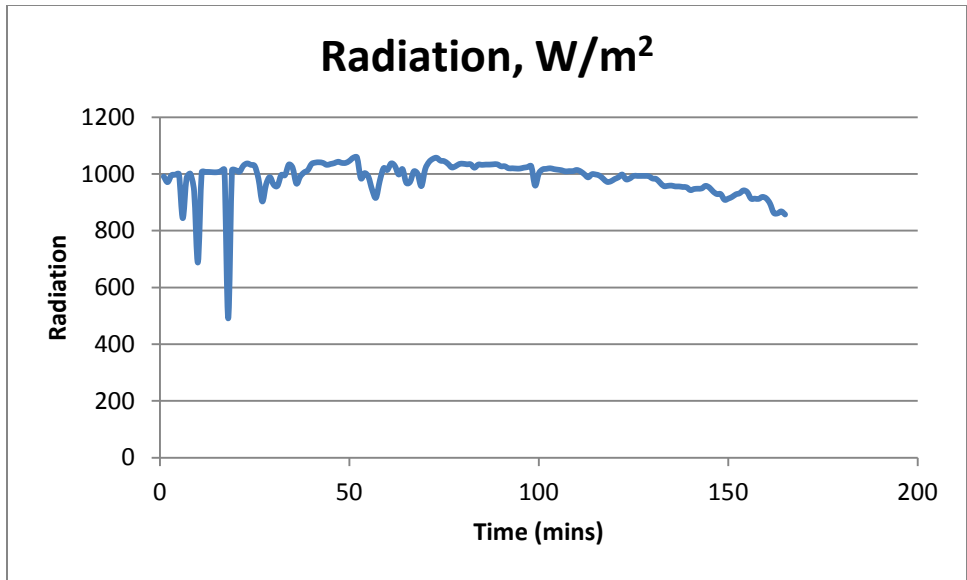
Figure 10: 300 mL, Radiation, Trial 1

The amount of water was reduced to 300mL and the system was run again. The temperatures throughout the system are shown in Figure 9. The radiation from that time period is in Figure 10. The temperature versus pressure graph (Figure 11) shows that the system did work; not only was the autoclave able to reach a pressure of about 17 psi, but the air was purged and the system was able to rebuild the pressure. The autoclave was at a temperature of above 121°C for over 50 minutes. This trial shows that the solar autoclave can reach the goals requisite for sterilization. The experiment was repeated again with the same amount of water and it was successful yet again. For this trial, the temperatures throughout the system, radiation from the time the trial was run, and the temperature versus pressure graphs are shown in Figures 12, 13, and 14, respectively. In this trial, the autoclave was able to reach a pressure 17 psi and the system was purged of its air. From the graph, it can be seen that the pressure was steadily increasing back up to 17 psi. One thing to note is that the temperature of the autoclave in this trial did not reach the goal of 121°C. The maximum temperature reached 118.77°C. However, there may have been some error with the thermocouple used. Using a more accurate

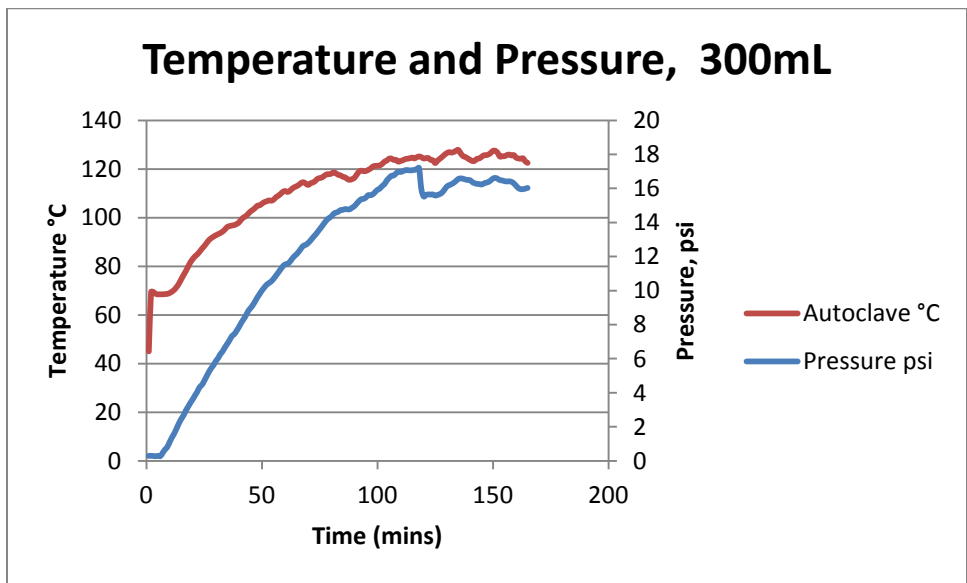
Figure 11: 300 mL, Temperature vs. Pressure, Trial 1

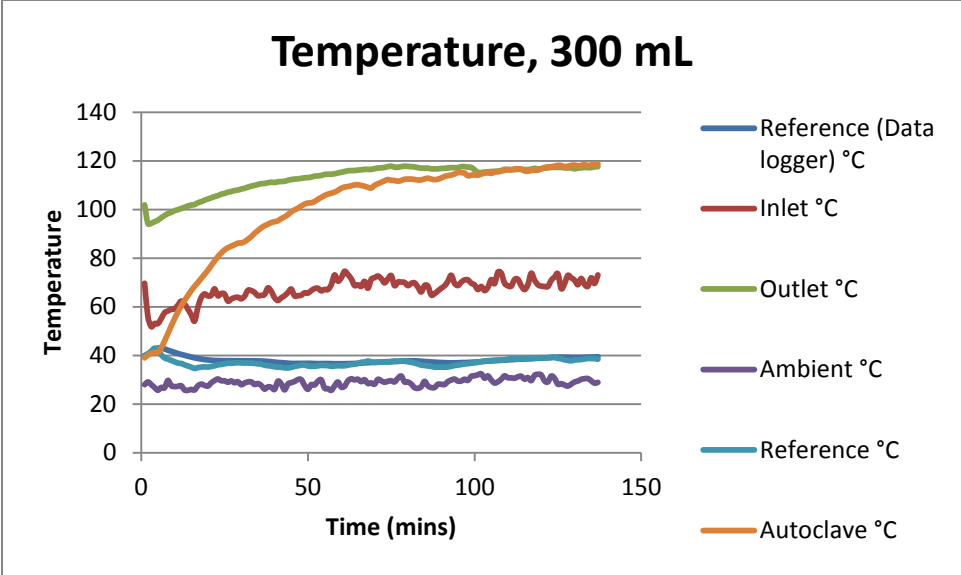
Figure 12: Temperatures, 300 mL, Trial 2

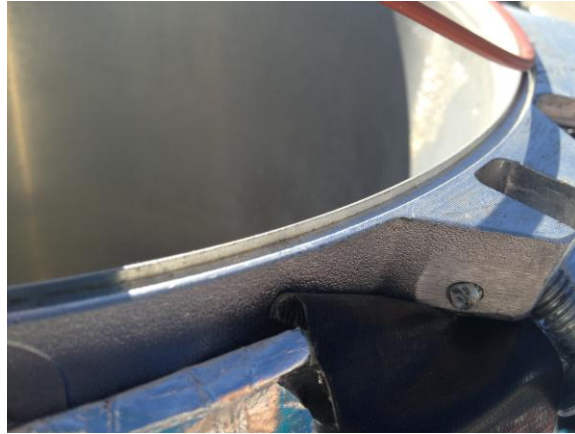
Figure 16: Machined groove for O-ring

When the system was run again, it was not able to hold pressure at all. There was a leak at the seal of the autoclave. It was not possible for the autoclave to build up pressure, thus making it impossible for the system to reach the goal temperature and pressure. To fix this, a groove for an O-ring was machined (Figure 16). This would allow for a full seal and assure that the lid of the autoclave would close level. Once this was done, the system was run again.

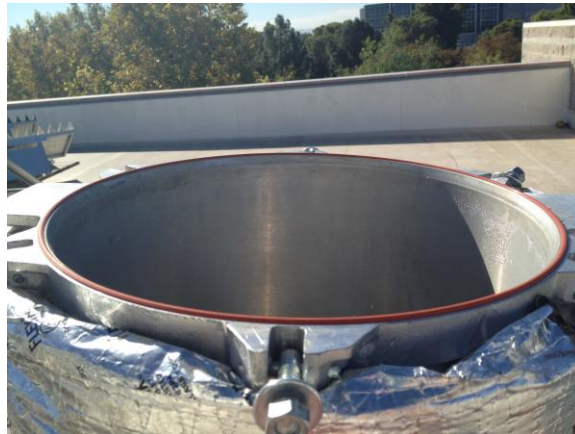
Figure 17: Autoclave with O-ring

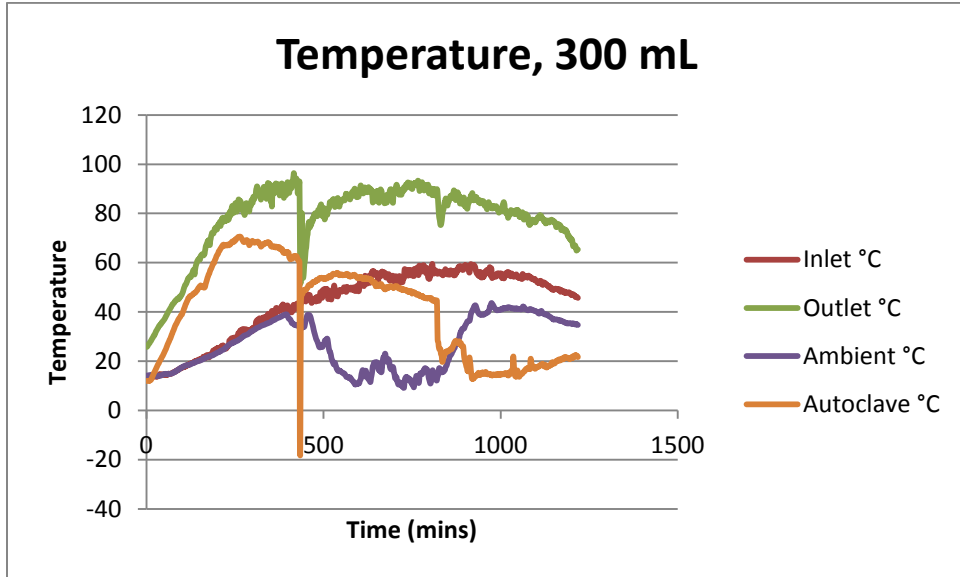
Figure 18: Temperatures, Last Trial

The last trial graphs are shown below in Figures 18, 19, and 20. From the temperature versus pressure graph, it can be seen that the autoclave was not able to reach the goal temperature and pressure. The system was left to run for the day, but it was still not able to build up pressure above 9 psi and the temperature did not cross about 70°C. This means that there was a constant leak in pressure somewhere in the system. Because of this leak, it made it impossible for

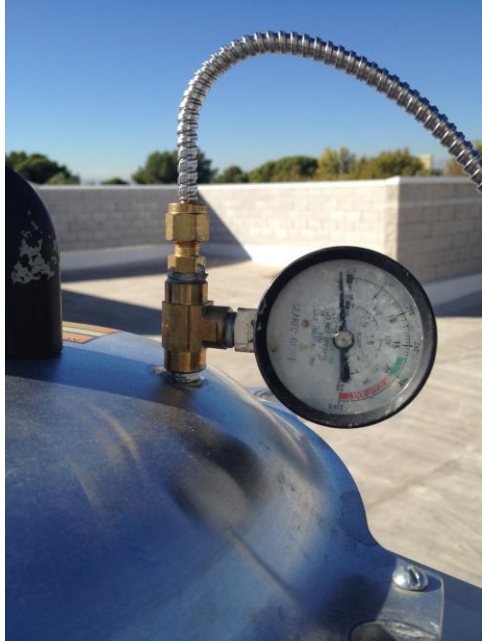
Figure 21: Piping where the thermocouple and pressure gauge connect to the lid

From the results shown above, it can be seen that a solar autoclave can be designed, but further research and redesign is needed. In order to fix the pressure leak issue, it will be necessary to find where it is leaking from. There are many possible leakage points. The seal on the autoclave had been resolved by adding the O-ring. The main points that need to be looked at would be where the thermocouple and pressure gauge are connected to the lid of the autoclave (Figure 21). It would need to be taken apart and cleaned with acetone to remove any dirt that may have collected over the time the autoclave was sitting outside. Teflon tape and a sealant could be added to help those points from leaking. If it is not the threads where it is leaking, it may be that the pressure gauge itself is leaking. After months of exposure to the sun, the materials in the pressure gauge may have weakened and cracked. This would have to be replaced before another test is run. Another place where it could be leaking pressure is from the points where the copper piping attaches to the autoclave (Figure 22). This can be fixed the same way as the previous issue. Once these are both taken apart, cleaned, and put together again with a new layer of Teflon tape and sealant, the system could be run as if it was being tested, then the points where it was thought there was pressure leaking could be applied with a solution that begins to bubble if there is air leaking. This would help in finding if these points are still an issue. Once this is resolved, it would be possible to begin testing again.

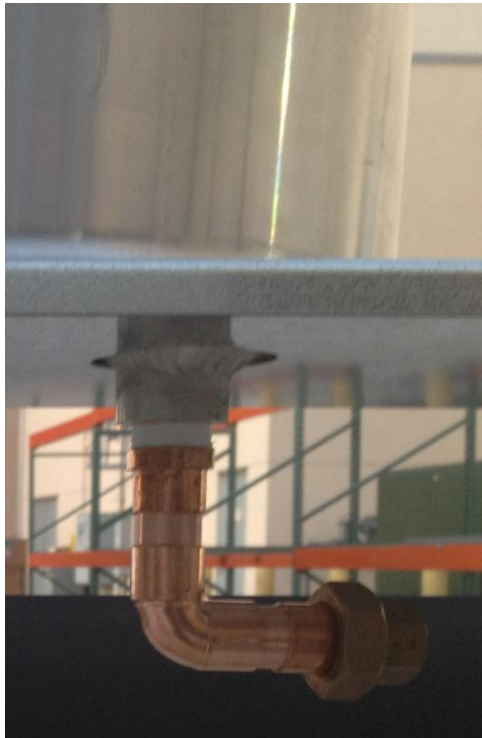
Figure 22: Copper piping that attaches to autoclave
