Performance of Concrete Incorporating Colloidal Nano-Silica

PERFORMANCE OF CONCRETE INCORPORATING
COLLOIDAL NANO-SILICA

Doctor of Philosophy in Civil Engineering

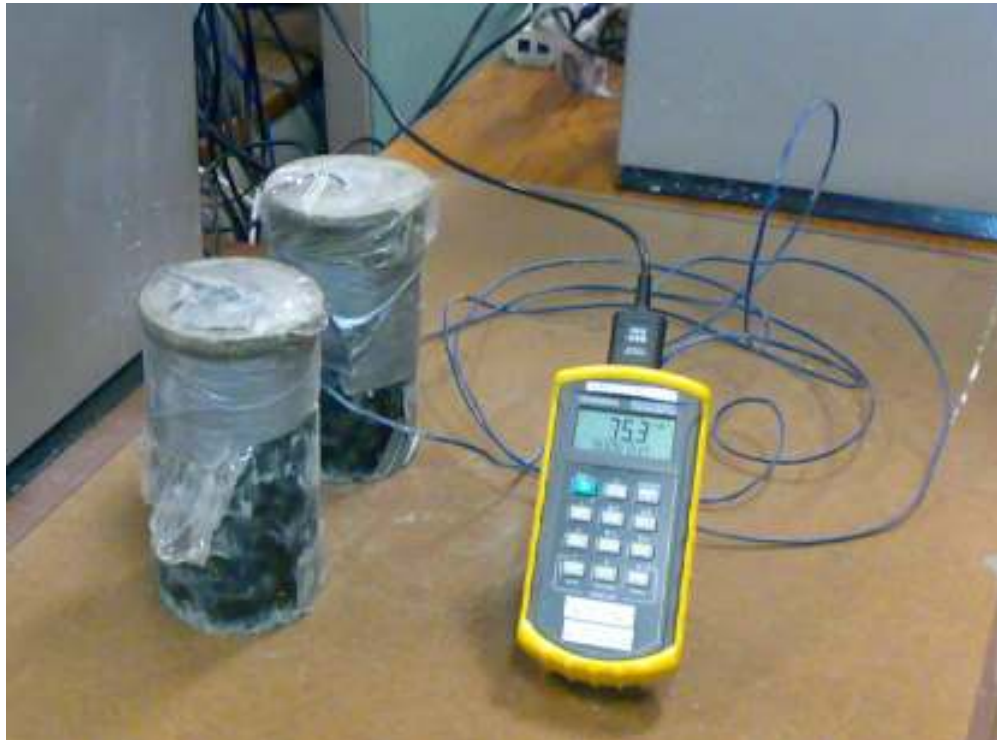
Figure 5 Adiabatic temperature test setup.

In order to monitor the change in temperature in the different concrete mixtures during the early hydration period, the adiabatic temperature test was conducted. Immediately after mixing, a 4×8 inches concrete cylinder mold is prepared and a thermocouple is inserted at 4" below of the cylinder top surface (mid height) in order to measure the temperature of the mixture according to ASTM C1064. The cylinder molds were covered and sealed to prevent moisture loss during the test and were kept in room temperature ($73 \pm 3^{\circ}\text{F}$). The adiabatic temperature of concrete was recorded every 2 minutes using a data

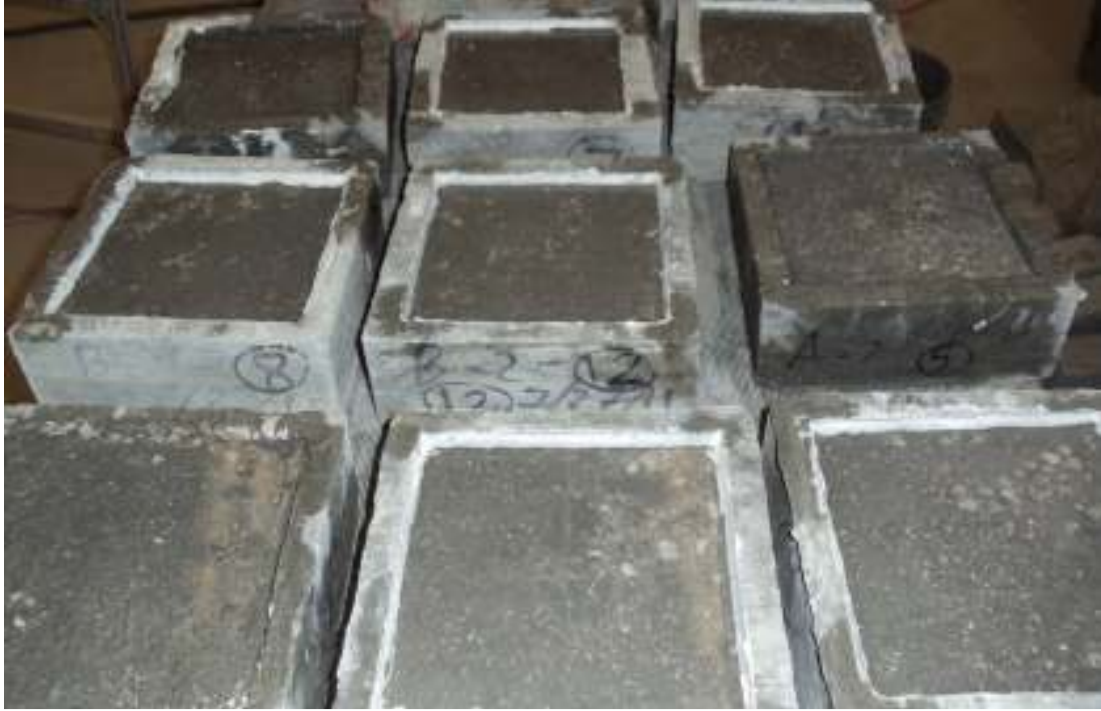
Figure 21 Surface scaling specimens during testing.

rated according to ASTM C672. The rating system is based on a scale of 0 to 5 with 0 means no scaling and 5 having the most severe scaling.

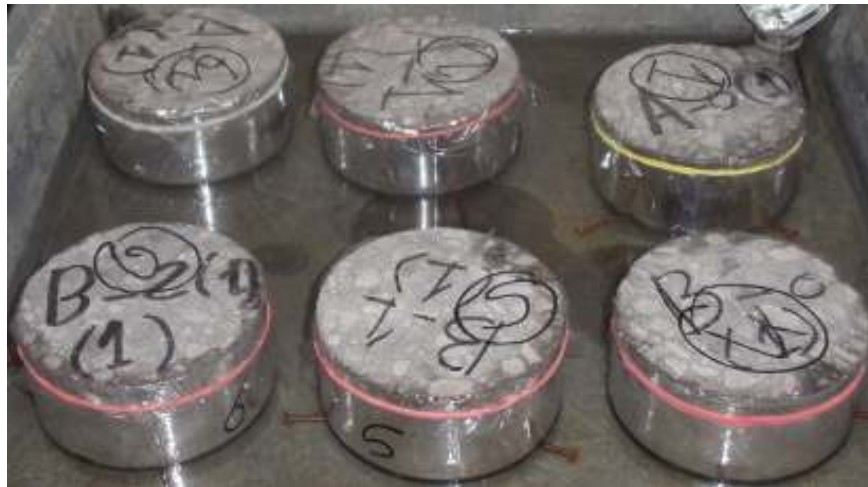
Figure 32 Specimens during absorption testing.

sides and top seals) to the nearest 0.01g and they were placed in a pan filled with tap water. The water level was kept at 1 to 3 mm above the bottom exposed surface during the eight days test duration. Figure 32 shows some of the specimens during the test procedure. During the test, the increase in mass of the specimens was monitored at specific times up to 8 days according to ASTM C1585. The absorption, I (mm), was calculated as the mass change in each specimen divided by the product of the cross section and the density of water. As specified by ASTM C1585, the absorption values were then plotted against the square root of the time in seconds.

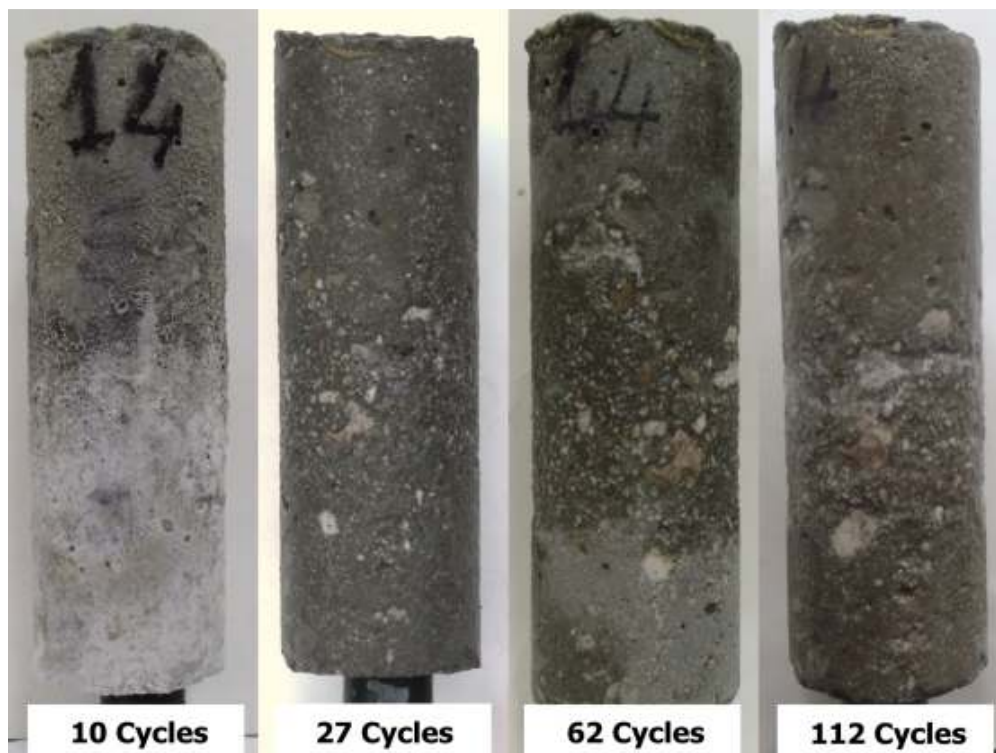
Figure 37 Damage in B-0 specimen at different ages of exposure.

in the damage observed in the tested specimens. This also conforms to the visual inspection of the specimens (Figures 34 through 39) which indicate no or inconsiderable damage at the immersed portions of the specimens although these parts are more vulnerable to the chemical attack.

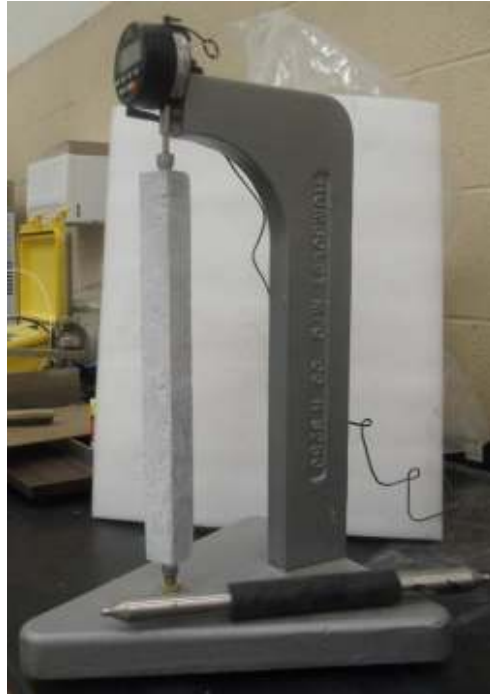
Figure 57 Length comparator and mortar bar specimen.

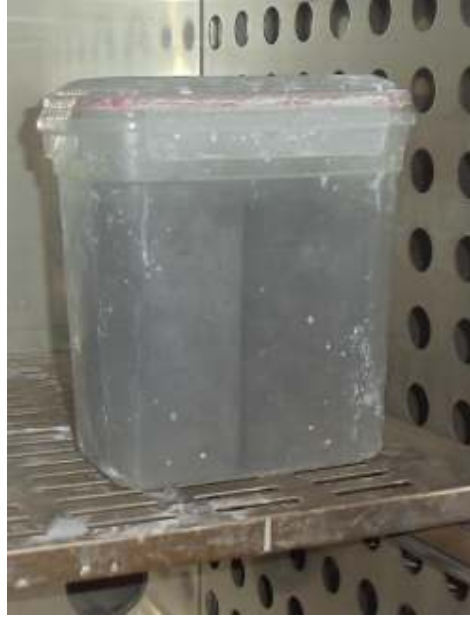
Figure 58 Containers and concrete cylinders inside the oven.

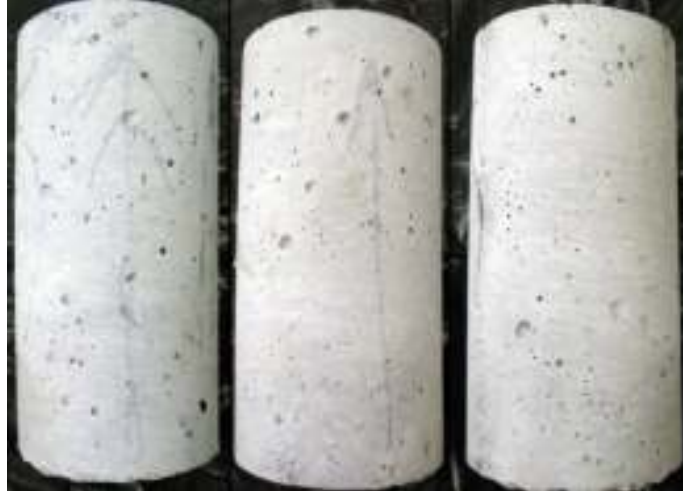
Figure 62 Concrete cylinders after 180 days of exposure.
